Report: Test and Balance
Date: 11/5/2021

PROJECT
ARBY'S #5451 - OKMULGEE, OK

129 S WOOD DR
OKMULGEE, OK

REMARKS

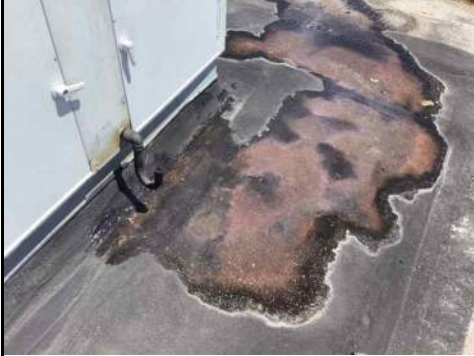
Issue ID:	0001	Status:	Open	Issue Priority:	
Equipment:	RTU-01			Created Date: 11-Aug-21	
Issue Description:					
Condensation lines are not installed correctly and is causing a water build up on roof.					
Issue Type:	Installation				
Role Assignment:	Mechanical Contractor				
Comments / Signature:					
Issue Photos:

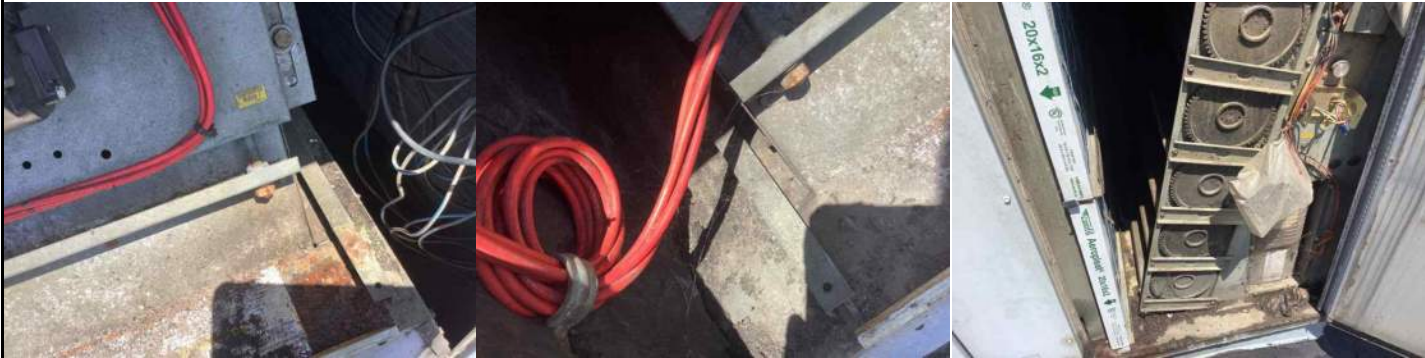
Issue ID:	0002	Status:	Open	Issue Priority:	
Equipment:	RTU-01			Created Date: 11-Aug-21	
Issue Description:					
Unit interior is very dirty and needs servicing.					
Issue Type:	Installation				
Role Assignment:	Mechanical Contractor				
Comments / Signature:					
Issue Photos:

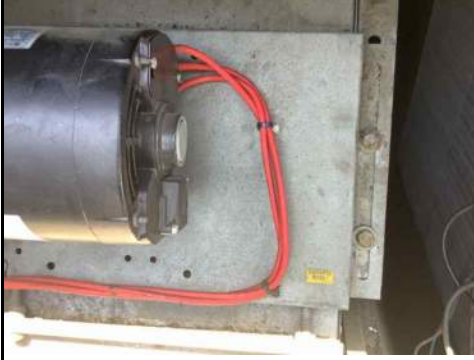
Issue ID:	0003	Status:	Open	Issue Priority:	
Equipment:	RTU-01				Created Date: 11-Aug-21
Issue Description:					
Belt is loose and was nit able to be tightened due to a bolt that was rusted shut.					
Issue Type:	Installation				
Role Assignment:	Mechanical Contractor				
Comments / Signature:					
Issue Photos:

HIGH	Belt is loose and could not be tightened due a rusted bolt. Recommend properly tightening.
RTU-2 (DINING)	
INFO ONLY	Airflow is 435 CFM/ton which is acceptable.
LOW	Return grilles are dirty. Recommend cleaning.
HIGH	Manager stated that the dining room RTU will suddenly turn off and that she has to manually reset the RTU at the breaker. This issue was not observed while the TAB tech was on site. Recommend troubleshooting issue.
HIGH	Motor is overamping but the motor sheave is frozen and speed could not be reduced. Recommend breaking free and slowing down until the motor is below the FLA rating. Fan should still be within design tolerance after making the adjustment.
HIGH	Condensate drain is broken off. Recommend repairing so that the unit can properly drain.
HIGH	Humidity sensor alarm is present on the Prodigy controller. RTU has humidity control but the humidity sensor is not wired/installed. Recommend completing and ensuring that it is properly communicating.

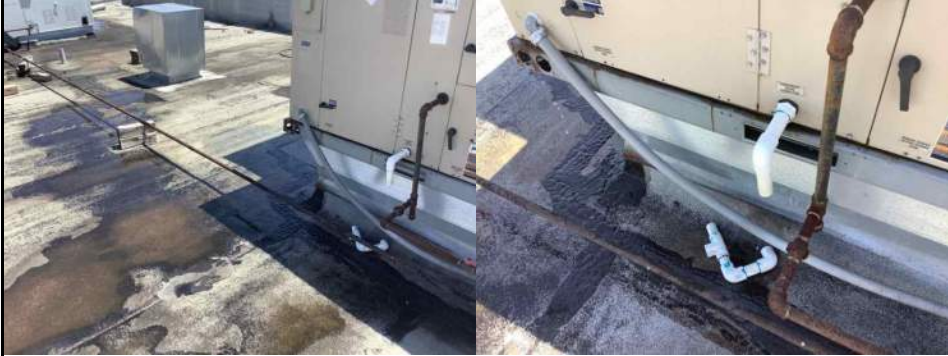
Issue ID:	0006	Status:	Open	Issue Priority:	
Equipment:	RTU-02			Created Date: 11-Aug-21	
Issue Description:					
Condensation lines are not installed properly and aren't connected causing a large water build up on roof.					
Issue Type:	Installation				
Role Assignment:	Mechanical Contractor				
Comments / Signature:					
Issue Photos:

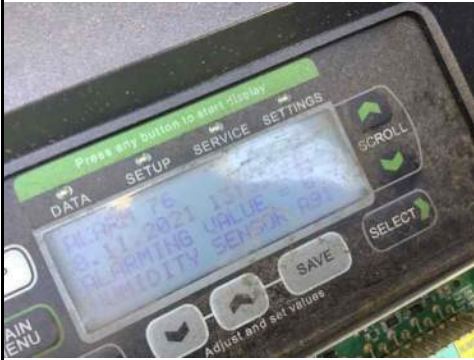
Issue ID:	0007	Status:	Open	Issue Priority:	
Equipment:	RTU-02			Created Date: 11-Aug-21	
Issue Description:					
Active alarm is reading: "Alarming Value:0 Humidity sensor A91"					
Issue Type:	Installation				
Role Assignment:	Mechanical Contractor				
Comments / Signature:					
Issue Photos:

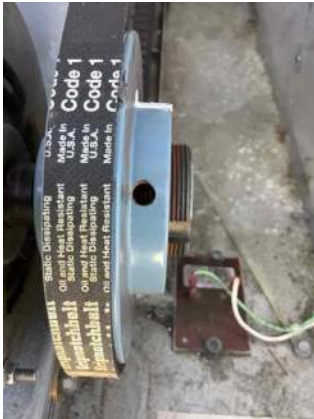
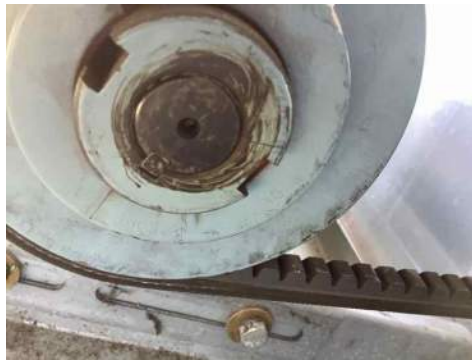
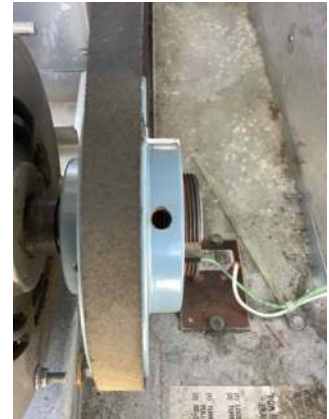
Issue Description:
 Unit is over amping and could not be slowed down due to the sheave being frozen shut, 2 missing set screws and slide in key.

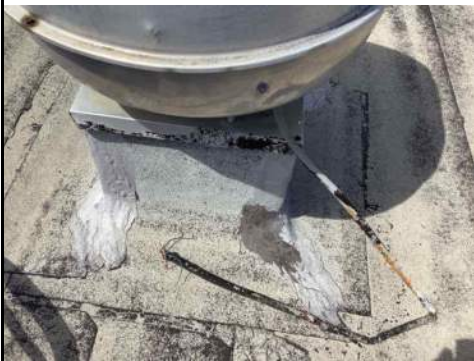
Issue Description:
 Fan is not wired in and is not operating.

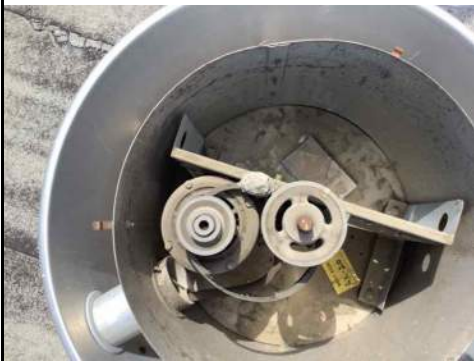
Name: Unit is very dirty and unit interior needs service.jpg
Captured: 8/11/2021 3:31 PM

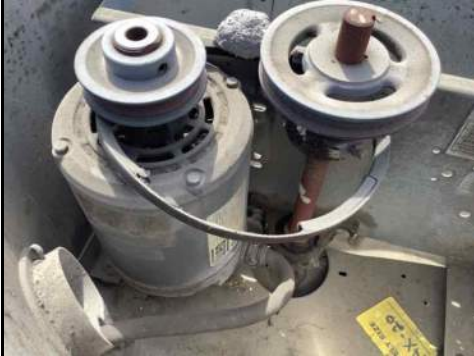
Issue ID:	0012	Status:	Open	Issue Priority:	
Equipment:	Kitchen Fan-02			Created Date: 11-Aug-21	
Issue Description: Belt needs to be replaced.					
Issue Type: Installation					
Role Assignment: Mechanical Contractor					
Comments / Signature:					
Issue Photos:

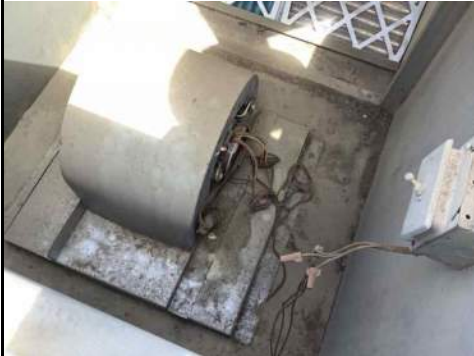
Issue ID:	0014	Status:	Open	Issue Priority:	
Equipment:	MAU			Created Date: 11-Aug-21	
Issue Description: MAU is not operating.					
Issue Type: Installation					
Role Assignment: Mechanical Contractor					
Comments / Signature:					
Issue Photos:

EF-4 (RESTROOM)	
HIGH	Fan is not operational and should be replaced. Curb size is 19.5"x19.5".
MUA (FRYER HOOD)	
HIGH	Fan is not operational. Fan is non-tempered and non-conditioned. Appears that based on HVAC/exhaust flows that a MUA will be required to maintain a positive building pressure. Recommend replacing with a heated MUA minimum and consulting Captive-Aire to see if they would recommend a conditioned MUA for the climate. Also recommend a PSP be installed in front of the hood for improved performance and comfort in the kitchen.

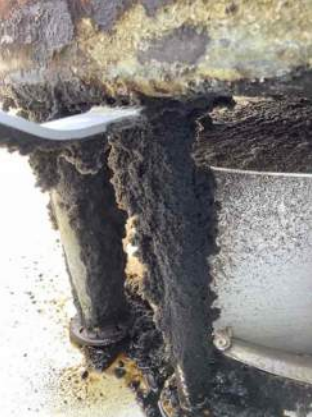
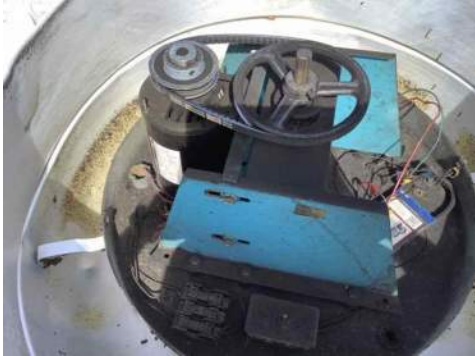
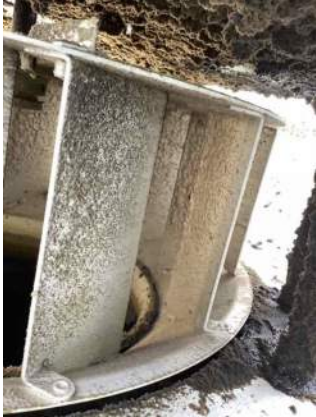
Issue ID:	0015	Status:	Open	Issue Priority:	
Equipment:	Kitchen Fan-01			Created Date: 11-Aug-21	
Issue Description: Unit is extremely filthy and needs the unit interior serviced.					
Issue Type: Installation Role Assignment: Mechanical Contractor Comments / Signature:					
Issue Photos:

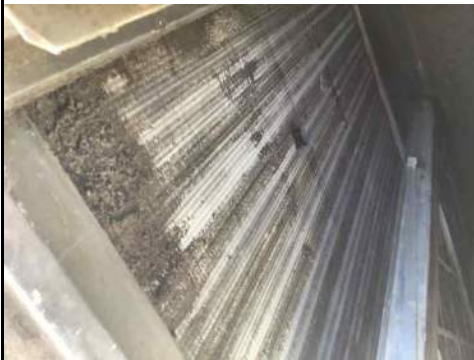
Verification	Response	Notes	By	Date/Time
6	Is gas piping installed and valves turned on?	Yes	SC	8/11/21 13:31
7	Are the condenser coils free of damage and clean? (Take picture)	No	SC	8/11/21 13:24

PRIORITY (HIGH/LOW/INFO ONLY)	
OVERALL BUILDING PERFORMANCE	
INFO ONLY	Net building airflow was initially -1830 CFM and after completion of balancing this was improved to net -1004 CFM and -0.0137" wc. Building is still highly negative and there are further recommendations below that need to be completed in order to improve performance.
RTU-1 (KITCHEN)	
INFO ONLY	Airflow is 303 CFM/ton which is lower than recommended although it is still within tolerance of the assumed original design of 333 CFM/ton.
LOW	Return grilles are dirty. Recommend cleaning.
LOW	Recommend cleaning inside RTU compartments.
HIGH	Outside air damper is not responding and could the damper could not be manually set. Recommend manually setting approximately 0.5" open.
HIGH	Evaporator coil is very dirty and likely causing airflow restriction. Recommend thorough deep clean of the coil. Make take several times to fully clean.
LOW	Condenser coil is dirty. Recommend cleaning.

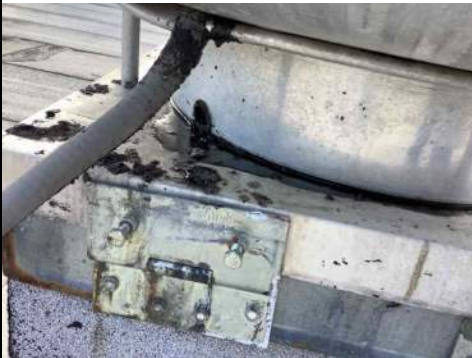
Verification	Response	Notes	By	Date/Time
1	Rotation is correct?	Yes	SC	8/11/21 16:12
2	Belts are tight and in good condition?	Yes	SC	8/11/21 16:12
3	Grease cup installed on grease hood fan?	No	SC	8/11/21 16:12
