Issue List

SPCC Aseptic Training Facility (Monroe, NC)

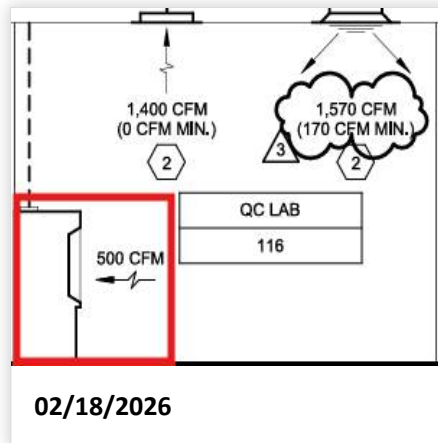
Issue Name : EF-2 Flow Setpoint
Description : According to the schedule, EF-2 CFM setpoint is 550 CFM, but the Airflow Diagram shows 500 CFM. Need clarification on the required CFM.
Created By : National TAB **Assigned To :** National TAB - Antonio Flores-De La Cruz
Status : Open
Priority : Urgent **Asset Tag :**
Originated Date : 02/18/2026 - Antonio Flores-De La Cruz - National TAB

- **02/25/2026 National TAB - Antonio Flores-De La Cruz**
 - An RFI is needed to clarify how the bypass operates in conjunction with the hood and the VFD: whether the bypass opens to maintain the same flow at the Hood, or if the VFD is used to reduce speed and lower CFM.

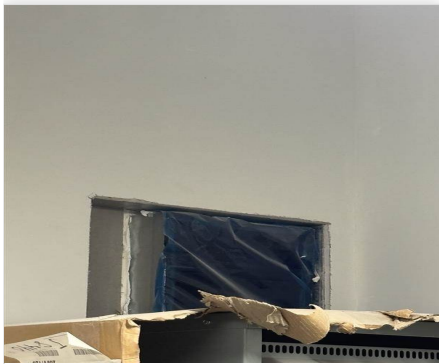
Issue Name : FCU F-2 Missing Grille
Description : FCU F-2 is missing the supply grille and is covered with plastic.
Created By : National TAB **Assigned To :** National TAB - Antonio Flores-De La Cruz
Status : Open
Priority : Urgent **Asset Tag :**
Originated Date : 02/19/2026 - Antonio Flores-De La Cruz - National TAB

- **02/24/2026 National TAB - Antonio Flores-De La Cruz**
 - Balanced without grille.

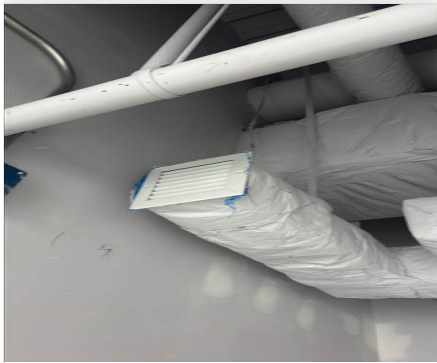
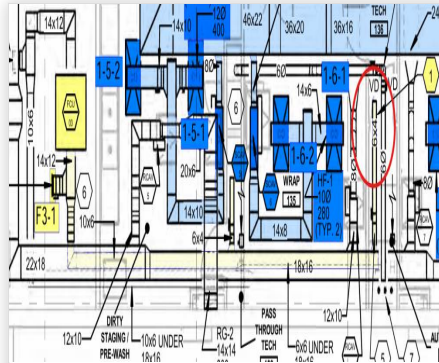
Issue Name : FCU F-3 missing damper
Description : Grille in AUTOCLAVE 137 for FCU F-3 is missing the OBD balancing damper. Also awaiting the Engineer's confirmation of increasing the grille from 50 CFM to 100 CFM, per the meeting on 2/19/2026.
Created By : National TAB
Assigned To : National TAB - Antonio Flores-De La Cruz
Status : Open
Priority : Urgent
Asset Tag :
Originated Date : 02/23/2026 - Antonio Flores-De La Cruz - National TAB

- **02/25/2026 National TAB - Antonio Flores-De La Cruz**
 - All supply and return grilles need dampers. Also, an RFI is needed to determine the new diffuser values. The actual installation does not match the design and needs clarification.

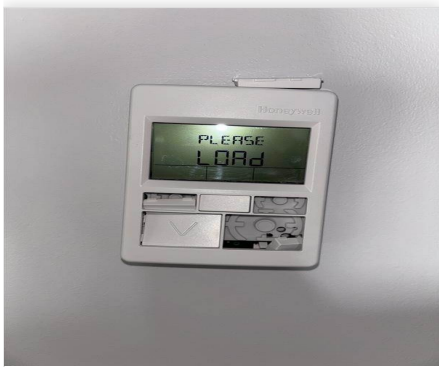
Issue Name : FCU's Not Operational
Description : Controls stated that FCU's program to control is not currently loaded.
Created By : National TAB **Assigned To :** National TAB - Antonio Flores-De La Cruz
Status : Open
Priority : **Urgent** **Asset Tag :**
Originated Date : 02/17/2026 - Antonio Flores-De La Cruz - National TAB

- **02/23/2026 National TAB - Antonio Flores-De La Cruz**
 - FCUs 1 and 2 are running, and FCU 3 will be running on 2/24/2026, according to FSS.

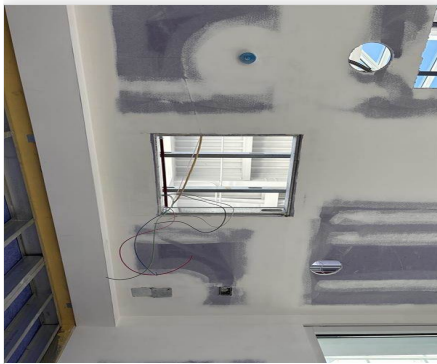
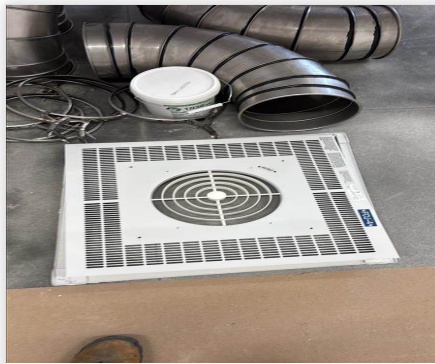
Issue Name : FCU-4 Not Installed
Description : FCU-4 is not installed.
Created By : National TAB **Assigned To :** National TAB - Antonio Flores-De La Cruz
Status : Open
Priority : Urgent **Asset Tag :**
Originated Date : 02/17/2026 - Antonio Flores-De La Cruz - National TAB

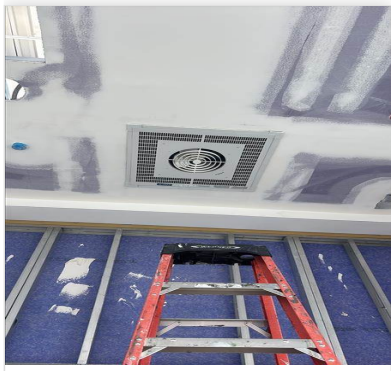
- **02/23/2026 National TAB - Antonio Flores-De La Cruz**
 - Installed, just needs to be wired by electricians.

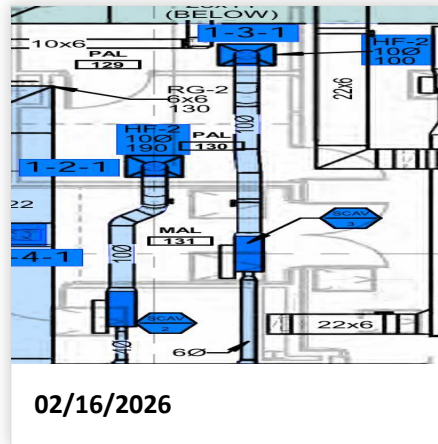
Issue Name : Flow Setpoints for SVAV-2 and SVAV-3
Description : SVA-2 and SVAV-3 do not match based on the schedule and connected load CFM values. Need clarification on what is required.
Created By : National TAB **Assigned To :** National TAB - Antonio Flores-De La Cruz
Status : Open
Priority : Urgent **Asset Tag :**
Originated Date : 02/16/2026 - Antonio Flores-De La Cruz - National TAB

- **02/25/2026 National TAB - Antonio Flores-De La Cruz**
 - IPS has returned the RFI to us, stating that we should switch the SCAV box tags and continue with the flows. Controls should change them and confirm completion with TAB.

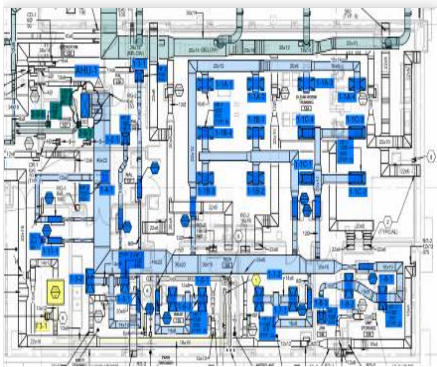
Issue Name : Missing HEPA Filters
Description : The clean rooms' diffusers do not have HEPA Filters installed.
Created By : National TAB **Assigned To :** National TAB - Antonio Flores-De La Cruz
Status : Open
Priority : Urgent **Asset Tag :**
Originated Date : 02/23/2026 - Antonio Flores-De La Cruz - National TAB

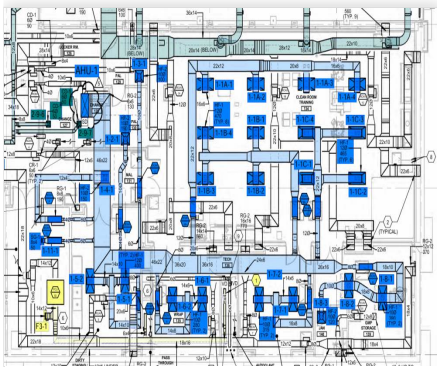
Issue Name : No Access Doors or Door Glass installed
Description : Access doors and door glass are not installed. Unable to pressure test and balance the return until installed.

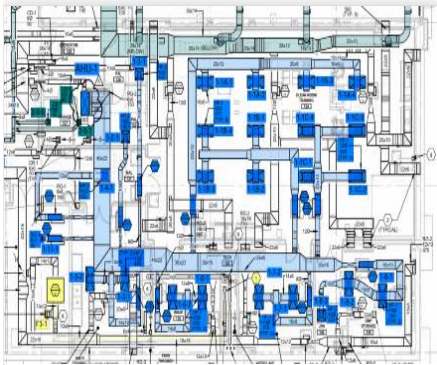
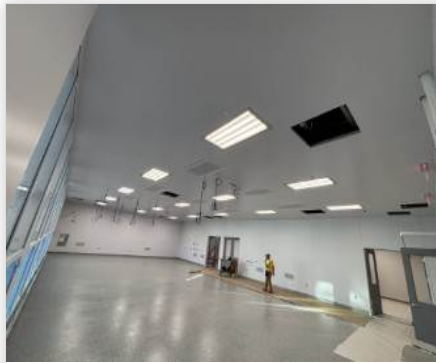
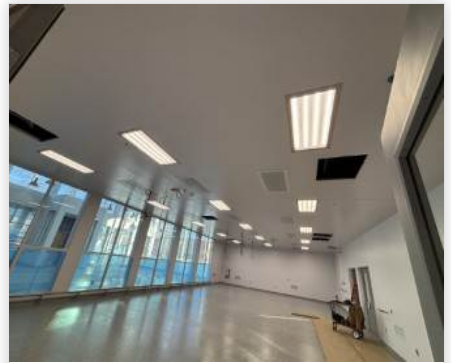
Issue Name : No Access to Supply Dampers
Description : CLEAN ROOM TRAINING 134 has a hard ceiling and no access to the dampers to balance the supply. Access is required or cable dampers to balance.
Created By : National TAB **Assigned To :** National TAB - Antonio Flores-De La Cruz
Status : Open
Priority : Urgent **Asset Tag :**
Originated Date : 02/23/2026 - Antonio Flores-De La Cruz - National TAB

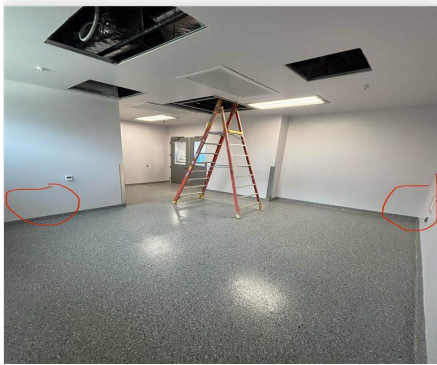
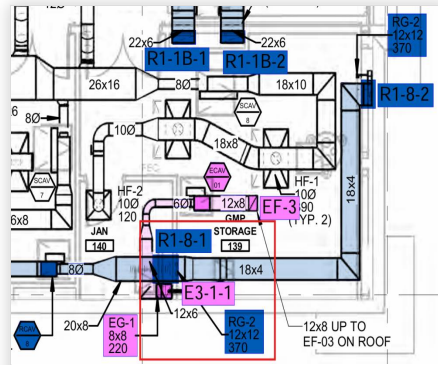
Issue Name : RCAV-8 Missing Grille / Low Airflow
Description : RCAV-8 is missing a grille. The VAV box is calibrated and can only achieve 640 CFM at 100% open damper. The rectangular duct attached to the grille appears to be sized for the 370 CFM design.
Created By : National TAB
Assigned To : National TAB - Antonio Flores-De La Cruz
Status : Open
Priority : Urgent
Asset Tag :
Originated Date : 02/25/2026 - Antonio Flores-De La Cruz - National TAB

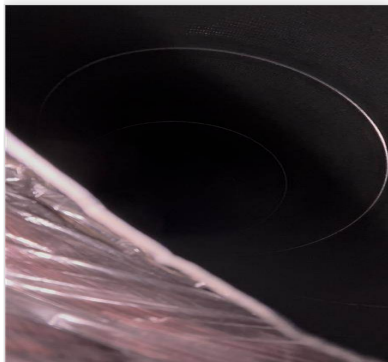
Issue Name : VAV-1 Low Flow
Description : At 100% open damper at VAV, max flow is only (817 CFM ACTUAL / 1100 CFM DESIGN). K factor is 986. Pressure goes up to 0.65" wc. VAV box is 10". No obstruction is found to limit flow to the box. Ductwork should be inspected.
Created By : National TAB **Assigned To :** National TAB - Antonio Flores-De La Cruz
Status : Open
Priority : Urgent **Asset Tag :**
Originated Date : 02/19/2026 - Antonio Flores-De La Cruz - National TAB

- **02/25/2026 National TAB - Antonio Flores-De La Cruz**
 - To verify the interior structure of the duct, a small incision was made in the flex to view the portion hidden by the wall leading into the room. It is believed that the path the duct follows restricts airflow due to the transition from the duct to the flex and to the VAV. This is not a straight path and could add resistance. Also, it appears that a portion of the hard duct has been bent inwards, as shown in the attached picture, and is no longer circular.

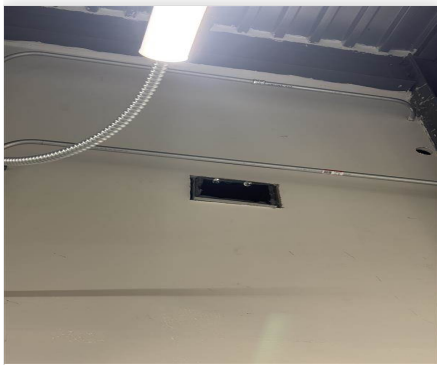
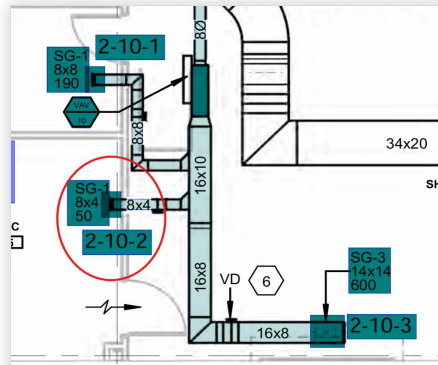
Issue Name : VAV-10 Missing Grille
Description : Grille 2-10-2 in ELEC 125 is not installed to balance. Total Flow was set in the meantime
Created By : National TAB **Assigned To :** National TAB - Antonio Flores-De La Cruz
Status : Open
Priority : Urgent **Asset Tag :**
Originated Date : 02/19/2026 - Antonio Flores-De La Cruz - National TAB

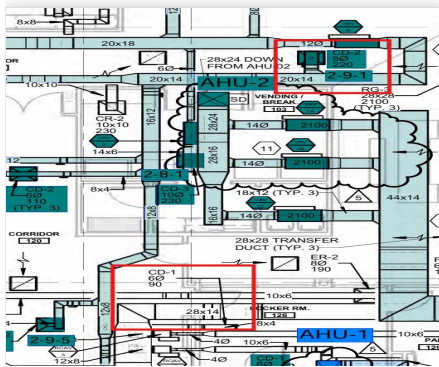
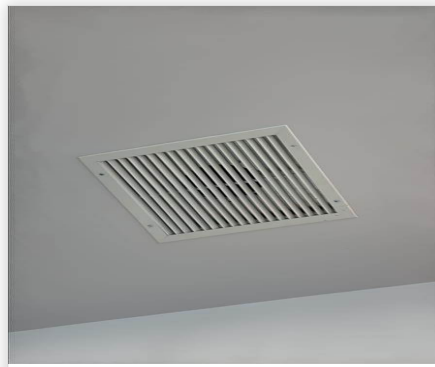
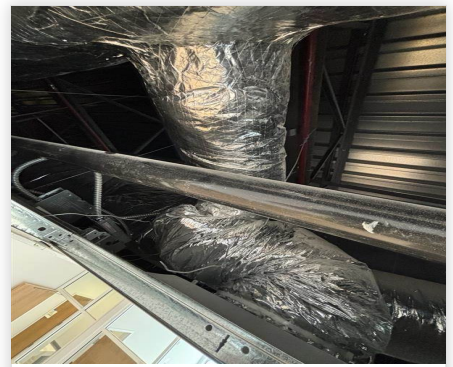
Issue Name : VAV-9 Missing Dampers
Description : Supply Diffuser in LOCKER RM 126 does not have a damper installed, as well as diffuser 2-9-1. 2-9-1 ductwork is also pinched and needs to be corrected.
Created By : National TAB
Assigned To : National TAB - Antonio Flores-De La Cruz
Status : Open
Priority : Urgent
Asset Tag :
Originated Date : 02/24/2026 - Antonio Flores-De La Cruz - National TAB
