Issue List

SPCC Aseptic Training Facility (Monroe, NC)

Project Issue Information

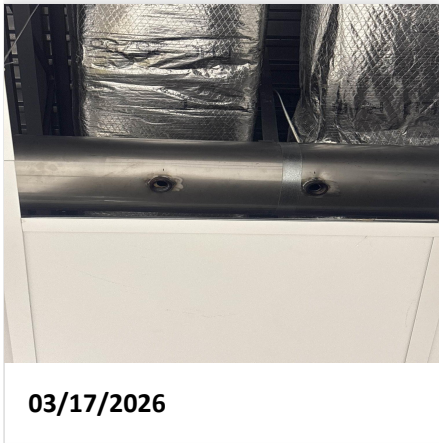
Issue Name : EF-2 Ductwork
Description : The Stainless Steel ductwork is installed, but the ports on the duct still need to be capped.
Created By : National TAB **Assigned To :** National TAB - Antonio Flores-De La Cruz
Status : Open
Priority : Urgent **Asset Tag :**
Originated Date : 03/17/2026 - Antonio Flores-De La Cruz - National TAB

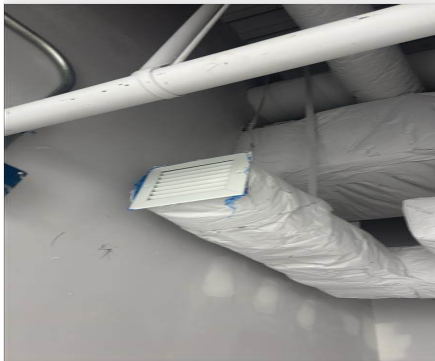
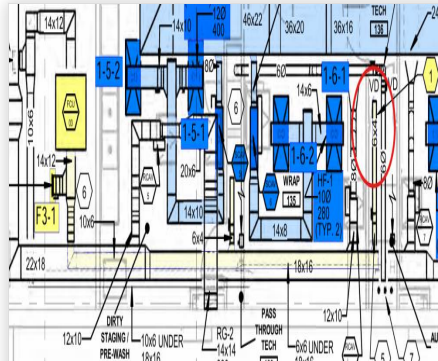
Issue Name : FCU F-3 missing damper
Description : Grille in AUTOCLAVE 137 for FCU F-3 is missing the OBD balancing damper. Also awaiting the Engineer's confirmation of increasing the grille from 50 CFM to 100 CFM, per the meeting on 2/19/2026.
Created By : National TAB **Assigned To :** National TAB - Antonio Flores-De La Cruz
Status : Open
Priority : Urgent **Asset Tag :**
Originated Date : 02/23/2026 - Antonio Flores-De La Cruz - National TAB

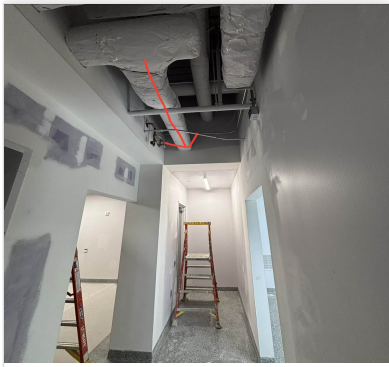
- **03/17/2026 National TAB - Antonio Flores-De La Cruz**
 - The supply duct in the AUTOCLAVE area goes into the wall but does not connect to a grille. It is inaccessible. The return damper for the FCU return grille in PROCESS UTILITIES 141 is not properly installed (One corner is floating) Also no answer on revised flows / ductwork. Damper for the supply not installed.

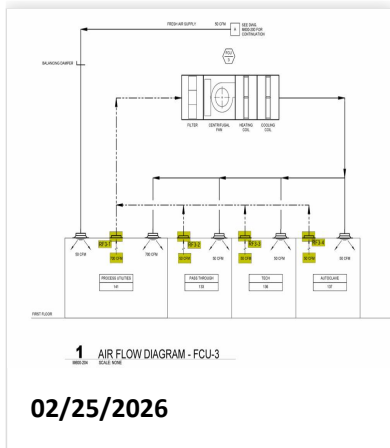
- All supply and return grilles need dampers. Also, an RFI is needed to determine the new diffuser values. The actual installation does not match the design and needs clarification.

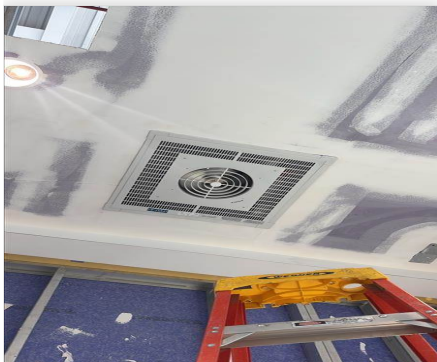
Issue Name : FCU-4 Fan Speed

Description : It appears there is no way to adjust speed on FCU-4, and flow is 372% above design (335 CFM ACTUAL / 90 CFM ACTUAL). Measurement was performed using a Velgrid because the unit's design places the supply and return on the same side. Attempted to use the visible dial and does nothing.

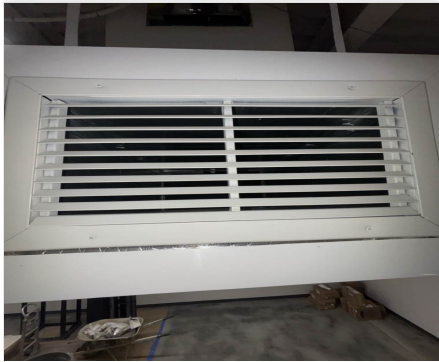
Issue Name : Missing Return Damper in RM SHIP/RECEIVE 123
Description : Return grille in SHIP/RECEIVE 123 is missing return damper to balance.
Created By : National TAB **Assigned To :** National TAB - Antonio Flores-De La Cruz
Status : Open
Priority : Urgent **Asset Tag :**
Originated Date : 03/17/2026 - Antonio Flores-De La Cruz - National TAB

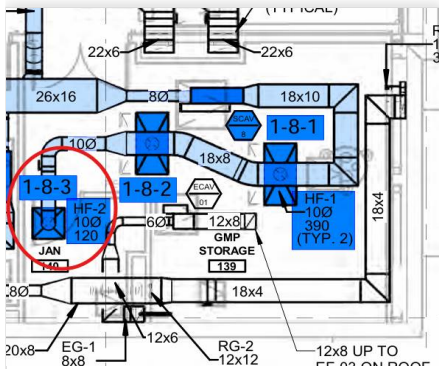
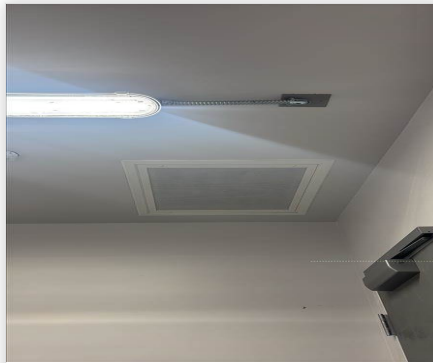
Issue Name : No Access to damper for SCAV-8 Grille
Description : Grille 1-8-3 has no access to the damper to balance. Also, unable to verify if the damper is installed. The VAV box is calibrated in the meantime.
Created By : National TAB
Assigned To : National TAB - Antonio Flores-De La Cruz
Status : Open
Priority : Urgent
Asset Tag :
Originated Date : 02/23/2026 - Antonio Flores-De La Cruz - National TAB

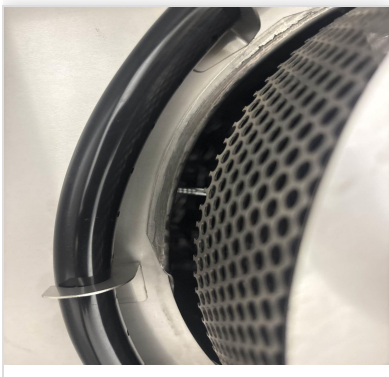
- **03/17/2026 National TAB - Antonio Flores-De La Cruz**
 - Attempted to use slider damper, unable to adjust to design because of screws.

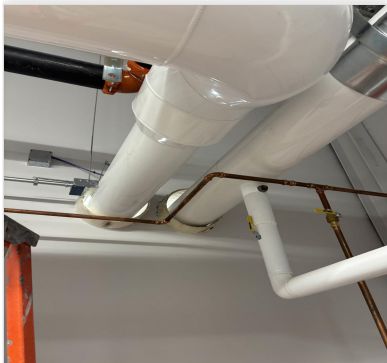
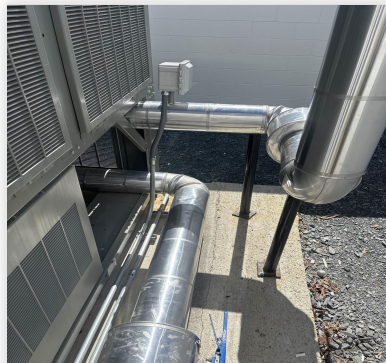
Issue Name : Test Ports on Chiller
Description : Test ports are required on the chiller to read pressure and set flow.
Created By : National TAB **Assigned To :** National TAB - Antonio Flores-De La Cruz
Status : Open
Priority : Urgent **Asset Tag :**
Originated Date : 02/25/2026 - Antonio Flores-De La Cruz - National TAB

- **03/17/2026 National TAB - Antonio Flores-De La Cruz**
 - The ports were searched for and not found. Unable to see where they were installed based on the response of it being installed.

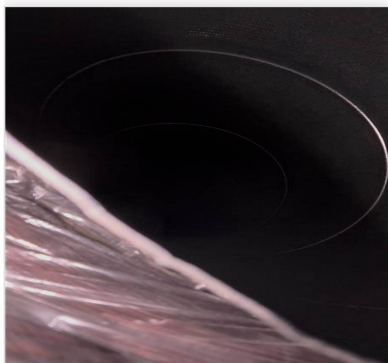
Issue Name : VAV-1 Low Flow
Description : At 100% open damper at VAV, max flow is only (817 CFM ACTUAL / 1100 CFM DESIGN). K factor is 986. Pressure goes up to 0.65" wc. VAV box is 10". No obstruction is found to limit flow to the box. Ductwork should be inspected.

- **03/17/2026 National TAB - Antonio Flores-De La Cruz**
 - Will check again
- **02/25/2026 National TAB - Antonio Flores-De La Cruz**
 - To verify the interior structure of the duct, a small incision was made in the flex to view the portion hidden by the wall leading into the room. It is believed that the path the duct follows restricts airflow due to the transition from the duct to the flex and to the VAV. This is not a straight path and could add resistance. Also, it appears that a portion of the hard duct has been bent inwards, as shown in the attached picture, and is no longer circular.

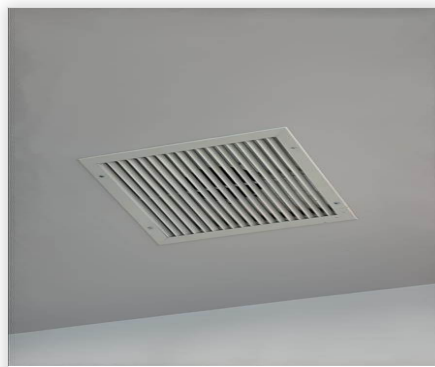
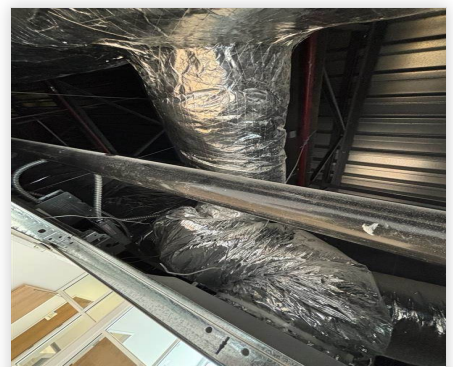
Issue Name : VAV-9 Missing Dampers
Description : Supply Diffuser in LOCKER RM 126 does not have a damper installed, as well as diffuser 2-9-1. 2-9-1 ductwork is also pinched and needs to be corrected.
Created By : National TAB **Assigned To :** National TAB - Antonio Flores-De La Cruz
Status : Open
Priority : Urgent **Asset Tag :**
Originated Date : 02/24/2026 - Antonio Flores-De La Cruz - National TAB

- **03/17/2026 National TAB - Antonio Flores-De La Cruz**
 - Diffuser 2-9-1 is still missing damper and pinched ductwork
