Issue List

12-04-23 CHIPOTLE #20-3885 MEDFIELD, MA (MEDFIELD)

Project Issue Information

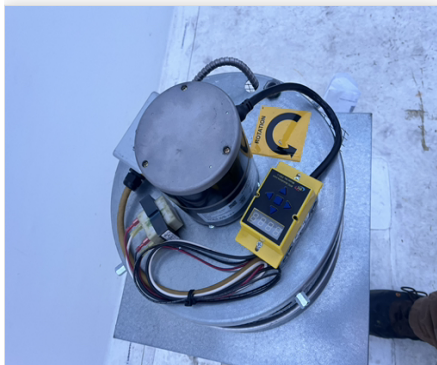
EF-2_no_power
12/06/2023

Issue Name : EF-2 is not powered
Description : EF-2 is not powered. Unable to to balance unit until electricians can provide power.
Created By : National TAB **Assigned To :** National TAB - David Annan
Status : Open
Priority : **Asset Tag :**
Originated Date : 12/06/2023 - David Annan - National TAB

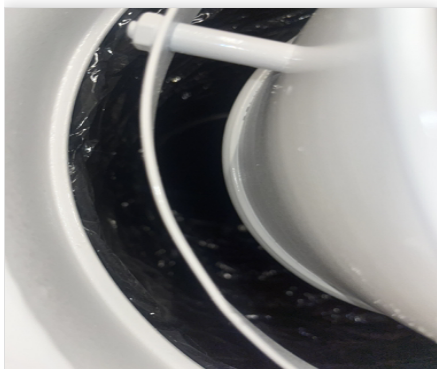
Inaccessible_damper.j..
12/06/2023

Issue Name : Inaccessible dampers / No access
Description : RTU-2 side wall diffusers do have dampers with access. Unable to complete diffuser balance. Unit total air flow will be balanced to design. Recommend installing integral dampers.
Created By : National TAB **Assigned To :** National TAB - David Annan
Status : Open
Priority : **Asset Tag :**
Originated Date : 12/06/2023 - David Annan - National TAB

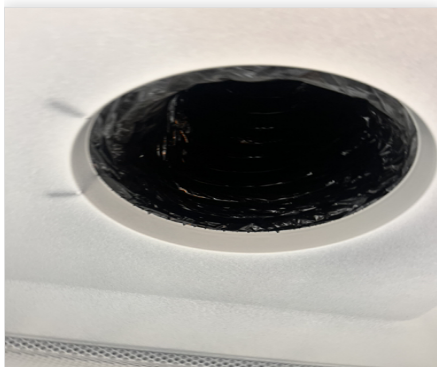
No_integral_damper.jp..
12/06/2023

Issue Name : Office damper is inaccessible
Description : The officer diffuser is over design tolerance. Unable to access the diffuse damper. Recommend having a integral damper installed at the diffuser.
Created By : National TAB **Assigned To :** National TAB - David Annan
Status : Open
Priority : **Asset Tag :**
Originated Date : 12/06/2023 - David Annan - National TAB

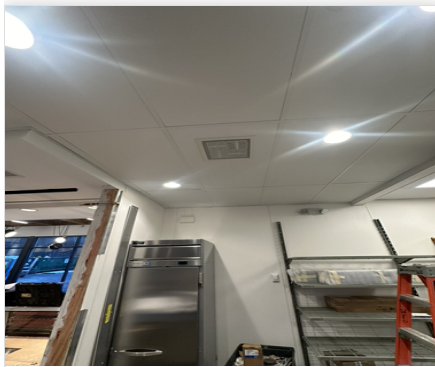
Diffuserwronglocation..
12/06/2023

Issue Name : One of the serving line diffuser (RTU-1) is installed in the wrong location
Description : There is one serving line diffuser installed by the walk-in cooler instead of the serving line as shown per MSET.
Created By : National TAB **Assigned To :** National TAB - David Annan
Status : Open
Priority : **Asset Tag :**
Originated Date : 12/06/2023 - David Annan - National TAB

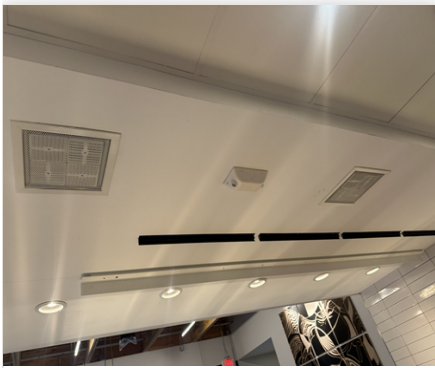
Deflectors_installed_..
12/06/2023

Issue Name : Serving line diffusers still have the 1x1 deflectors installed
Description : All serving line diffusers need to have the 1x1 deflectors removed.
Created By : National TAB **Assigned To :** National TAB - David Annan
Status : Open
Priority : **Asset Tag :**
Originated Date : 12/06/2023 - David Annan - National TAB
