Report: Deficiency Report
Function: Test, Adjust, & Balance
Date: 08/20/2025
Completed By: National TAB

PROJECT
08-18-25 QT #1101 SENECA, SC

QUIKTRIP
4705 SOUTH 129TH EAST AVENUE
TULSA, OK 74134

Issue List

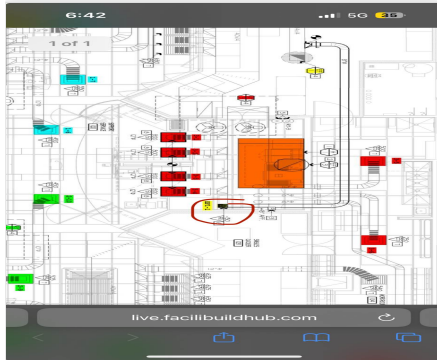
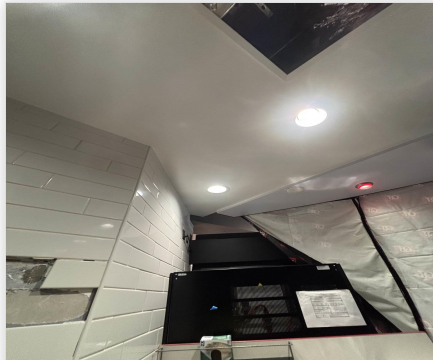
Issue Name : EF1-1 not installed
Description : To complete balance, EF1-1 needs to be installed. According to GC the SGRD will be installed later this week.
Created By : National TAB **Assigned To :** National TAB - Daniel Covaci
Status : Open
Priority : **Urgent** **Asset Tag :** EF1
Originated Date : 08/20/2025 - Chistian Moller - National TAB

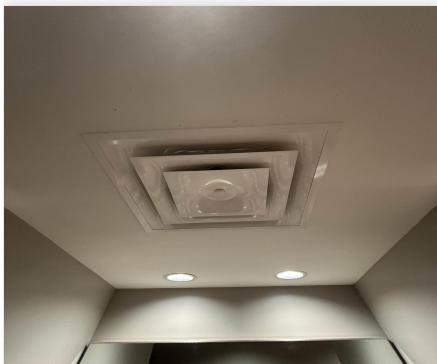
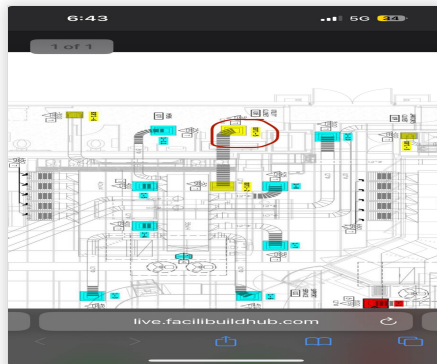
Issue Name : EF1-5 no flow
Description : EF1-5 did not have an airflow when total cfm for EF1 was being taken. Could not diagnose problem while on site.
Created By : National TAB **Assigned To :** National TAB - Daniel Covaci
Status : Open
Priority : Medium **Asset Tag :** EF1
Originated Date : 08/20/2025 - Chistian Moller - National TAB

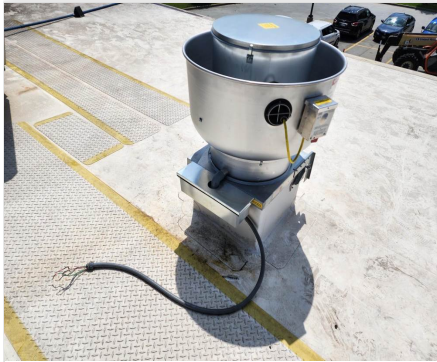
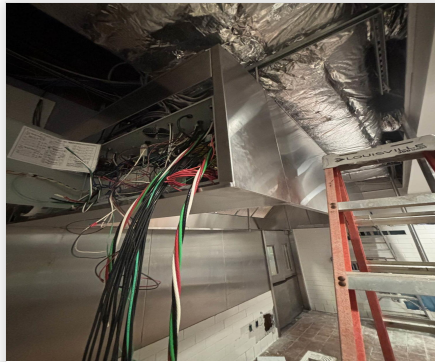
Issue Name : Hood not finished
Description : Per the GC the hood will not be completed until late Thursday (8/21) or early Friday (8/22)
Created By : National TAB **Assigned To :** National TAB - Dan Hertenstein
Status : Open
Priority : Urgent **Asset Tag :** HD1
Originated Date : 08/20/2025 - Chistian Moller - National TAB

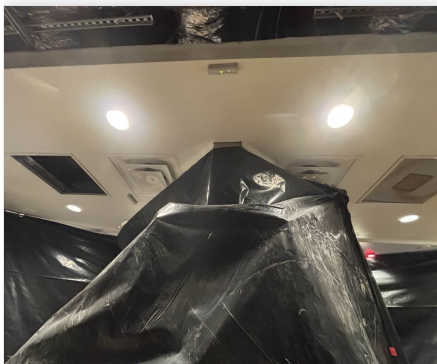
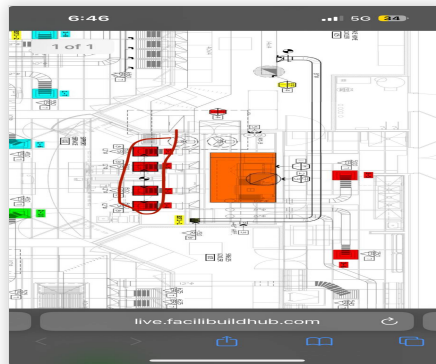
Issue Name : RTU 3 SGRD 1 through 4 not proper size
Description : SGRD's 1 through 4 are not the proper size and could not be balanced accordingly. RTU 3 is balanced to total.
Created By : National TAB **Assigned To :** National TAB - Daniel Covaci
Status : Open
Priority : Urgent **Asset Tag :** RT-3
Originated Date : 08/20/2025 - Chistian Moller - National TAB

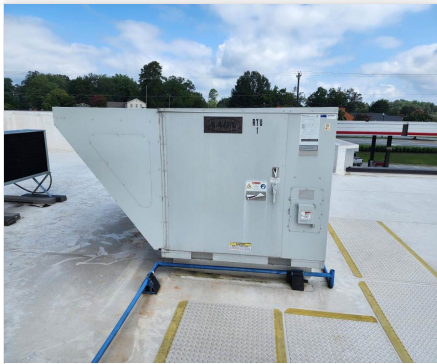
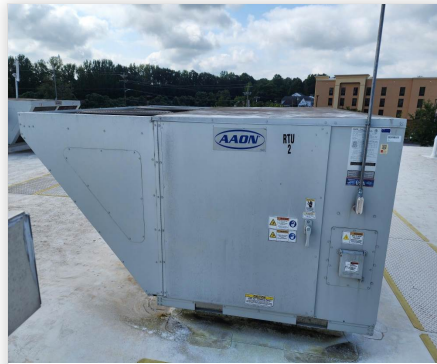
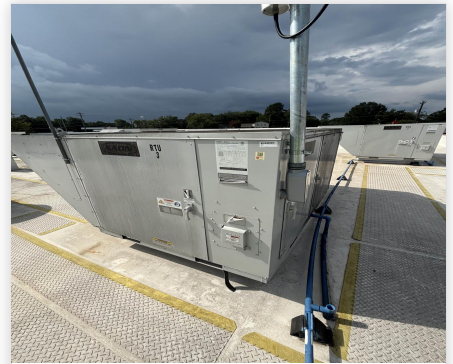
Issue Name : RTU multiple OA damper positions could not be set
Description : Site plans call for multiple OA positions to be set (800 & 350 CFM) both positions were found and marked but could not be set as alternating positions. All 3 RTU's left at 800 OA CFM.
Created By : National TAB **Assigned To :** National TAB - Daniel Covaci
Status : Open
Priority : Urgent **Asset Tag :**
Originated Date : 08/20/2025 - Chistian Moller - National TAB
