PlanGrid Task Report - Jan 7, 2025

Prepared by Dale Wheeler

Jan 7, 2025

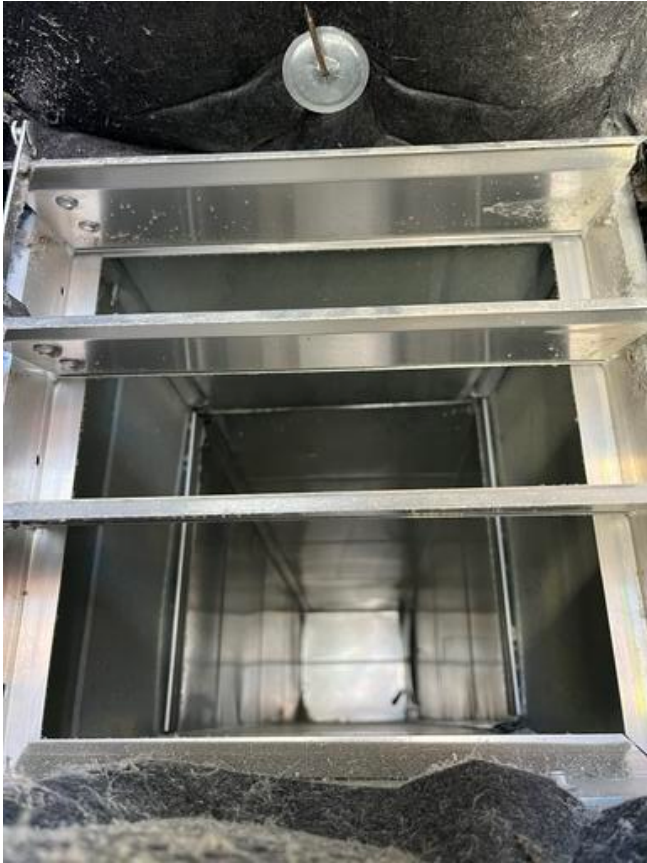
IMG_6639

#530 [EXHA 500] [NEW] Restroom rectangular duct riser.

Restroom exhaust rectangular duct riser not correctly lined per specification. Liner is not installed below back draft damper; liner should be installed entire length of square duct.

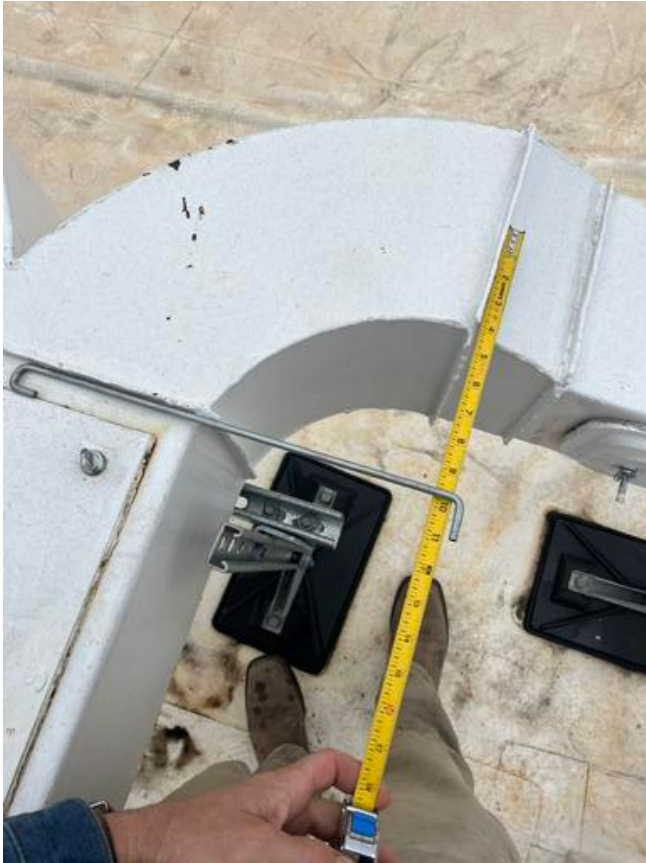
IMG_6638

#529 [EXHA 003] [NEW] CRITICAL – Incorrect grease exhaust duct ells.

EF2 has two grease duct turns that do not have long radius turns installed. Grease ductwork not constructed with long radius centerline $R=3W/2$ fittings per specification. Short radius, mitered ells, and offsets greater than 45 degrees are not allowed.

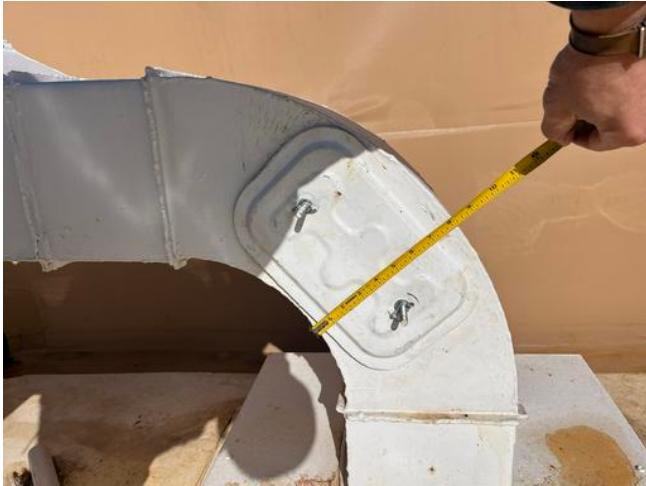
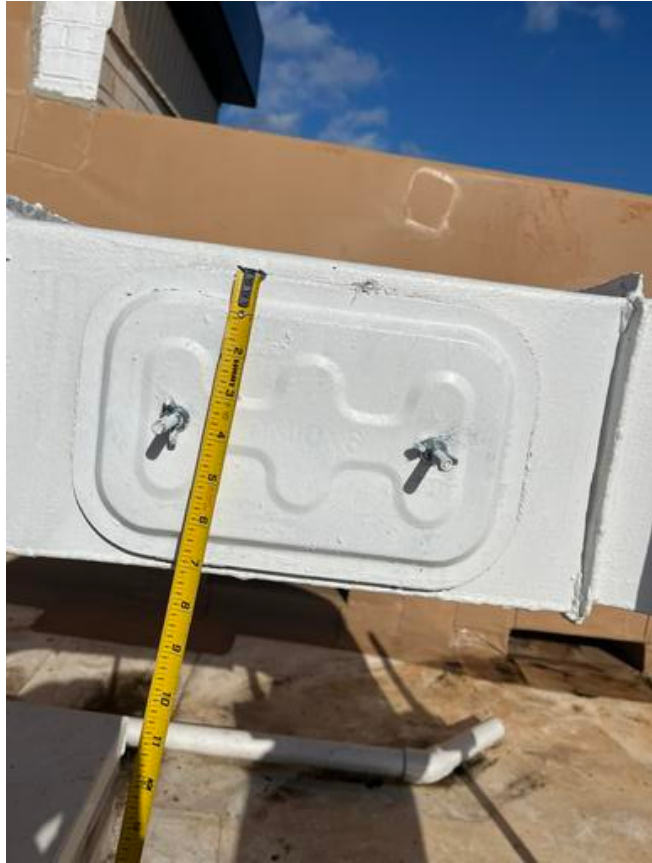
#528 [EXHA 001] [NEW] CRITICAL – Grease duct access doors.

EF2 per prints has 5
incorrect sized grease
cleanout doors installed.
EF1 per prints has 3
incorrect sized grease
cleanout doors installed.
Page: M-250
Detail: 1

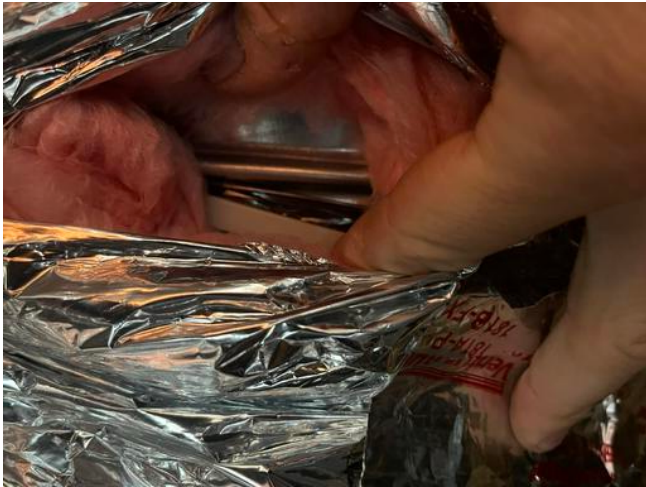
IMG_6642

#527 [DUCT 006] [NEW] CRITICAL – Flex duct installation.

AC2 & AC3 supply grills were spot checked and flex inner core was banded but not also taped. Inner flex core should be banded and also taped.

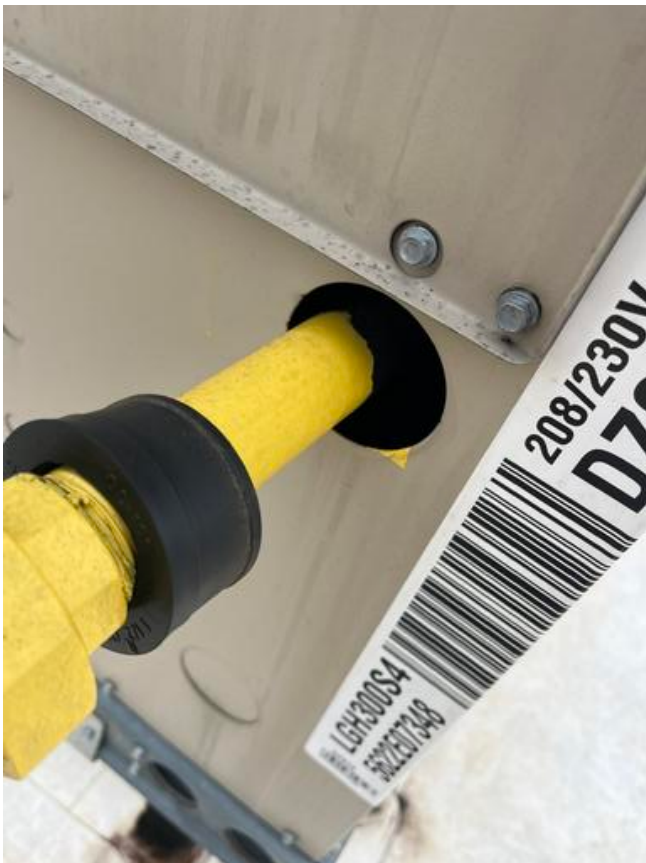
IMG_6636

#526 [UNIT 510] [NEW] Gas inlet grommet.

AC1 gas inlet grommet is missing at the gas line/RTU penetration point.
