Report: TAB REPORT
Function: Test, Adjust, & Balance
Date: 03/07/2024
Completed By: National TAB

PROJECT
03-04-24 CULVERS JEFFERSONVILLE, IN

Project: 03-04-24 CULVERS JEFFERSONVILLE, IN

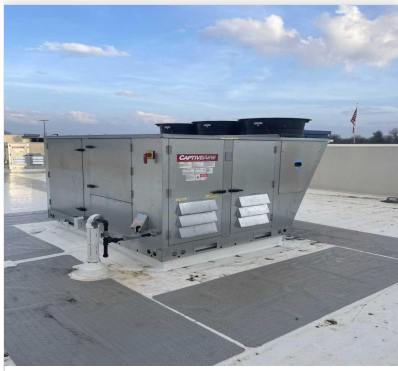
Issue Name : RTU-2 Faults
Description : RTU-2 HMI showing the following faults: DF MAIN PHASE LOSS, DF SAFE STOP, DF TORQUE LIMIT. Contacted Captive Aire technical services and they were aware of the error. They informed me they were waiting for GC to have proper wiring type installed before completing connections.
Created By : National TAB **Assigned To :** National TAB - Dan Hertenstein
Status : Open
Priority : Medium **Asset Tag :** RTU2
Originated Date : 03/05/2024 - Jordan Best - National TAB

Issue Name : RTU-2 Smoke Detector
Description : Smoke detector wires for RTU-2 not landed at unit on roof. Captive Aire technical services said this is due to incorrect wire type used originally.
Created By : National TAB **Assigned To :** National TAB - Dan Hertenstein
Status : Open
Priority : Urgent **Asset Tag :** RTU2
Originated Date : 03/05/2024 - Jordan Best - National TAB

Fan Speed Set Pt. 55 HZ. Damper for diffuser 1 is inaccessible and damper for diffuser 4 is bound up. Unable to balance all diffusers to design.

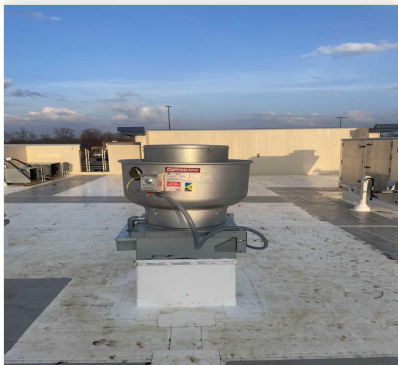
EF-1A

Issue Name : No Power EF-1
Description : EF-1 is not operational and does not appear to have power supplied to the unit. Styrofoam used for shipping needs to be removed from blower prior to starting fan after supplying power.
Created By : National TAB **Assigned To :** National TAB - Dan Hertenstein
Status : Open
Priority : High **Asset Tag :** EFA1
Originated Date : 03/05/2024 - Jordan Best - National TAB

No power to unit.
