**Report: DEFICIENCY REPORT**  
**Function: Test, Adjust, & Balance**  
**Date: 05/01/2025**  
**Completed By: National TAB**

**PROJECT**  
**04-28-25 CULVERS ROCKMART, GA**

1939 NATHAN DEAN PKWY

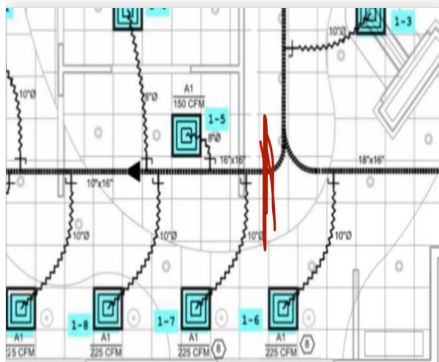
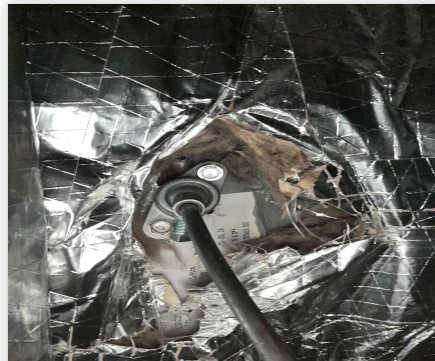
**Issue Name :** AC1 BRANCH DAMPER IS STUCK SHUT  
**Description :** AC1 has a branch damper that is broken and stuck shut. The mechanical onsite was unable to fix the issue due to lack of the proper tools. This branch restricts the airflow of diffusers 4, 5, 7, 8, 9, 10, & 11. Until this is fixed, the unit is unable to be balanced.

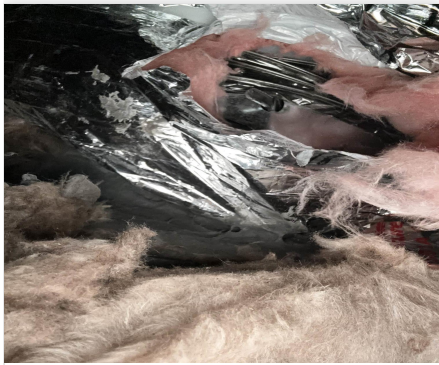
**Issue Name :** AC1 DAMPER HANDLE IS MISSING  
**Description :** The damper for the diffuser in the men's restroom is missing a damper handle.  
**Created By :** National TAB                      **Assigned To :** National TAB - Ben Searles  
**Status :** Open  
**Priority :** Urgent                                      **Asset Tag :**  
**Originated Date :** 05/01/2025 - Ben Searles - National TAB

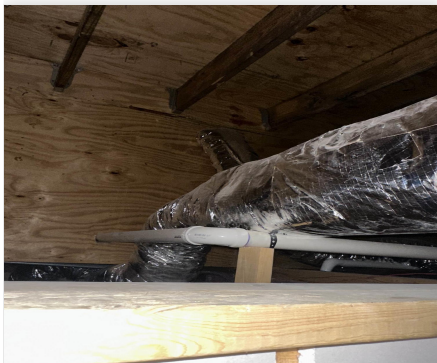
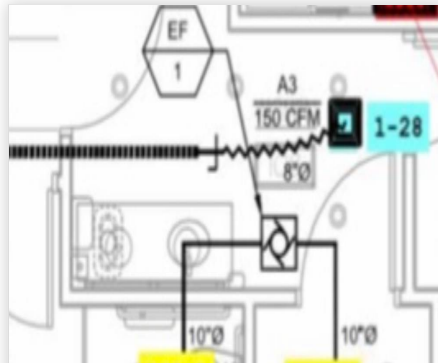
**Issue Name :** AC1 DAMPER INACCESSIBLE  
**Description :** The damper to the diffuser in the women's restroom is located above hard ceiling and is inaccessible. This is where the plans requested it to be located. The damper handle will need to be moved in order to effectively balance the diffuser.  
**Created By :** National TAB                      **Assigned To :** National TAB - Ben Searles  
**Status :** Open  
**Priority :** Urgent                                      **Asset Tag :**  
**Originated Date :** 05/01/2025 - Ben Searles - National TAB

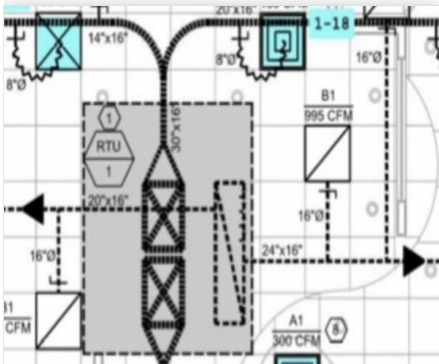
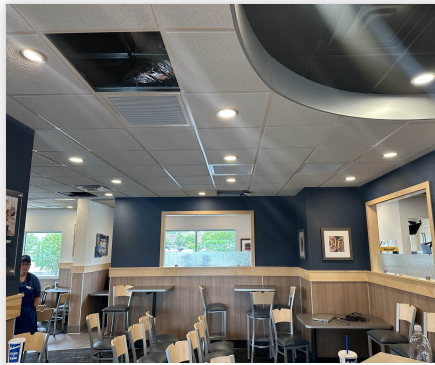
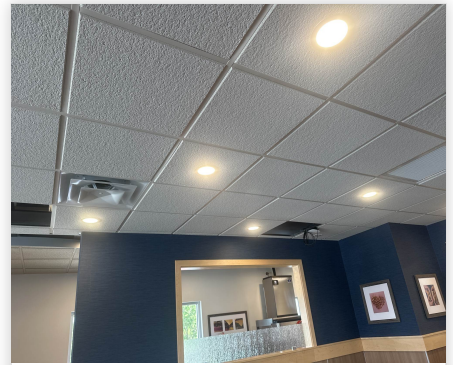
**Issue Name :** AC1 MISSING RETURN AND SUPPLY  
**Description :** AC1 is missing a return as well as supply diffuser 1-18 as depicted in the image below. Without these, the unit is unable to be properly balanced.  
**Created By :** National TAB                      **Assigned To :** National TAB - Ben Searles  
**Status :** Open  
**Priority :** Urgent                                      **Asset Tag :**  
**Originated Date :** 05/01/2025 - Ben Searles - National TAB

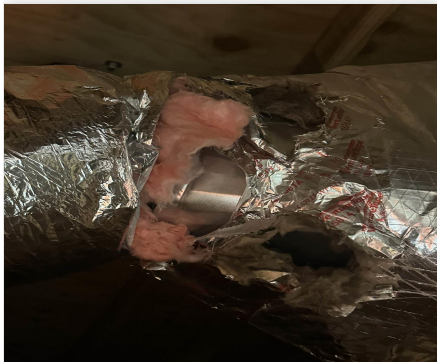
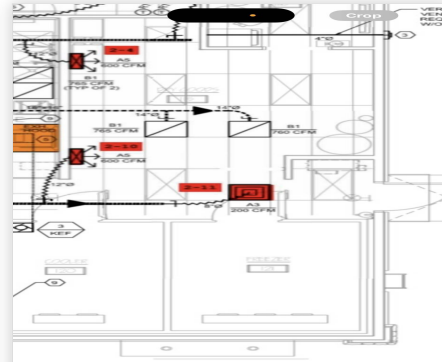
**Issue Name :** AC2 DIFFUSER IS MISSING A DAMPER  
**Description :** Diffuser 11 for AC2 is missing a damper and is unable to be balanced. The mechanical on-site reviewed the ductwork and was unable to locate the damper as well.  
**Created By :** National TAB                      **Assigned To :** National TAB - Ben Searles  
**Status :** Open  
**Priority :** Urgent                                      **Asset Tag :**  
**Originated Date :** 05/01/2025 - Ben Searles - National TAB

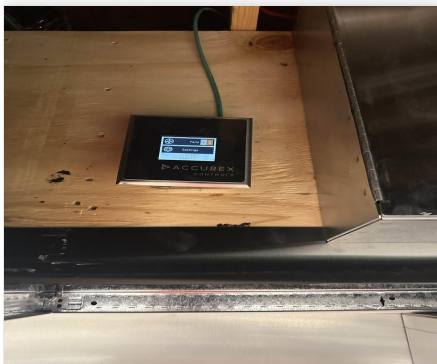
**Issue Name :** ACCUREX CONTROL BOARD IS ABOVE THE CEILING GRID  
**Description :** The Accurex control board for the kitchen hoods is located above the ceiling grid. This should be dropped to be more accessible.  
**Created By :** National TAB                      **Assigned To :** National TAB - Ben Searles  
**Status :** Open  
**Priority :** Low                                      **Asset Tag :**  
**Originated Date :** 05/01/2025 - Ben Searles - National TAB

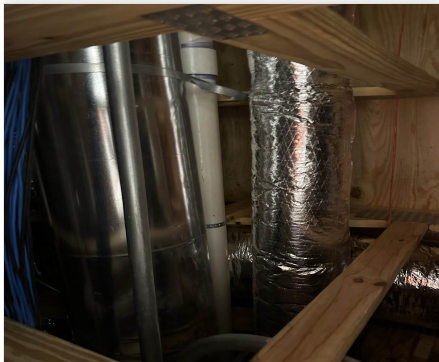
**Issue Name :** DUCTWORK IS MISSING INSULATION  
**Description :** There is a line of ductwork that is missing insulation. This ductwork feeds the returns of AC2.  
**Created By :** National TAB                      **Assigned To :** National TAB - Ben Searles  
**Status :** Open  
**Priority :** Low                                      **Asset Tag :**  
**Originated Date :** 05/01/2025 - Ben Searles - National TAB

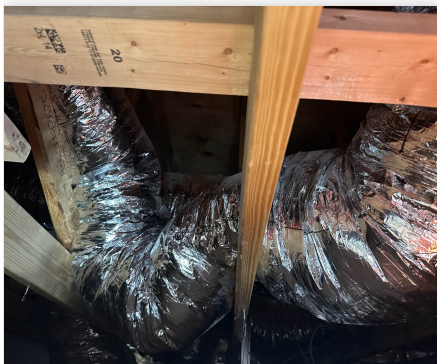
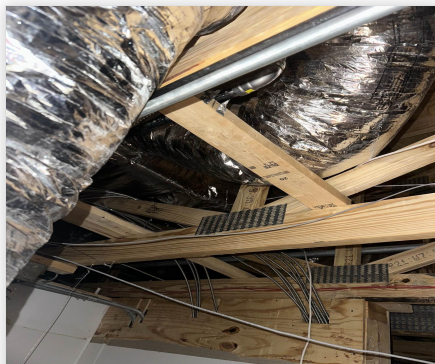
**Issue Name :** EXCESSIVE FLEX RUNS  
**Description :** A couple instances of excessive flex being used was observed. Recommend shortening the runs to improve airflow to the diffusers.  
**Created By :** National TAB                      **Assigned To :** National TAB - Ben Searles  
**Status :** Open  
**Priority :** Medium                                      **Asset Tag :**  
**Originated Date :** 05/01/2025 - Ben Searles - National TAB
