**Report: DEFICIENCY REPORT**  
**Function: Test, Adjust, & Balance**  
**Date: 05/01/2025**  
**Completed By: National TAB**

**PROJECT**  
**04-28-25 CULVERS ROCKMART, GA**

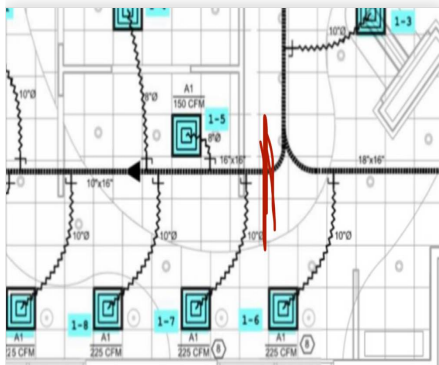
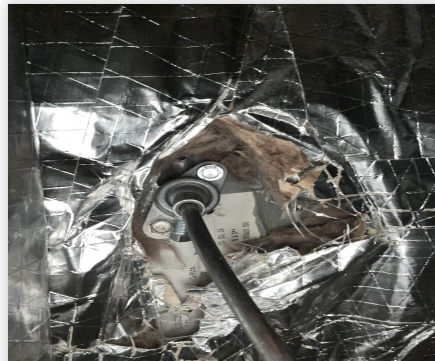
**Issue Name :** AC1 BRANCH DAMPER IS STUCK SHUT  
**Description :** AC1 has a branch damper that is broken and stuck shut. This branch restricts the airflow of diffusers 4, 5, 7, 8, 9, 10, & 11. Until this is fixed, the unit is unable to be balanced.

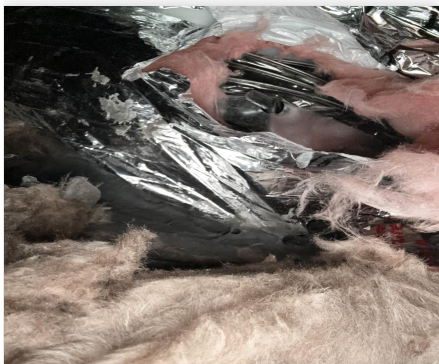
**Issue Name :** AC1 DAMPER HANDLE IS MISSING  
**Description :** The damper for the diffuser in the men's restroom is missing a damper handle.  
**Created By :** National TAB                      **Assigned To :** National TAB - Ben Searles  
**Status :** Closed  
**Priority :** Urgent                                      **Asset Tag :**  
**Originated Date :** 05/01/2025 - Ben Searles - National TAB

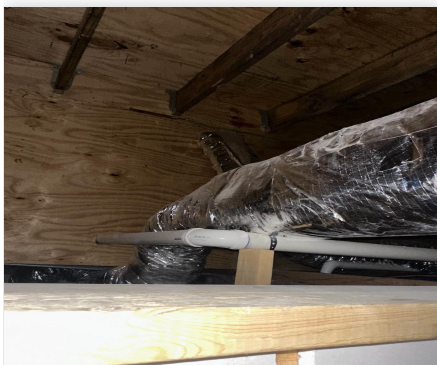
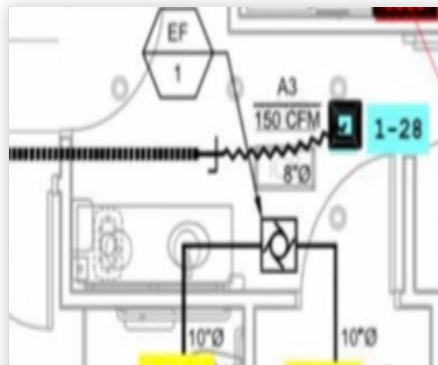
**Issue Name :** AC1 DAMPER INACCESSIBLE  
**Description :** The damper to the diffuser in the women's restroom is located above hard ceiling and is inaccessible. This is where the plans requested it to be located. The damper handle will need to be moved in order to effectively balance the diffuser.  
**Created By :** National TAB      **Assigned To :** National TAB - Ben Searles  
**Status :** Closed  
**Priority :** Urgent      **Asset Tag :**  
**Originated Date :** 05/01/2025 - Ben Searles - National TAB

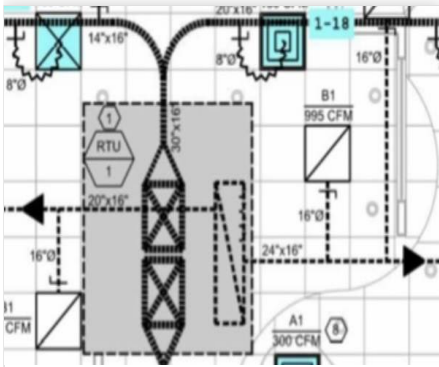
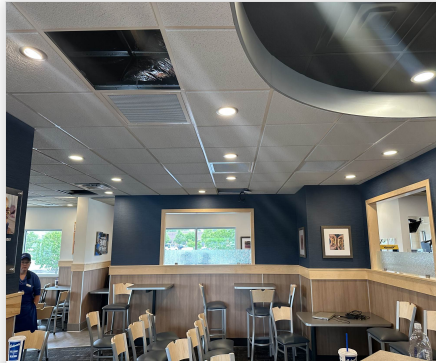
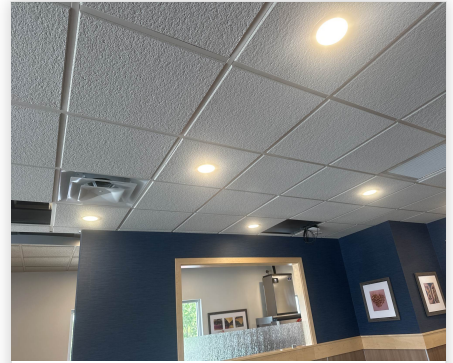
**Issue Name :** AC1 MISSING RETURN AND SUPPLY  
**Description :** AC1 is missing a return as well as supply diffuser 1-18 as depicted in the image below. Without these, the unit is unable to be properly balanced.  
**Created By :** National TAB                      **Assigned To :** National TAB - Ben Searles  
**Status :** Closed  
**Priority :** Urgent                                      **Asset Tag :**  
**Originated Date :** 05/01/2025 - Ben Searles - National TAB

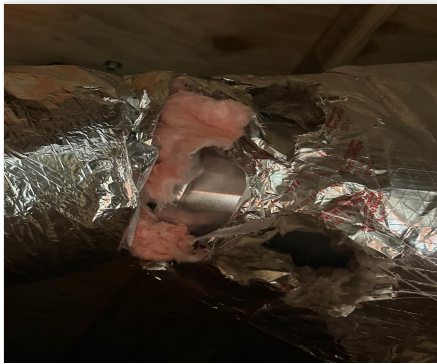
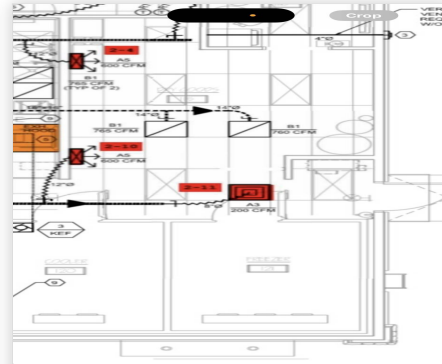
**Issue Name :** AC2 DIFFUSER IS MISSING A DAMPER  
**Description :** Diffuser 11 for AC2 is missing a damper and is unable to be balanced. The mechanical on-site reviewed the ductwork and was unable to locate the damper as well.  
**Created By :** National TAB                      **Assigned To :** National TAB - Ben Searles  
**Status :** Closed  
**Priority :** Urgent                                      **Asset Tag :**  
**Originated Date :** 05/01/2025 - Ben Searles - National TAB

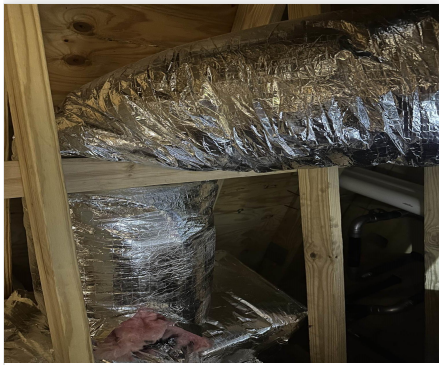
**Issue Name :** EXCESSIVE FLEX RUNS  
**Description :** A couple instances of excessive flex being used was observed.  
Recommend shortening the runs to improve airflow to the diffusers.  
**Created By :** National TAB                      **Assigned To :** National TAB - Ben Searles  
**Status :** Closed  
**Priority :** Medium                                      **Asset Tag :**  
**Originated Date :** 05/01/2025 - Ben Searles - National TAB
