**Report: HVAC Findings for CFA 5073**

**Function: Test, Adjust, & Balance**

**Date: 08/07/2023**

**08-14-23 CHICK-FIL-A #05073 - GRAND  
RAPIDS, MI (ALPINE AVE (MI) FSU) NEW  
STORE**

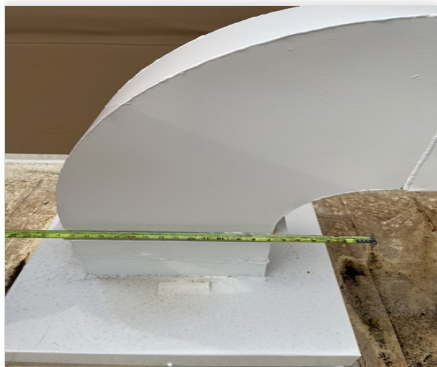
**Greaseductelbow  
08/07/2023**

**Issue Name :** CRITICAL: Grease duct elbows  
**Description :** Not all elbows are of long radius type. See M301 Kitchen Hood System Note 5. Short radius elbows add restriction and can impact unit performance.  
**Created By :** National TAB                      **Assigned To :** National TAB - Tyler Youells  
**Status :** Open  
**Originated Date :** 08/07/2023 - Gabe Merk - National TAB

**Air flow within hoods are at an acceptable range. They can keep them.**

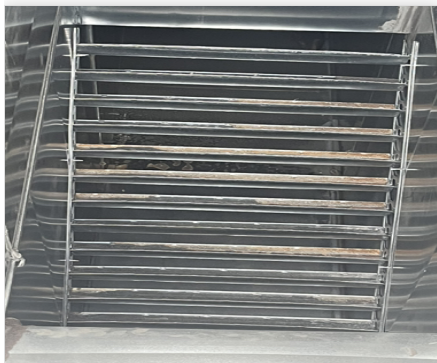
**Incorrectturningvanes..**  
**08/07/2023**

**Issue Name :** CRITICAL: Incorrect Turning Vanes Installed  
**Description :** Incorrect double thickness turning vanes installed in supply of all AC units. Single thickness turning vanes are to be used. See M401 Detail 5  
Incorrect turning vanes add restriction and can hurt unit performance.  
**Created By :** National TAB                      **Assigned To :** National TAB - Tyler Youells  
**Status :** Open  
**Originated Date :** 08/07/2023 - Gabe Merk - National TAB

Replace with single thickness turning vanes per Detail 5 on M401.

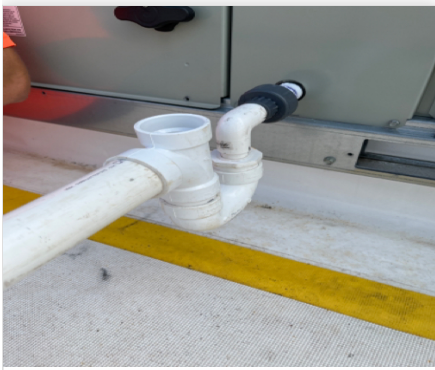
ACCondensatetrp  
08/07/2023

**Issue Name :** NON-CRITICAL: AC Condensate Lines  
**Description :** All AC Condensate lines missing clean out. AC1 has no 2" drop after trap. See applicable Plumbing drawing  
**Created By :** National TAB                      **Assigned To :** National TAB - Tyler Youells  
**Status :** Open  
**Originated Date :** 08/07/2023 - Gabe Merk - National TAB

- **08/10/2023 National TAB - Tyler Youells**
  - Note AC-4 condensate is also not draining properly. The drain line was piped up the slope of the roof and water is leaking out of the leaving side union of the condensate trap.

Fix condensate trap to match detail 2 on P250

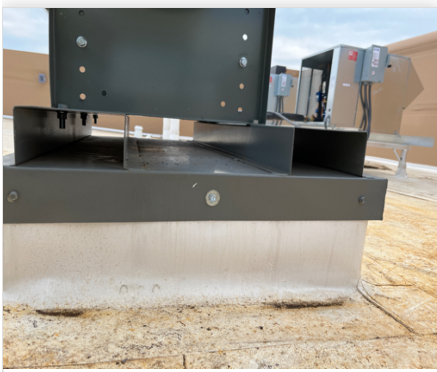
EF1greaseduct  
08/07/2023

**Issue Name :** NON-CRITICAL: G2 Dripguards  
**Description :** EF1 and EF2 do not have the drip guards nor pvc drains. See M401 Detail 3  
**Created By :** National TAB                      **Assigned To :** National TAB - Tyler Youells  
**Status :** Open  
**Originated Date :** 08/07/2023 - Gabe Merk - National TAB

Install G2 grip guard per  
Detail 3 M401.

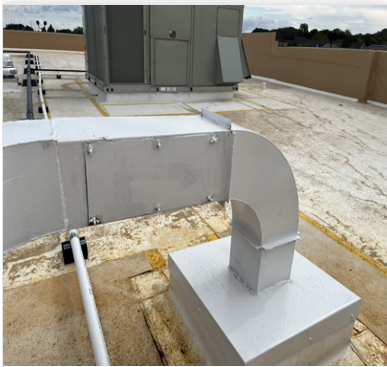
Unsupportedgreaseductatdr  
op  
08/07/2023

**Issue Name :** NON-CRITICAL: Grease duct is not supported  
**Description :** Grease ducts are not supported at duct drops. See M401 Detail 3  
KeyNote 2  
**Created By :** National TAB **Assigned To :** National TAB - Tyler Youells  
**Status :** Open  
**Originated Date :** 08/07/2023 - Gabe Merk - National TAB

Provide support per detail.

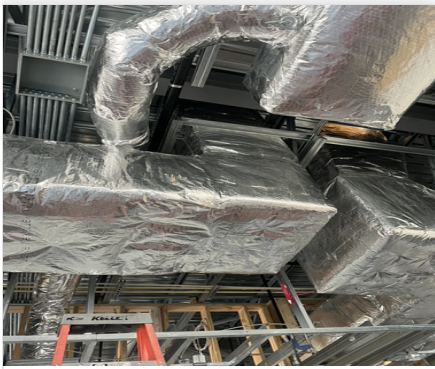
Turningvanereturn.jpe..  
06/20/2023

**Issue Name :** REVIEW + RECTIFY: Turning Vanes installed in AC Returns  
**Description :** Could not gain access but was informed turning vanes are installed in the returns of all AC units. Turning vanes are only to be installed in Supply ductwork. See M-901, 2.02, P.  
**Created By :** National TAB                      **Assigned To :** National TAB - Michael McDonnell  
**Status :** Open  
**Originated Date :** 06/20/2023 - Michael McDonnell - National TAB

- **08/07/2023**    **National TAB - Tyler Youells**
  - Turnings Vanes remain in the returns upon return TAB trip.

Leave them.

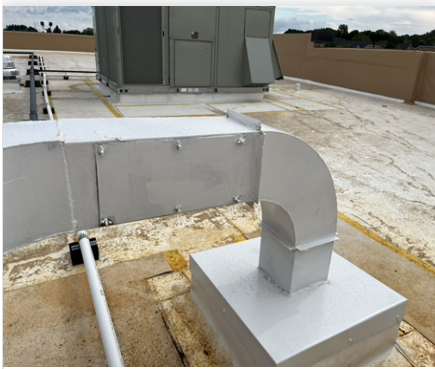
**Greaseductcleanout.jp..  
08/07/2023**

**Issue Name :** REVIEW AND RECTIFY: Grease duct clean out  
**Description :** Grease duct clean outs that are installed are incorrect. They are to have a 1 1/4" standoff flange. Downturn elbows are to have grease clean outs as well. See M250 Grease access door schedule. And Detail 1 for locations  
**Created By :** National TAB                      **Assigned To :** National TAB - Tyler Youells  
**Status :** Open  
**Originated Date :** 08/07/2023 - Gabe Merk - National TAB

**Install access ports for grease duct.**

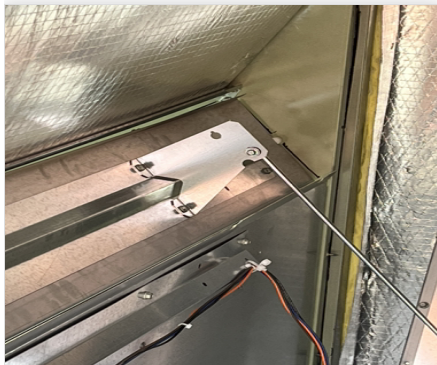
**Markedposition**  
**08/09/2023**

**Issue Name :** REVIEW+RECTIFY: AC-1 Economizer  
**Description :** Ac-1 economizer is not responding to change in commands after the return damper blockage was removed. MC found damper motor has failed and needs replacing. NTAB was able to balance and mark the damper manually. MC to set percentage based on marked position once fixed.  
**Created By :** National TAB                      **Assigned To :** National TAB - Tyler Youells  
**Status :** Open  
**Originated Date :** 08/09/2023 - Tyler Youells - National TAB

**Fix economizer for AC-1**

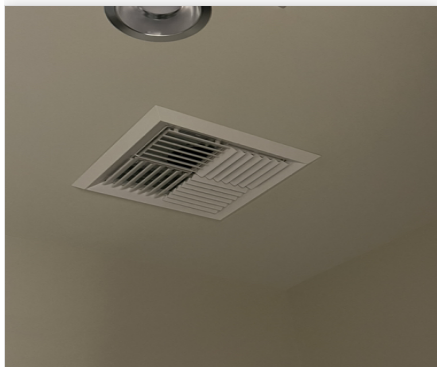
**Incorrectexhaustgrill..**  
**08/09/2023**

**Issue Name :** REVIEW+RECTIFY: Employee RR exhaust grille  
**Description :** The employee restroom exhaust Grille was installed as a 4-way supply when it is specified to be perforated type return. See M401 Air device schedule for proper Terminal device type.  
**Created By :** National TAB                      **Assigned To :** National TAB - Tyler Youells  
**Status :** Open  
**Originated Date :** 08/09/2023 - Tyler Youells - National TAB

replace supply diffuser with return grille from page 16.

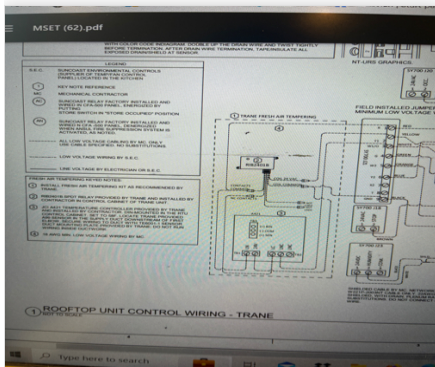
**Freshairtemperingdeta..  
08/09/2023**

**Issue Name :** REVIEW+RECTIFY: Fresh Air Tempering Kits  
**Description :** All 4 AC units are to have fresh air tempering kits field installed. Kits are not installed or seem to be on-site. Recommend contacting TRANE. See: M-250 Gas fired Rtu schedule. And See M501 Detail 1 TRANE wiring  
**Created By :** National TAB                      **Assigned To :** National TAB - Tyler Youells  
**Status :** Open  
**Originated Date :** 08/09/2023 - Tyler Youells - National TAB

Contact Trane and install parts as needed.

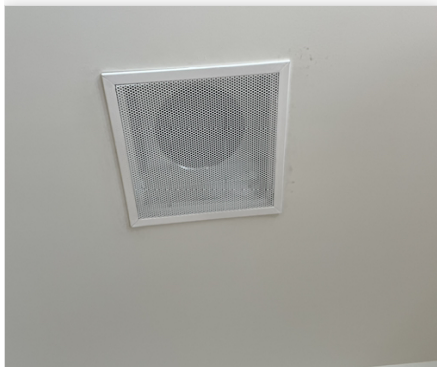
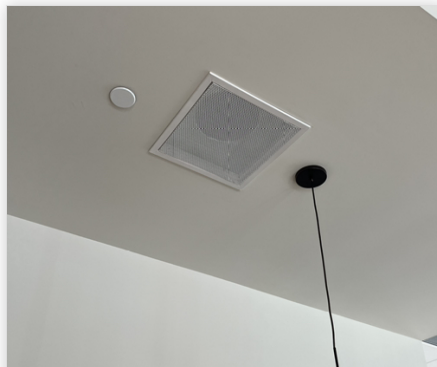
**Issue Name :** REVIEW+RECTIFY: Incorrect Air Devices  
**Description :** Diffuser located in the Drywall soffits are incorrect type. Correct type is perforated lay in with 4 way deflectors. See M401 Air device schedule for proper Air device.  
**Created By :** National TAB                      **Assigned To :** National TAB - Tyler Youells  
**Status :** Open  
**Originated Date :** 08/09/2023 - Tyler Youells - National TAB

Swap with 4 way in restroom from page 14.

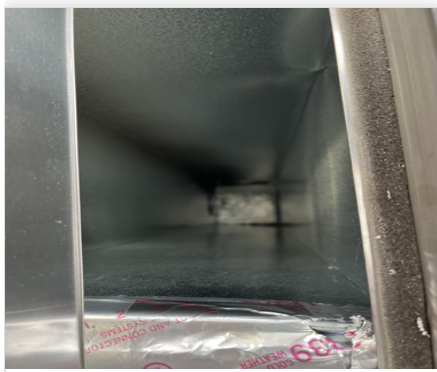
**RRExhaustdrop  
08/07/2023**

**Issue Name :** REVIEW+RECTIFY: RR Exhaust drop insulation  
**Description :** Restroom exhaust drop is externally insulated and should be internally insulated. See M901 Section 2.02 Note J.  
**Created By :** National TAB                      **Assigned To :** National TAB - Tyler Youells  
**Status :** Open  
**Originated Date :** 08/07/2023 - Gabe Merk - National TAB

- **08/10/2023 National TAB - Tyler Youells**
  - Recommend reviewing with Engineer of Record to see if external insulation would be permissible.

The external insulation is acceptable.
