Report: TAB Report
Function: Test, Adjust, & Balance
Date: 01/20/2026
Completed By: National TAB

03-16-26 WAWA #7222 SILVERTON, OH

Wawa
260 West Baltimore Pike

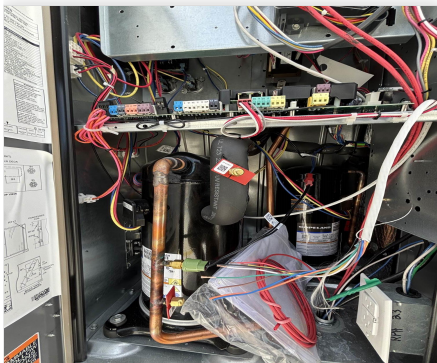
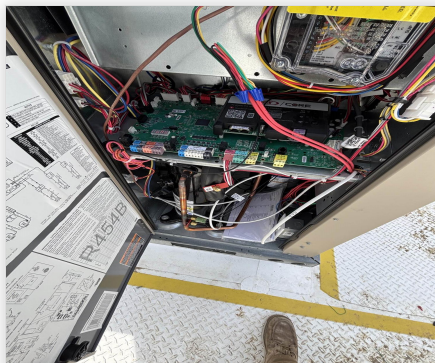
Issue Name : RTU temp sensor wiring not landed
Description : The wiring for the temp sensors is not landed at any of the RTU's. The unit has no temp being relayed to it and this makes it so that no cooling or heating will be called for.
Created By : National TAB **Assigned To :** National TAB - Will Turnbough
Status : Open
Priority : Urgent **Asset Tag :**
Originated Date : 03/19/2026 - Corey Dick - National TAB

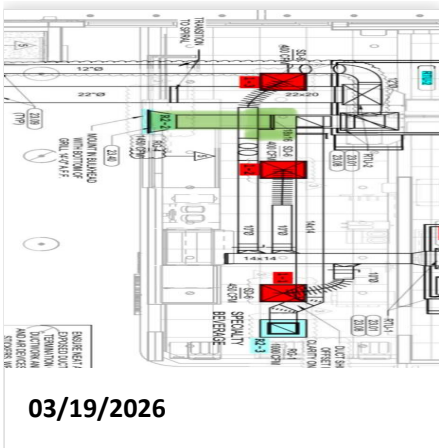
Issue Name : RTU-2 return grilles not balanced
Description : The return grilles for RTU-2 were unable to be balanced due to no damper being installed on diffuser 2 (highlighted).
Created By : National TAB **Assigned To :** National TAB - Will Turnbough
Status : Open
Priority : Low **Asset Tag :**
Originated Date : 03/19/2026 - Corey Dick - National TAB

Return diffusers not able to be balanced due to missing damper on diffuser 2

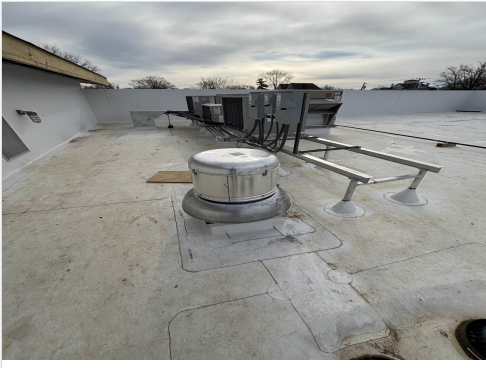
Asset: EF-1

No face dampers installed for restroom exhaust EF-1

No unit tags. Diffusers not able to be balanced due to lack of face dampers.
