Pictures

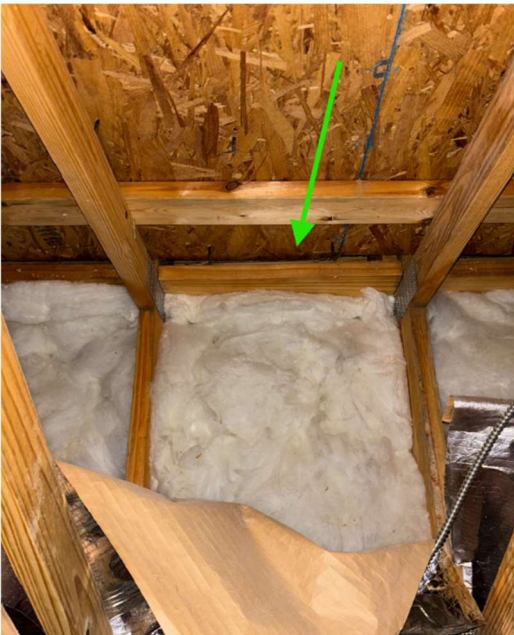
Figure 1. Typical area where leakage was observed along exterior walls

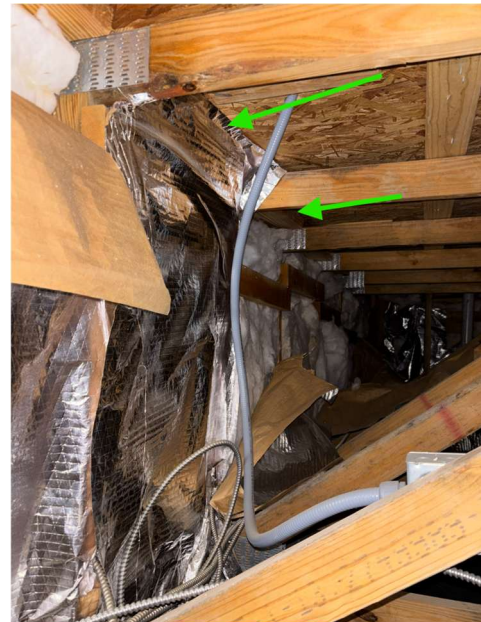
Figure 2. Typical area where leakage was observed along exterior walls

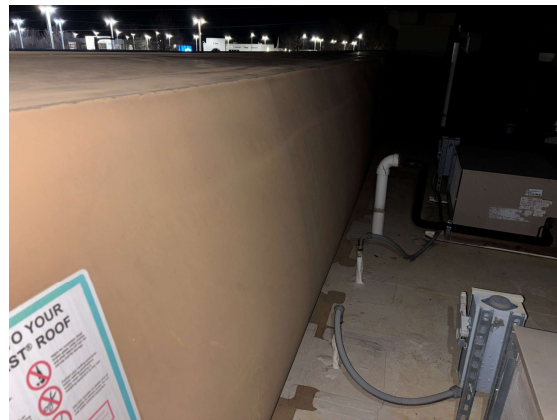
Figure 32. Roof material on parapet blowing out during pressurization test. Link to video:

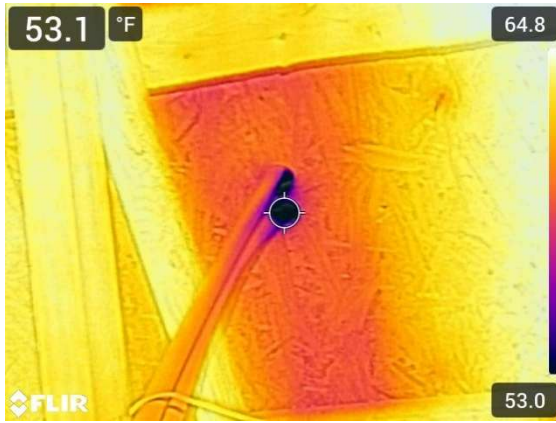
Figure 33. Wiring penetration above ceiling

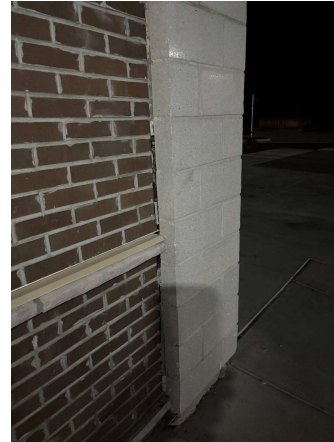
Figure 34. Air felt in the gap in masonry at West corner
