# PlanGrid Task Report - Oct 6, 2025

**L05825\_Munford FSU (TN)**

11103 U.S. 51, Atoka, Tennessee

**#326 [SITE 010] [NEW] CRITICAL – Return visit required.**

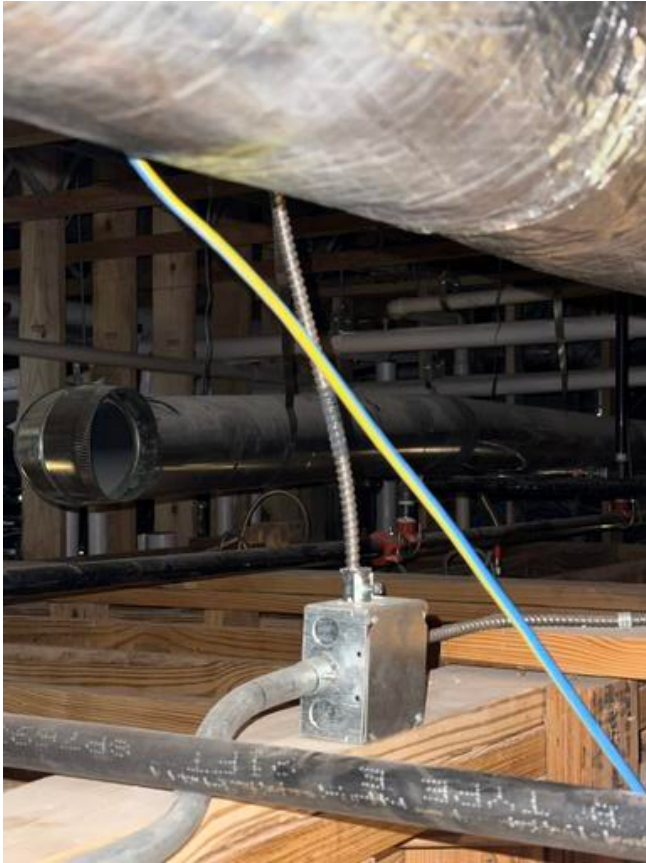
IMG\_7473

**#325 [DUCT 020] [NEW] CRITICAL – Branch ductwork deficiency.**

SA and/or RA branch ductwork not connected to a diffuser or duct missing. Duct for EF-3 Restroom is not complete.

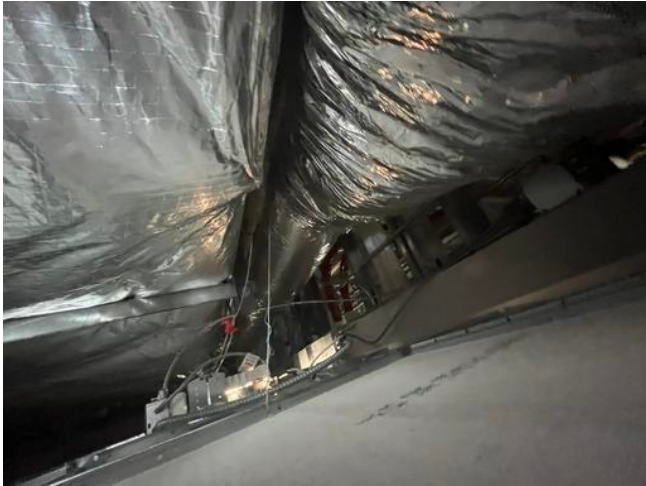
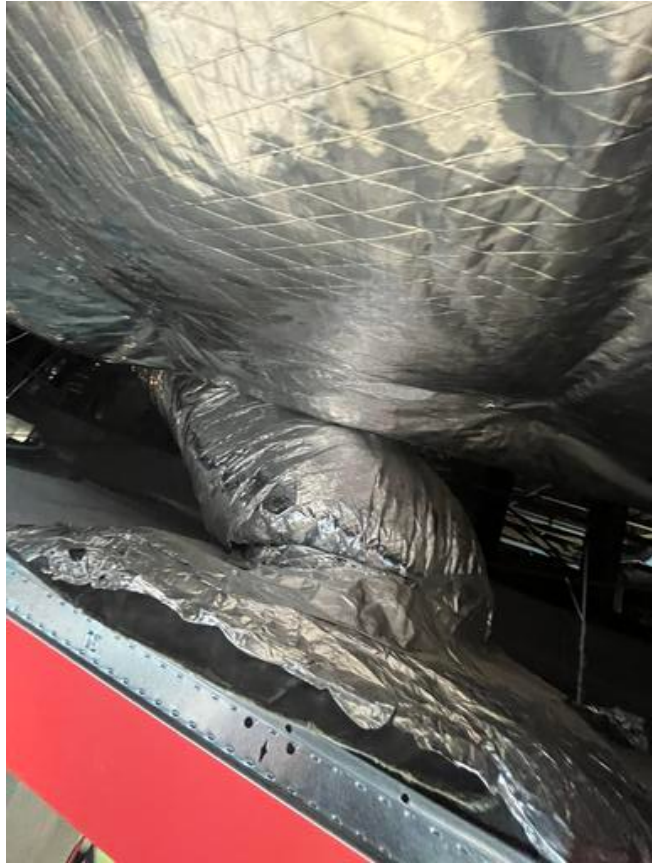
## #319 [DUCT 007] [NEW] CRITICAL – Diffuser rigid 90's.

Ensure rigid 90 degree fittings are secured to diffusers, with hard pipe risers adjusted to meet take off height elevation and connected to horizontal flex. No flex in drops allowed per details. Diffuser 3-19 above checkout  
Counter is flexed and not hard pipe 90 to diffuser.

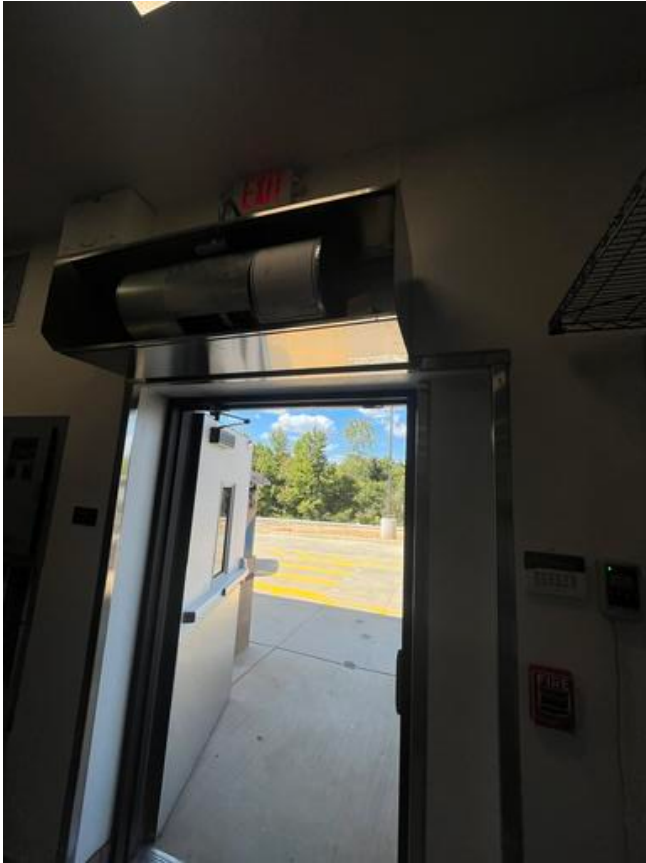
IMG\_9177

## #318 [CURT 501] [NEW] Air curtain power.

Air curtain power does not cycle properly from local disconnect at time of TAB inspection. Could not test functionality of air curtains during TAB.

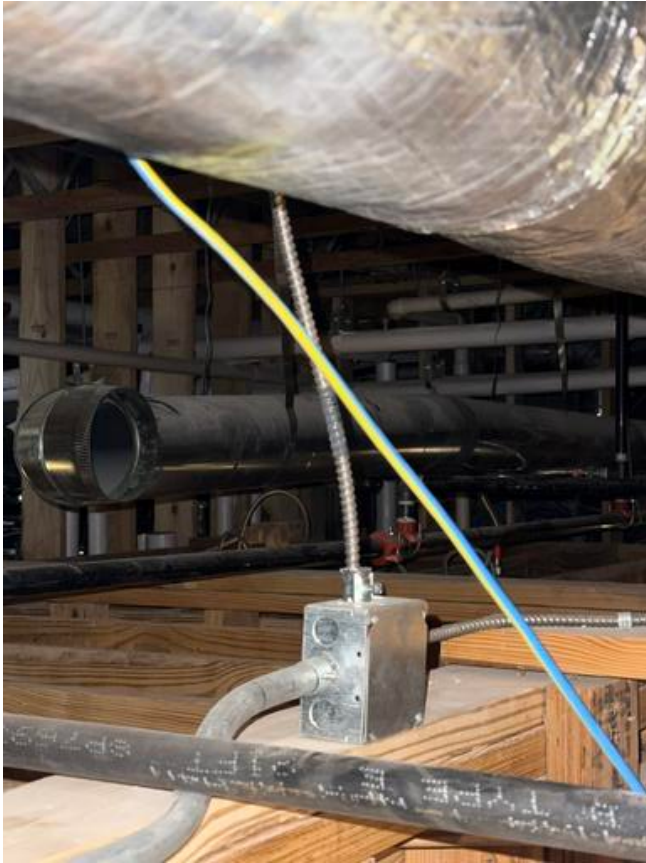
IMG\_7473

## #315 [DUCT 502] [NEW] Restroom round exhaust duct insulation.

Restroom round exhaust duct is to be externally insulated to mitigate noise per mechanical specifications.

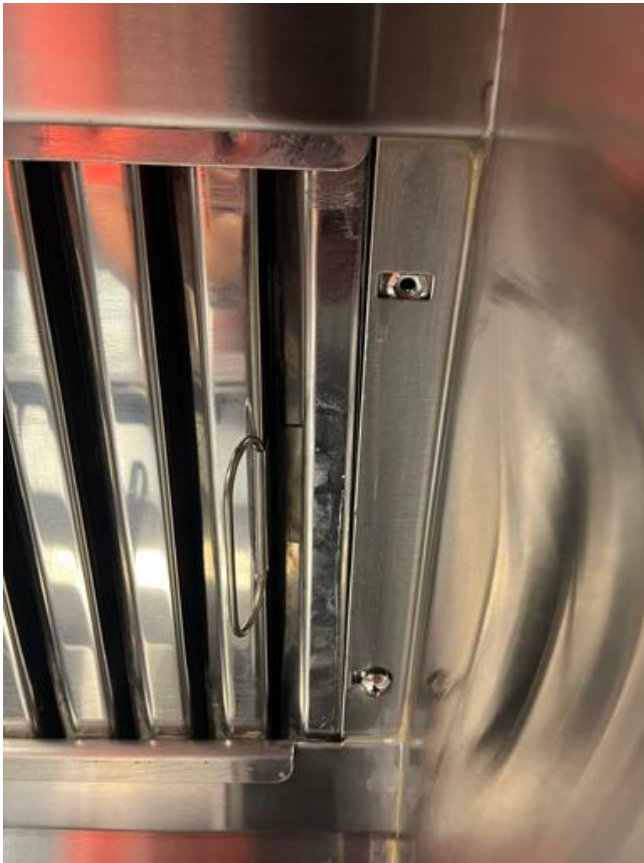
IMG\_9161

## #267 [HOOD 005] CRITICAL - Hood slider filter bracket bolt.

Hood-3 slider bracket that secured fitment tightness has a bolt missing, unable to secure filter bank to remove gaps in filters.

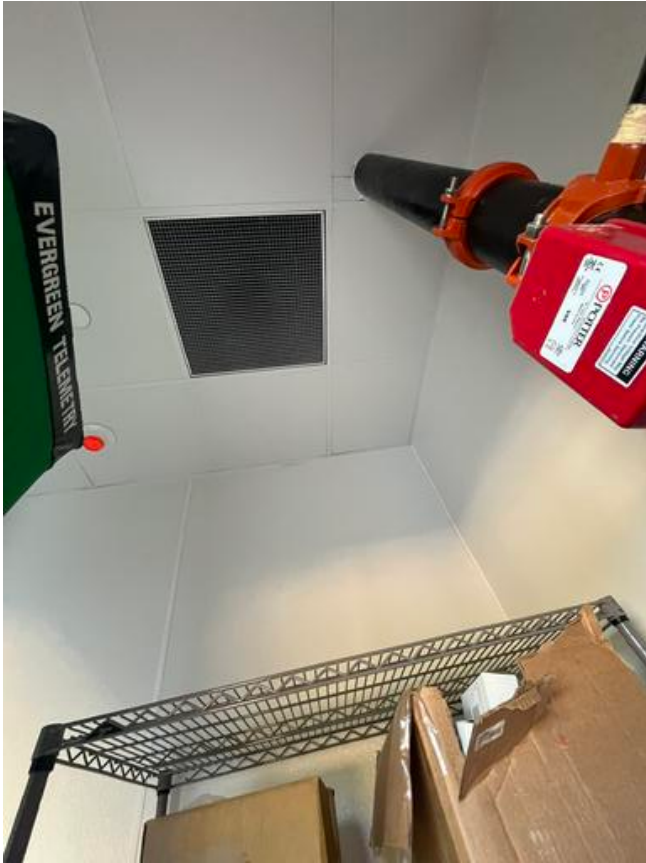
IMG\_9149

**#264 [DUCT 015] [NEW] CRITICAL – Air device wrong type.**

Diffuser does not match specified type on air device schedule. Diffuser 4-7 in riser room is egg crate return style diffuser.

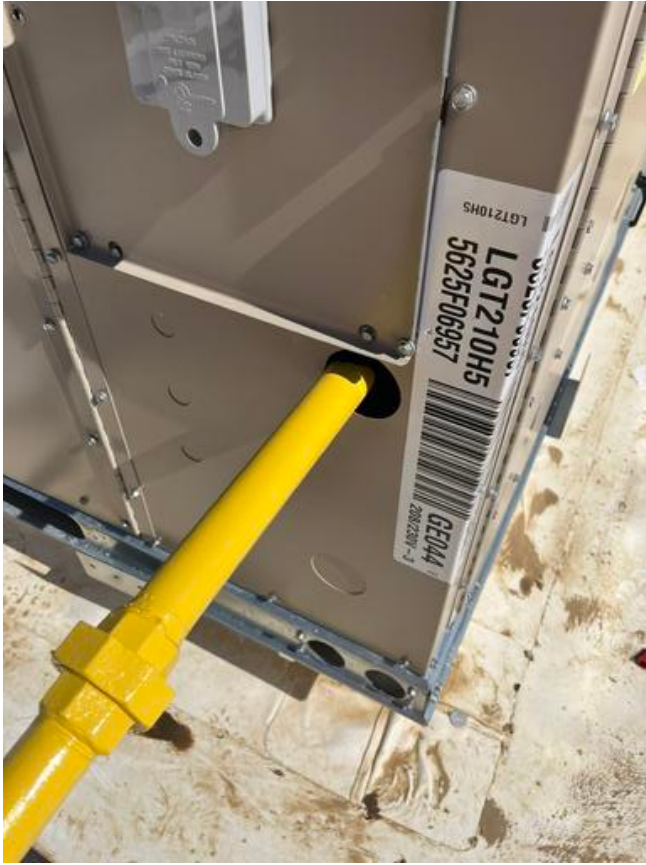
IMG\_9153

## #262 [UNIT 510] [NEW] Gas inlet grommet.

AC gas inlet grommet is missing at the gas line/RTU penetration point.

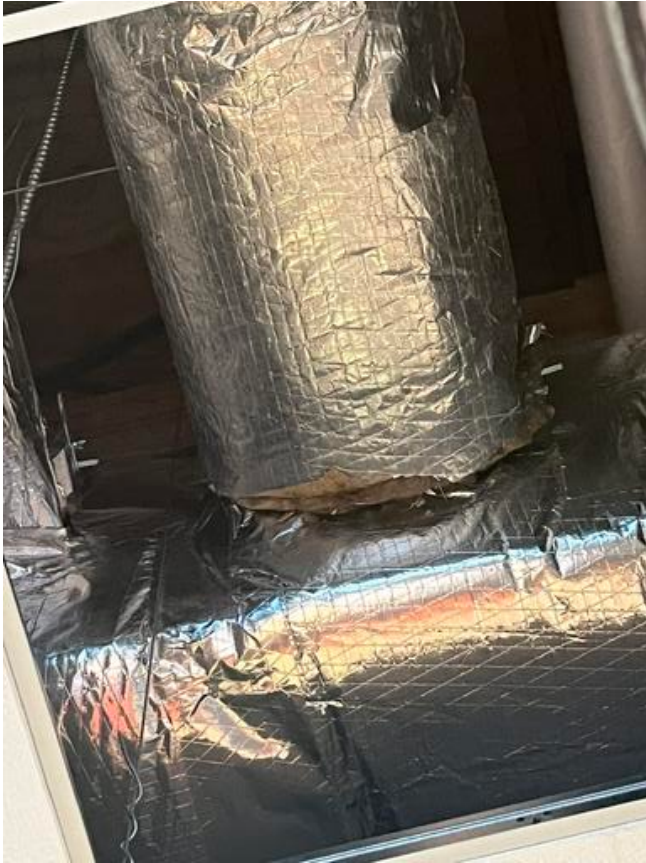
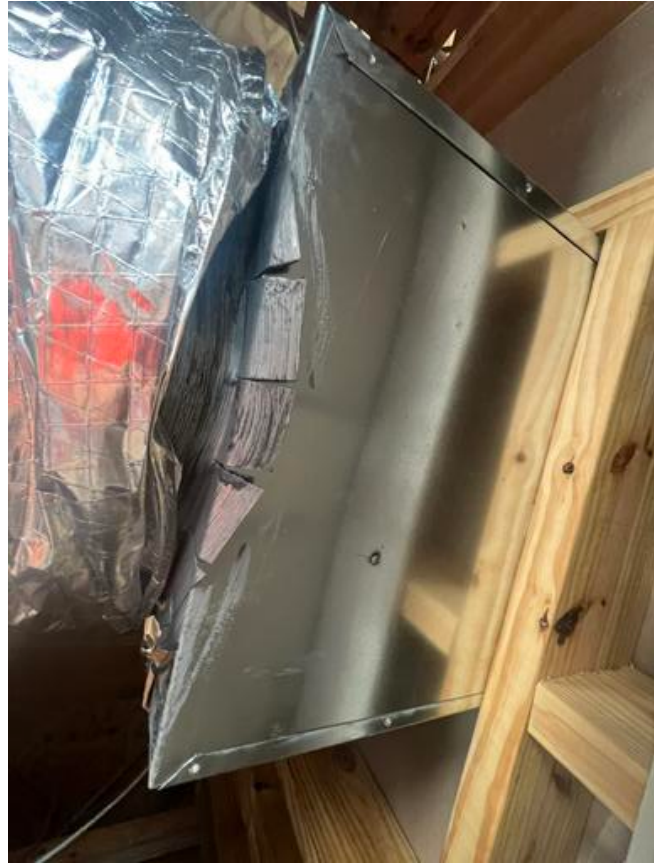
**#31 [DUCT 005] [NEW] CRITICAL – Duct leaks observed.**

Ensure duct is sealed at all start collars, traverse joints, seams, and connections to air device collars. Review all.

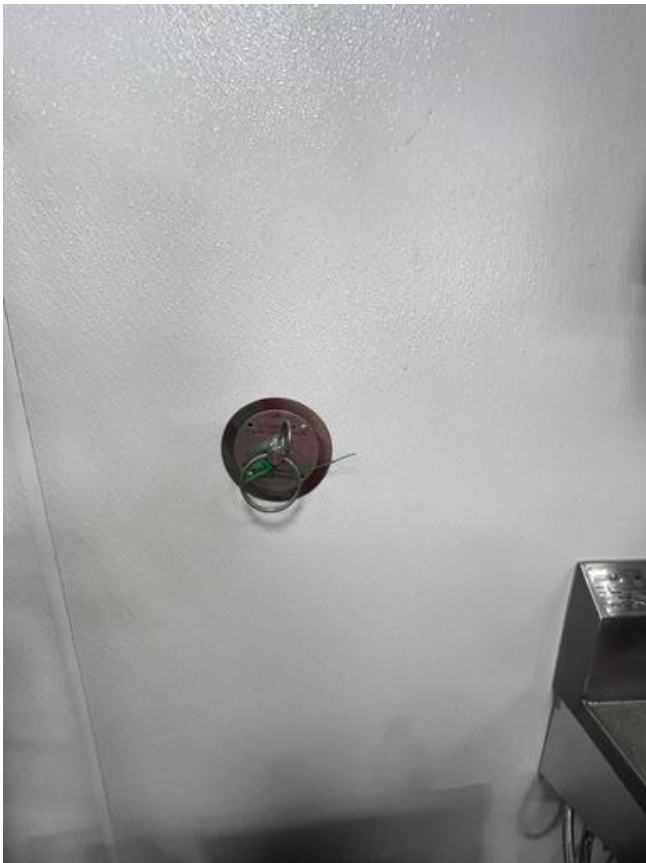
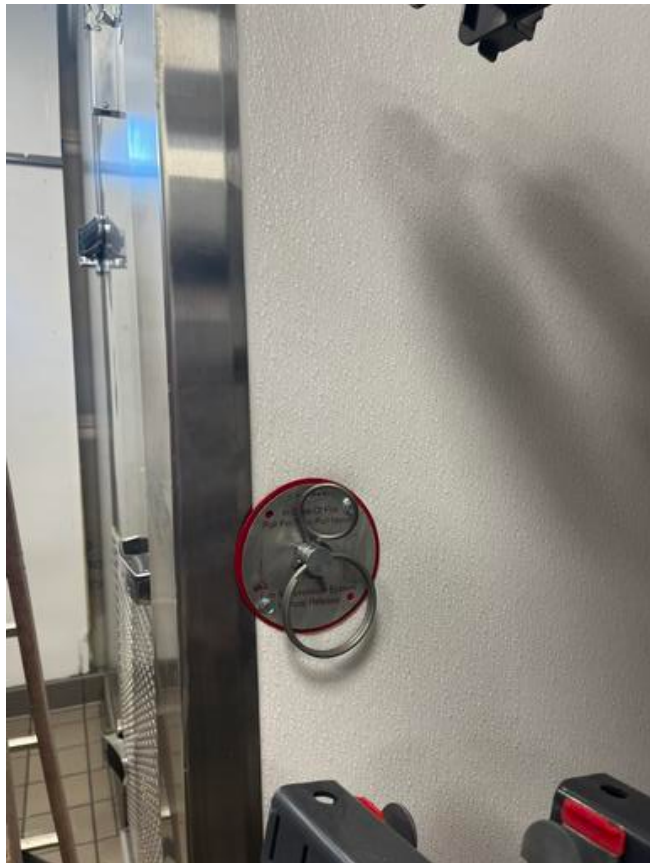
## #27 [CNTL 509] [NEW] Ansul pull labeling.

Label all ansul pull stations for which hoods they serve.

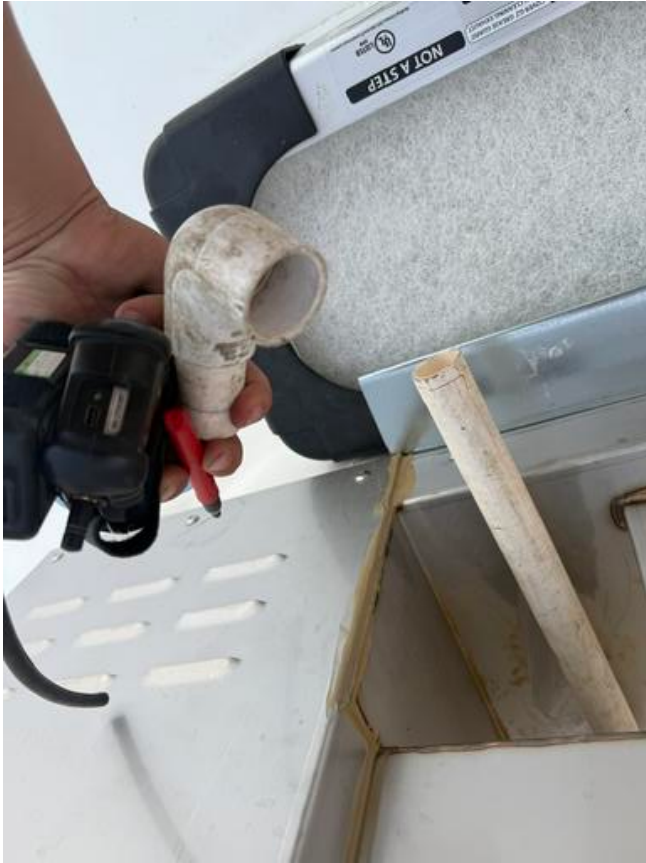
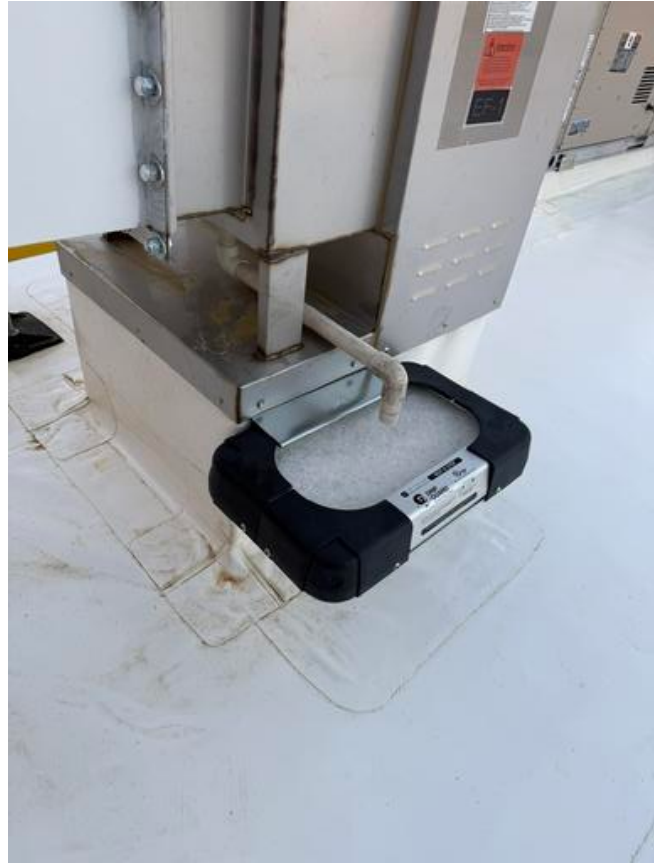
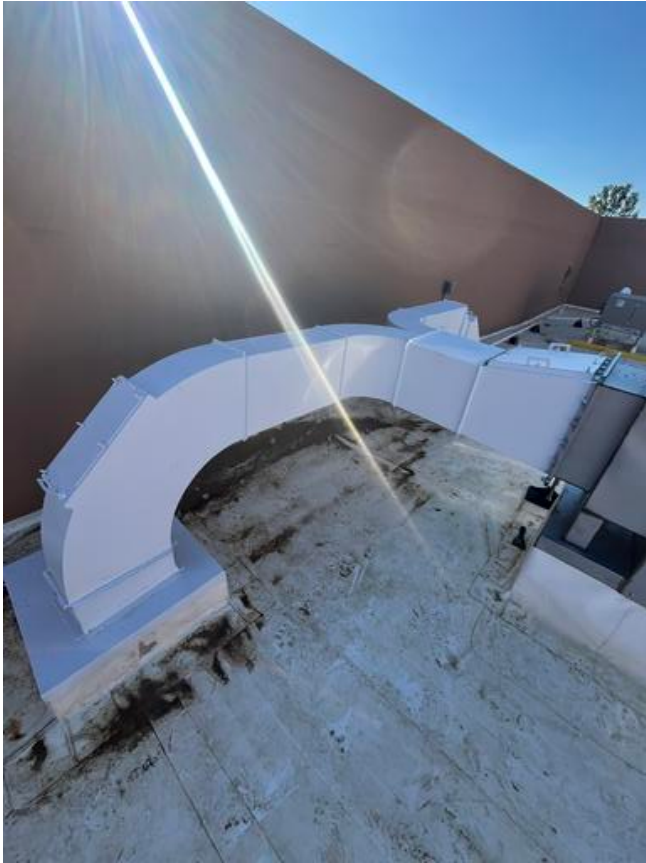
## #22 [EXHA 507] [NEW] Exhaust fan drain line.

Exhaust fan drain is not properly installed, pitched, or routed to center of drip guard per detail. If gas piping is used, will need to be painted for rust protection.

10/01/25 drip guard is installed on the left side of the EF, plans show to install underneath the front side of housing. PVC drain needs to be glued together.

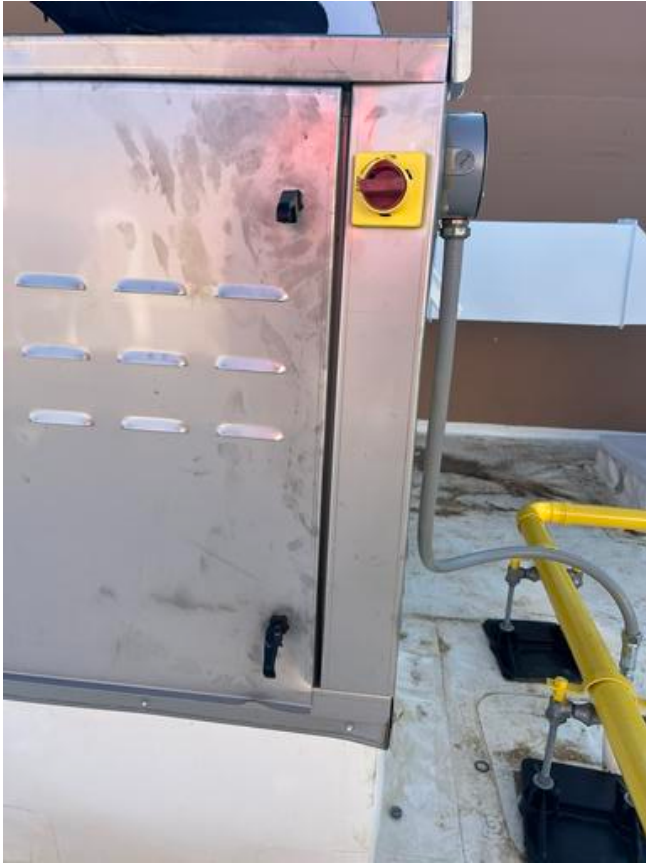
IMG\_9122

## #18 [EXHA 999] [NEW] (MISC) [Damage to EF-1 access Door]

There is damage on the  
Access door to the blower  
compartment for EF-1.

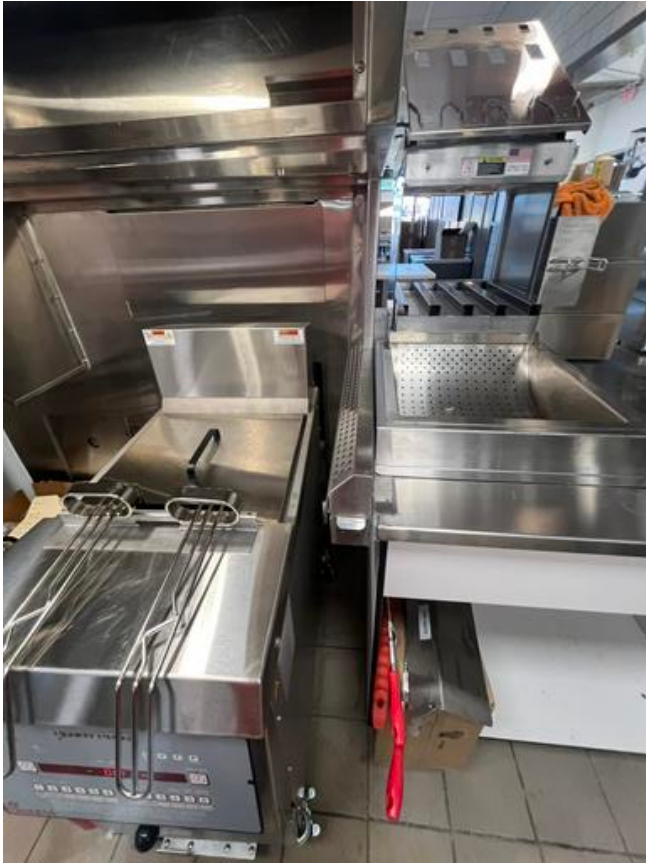
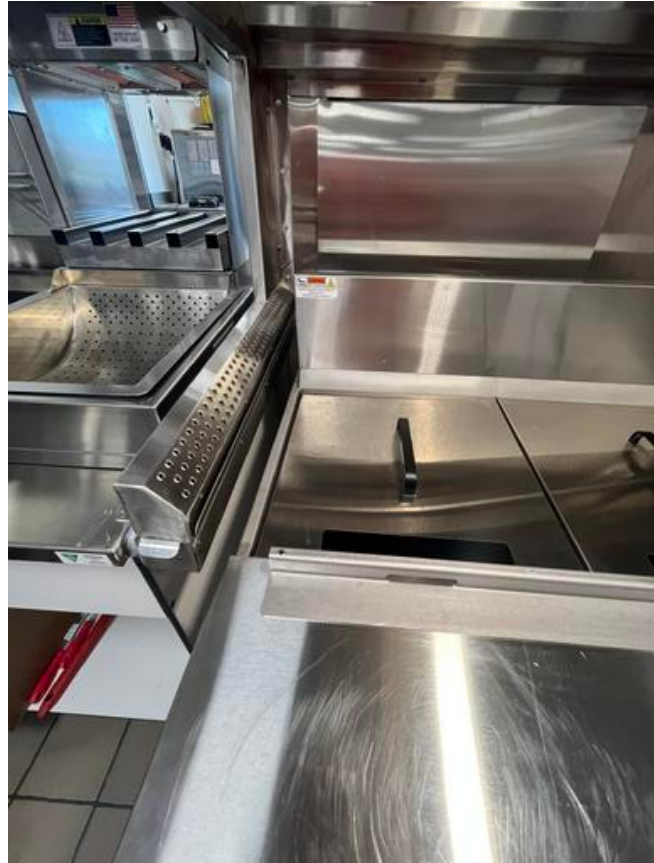
**#16 [HOOD 512] [NEW] Grease cup and fry chute.**

Hood is missing its grease cup and / or fry chute. HD-2/ HD-3

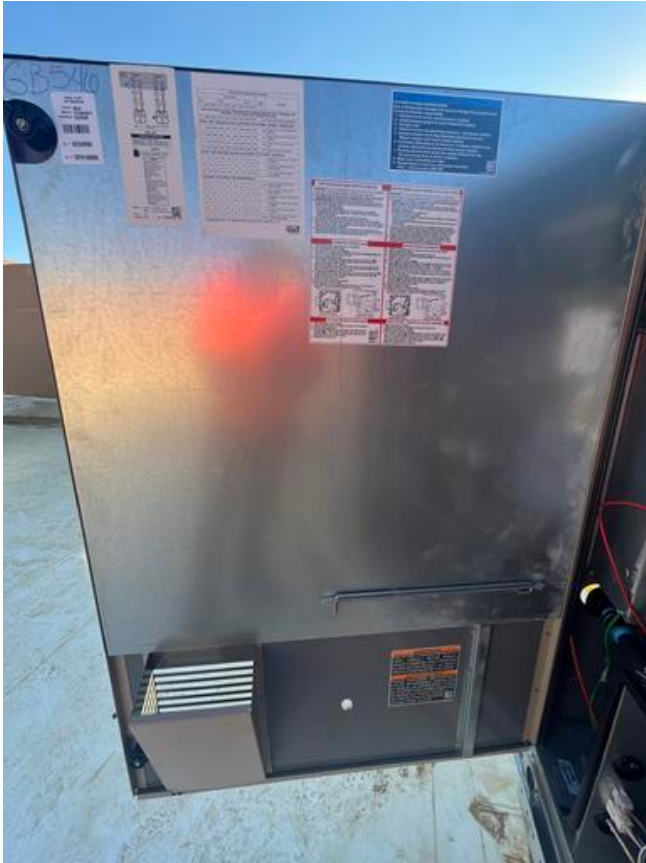
IMG\_9118

## #14 [UNIT 501] [NEW] Equipment low voltage diagrams

Equipment missing  
laminated copy of controls  
detail low voltage wiring  
diagrams.

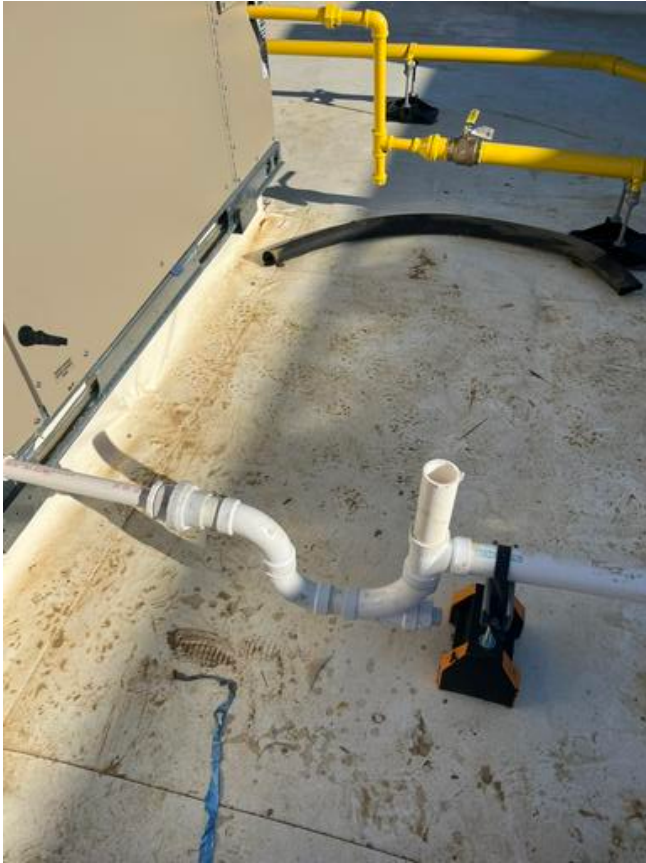
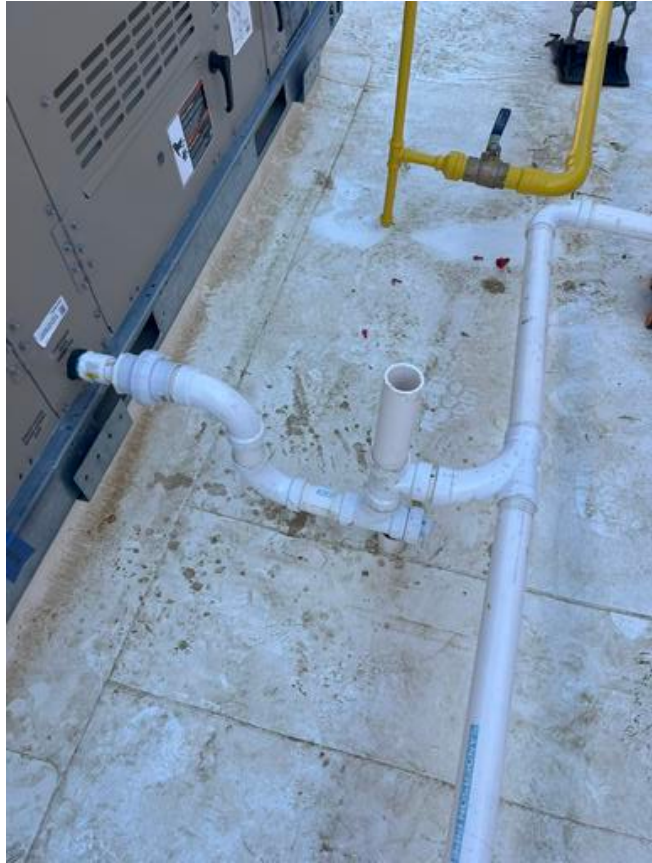
## #12 [UNIT 517] [NEW] Condensate piping construction.

Equipment condensate piping or p-trap is not constructed per normal CFA specifications.
