Report: TAB Report
Function: Test, Adjust, & Balance
Date: 10/23/2024
Completed By: National TAB

PROJECT
10-21-24 CHIPOTLE #5173 NAVARRE, FL

Project: 10-21-24 CHIPOTLE #5173 NAVARRE, FL

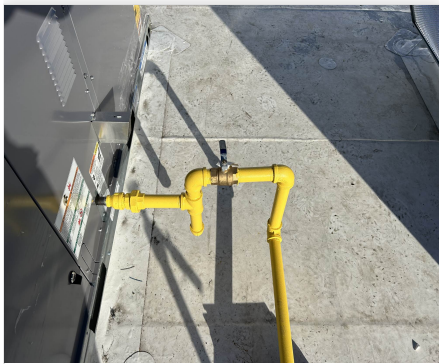
Issue Name : Gas Valves Closed
Description : All rooftop gas valves are currently closed.
Created By : National TAB **Assigned To :** National TAB - Will Turnbough
Status : Open
Priority : InfoOnly **Asset Tag :** RTU 1
Originated Date : 10/23/2024 - Mark Johnson - National TAB

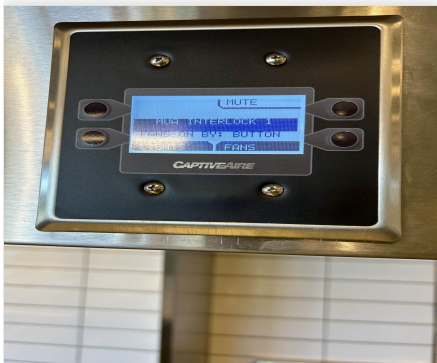
Issue Name : Hood Alarm - MUA Interlock 1
Description : Hood exhaust fan and MUA will not run consistently due to the hood alarm "MUA Interlock 1." Hood powers down approximately 30 seconds after turning on. Cannot balance hood exhaust or MUA until resolved.
Created By : National TAB **Assigned To :** National TAB - Will Turnbough
Status : Open
Priority : Urgent **Asset Tag :** HD1
Originated Date : 10/22/2024 - Mark Johnson - National TAB

- **10/23/2024 National TAB - Mark Johnson**
 - Alarm is still present, but hood exhaust now runs consistently and was successfully balanced. MUA unit remains not functional.

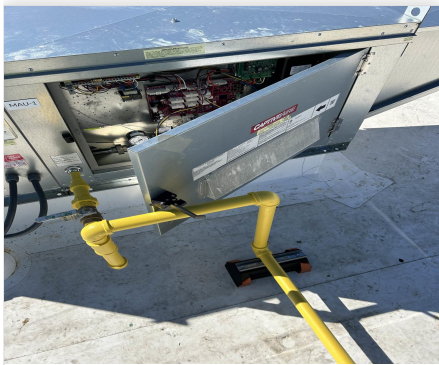
Issue Name : MUA Door Obstruction
Description : The door to the MUA control panel cannot open fully due to location of gas piping. Access to MUA HMI is restricted.
Created By : National TAB **Assigned To :** National TAB - Will Turnbough
Status : Open
Priority : Low **Asset Tag :** MUA 1
Originated Date : 10/22/2024 - Mark Johnson - National TAB

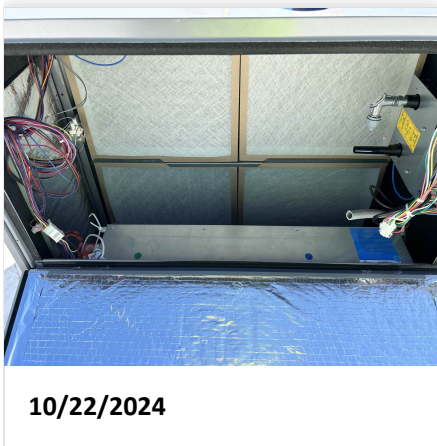
Issue Name : RTUs - Construction Filters
Description : Both RTUs have temporary construction filters installed. Recommend installing required final filters.
Created By : National TAB **Assigned To :** National TAB - Will Turnbough
Status : Open
Priority : Low **Asset Tag :** RTU 1
Originated Date : 10/22/2024 - Mark Johnson - National TAB
