**Report: Deficiency Report**  
**Function: Test, Adjust, & Balance**  
**Date: 10/21/2024**  
**Completed By: National TAB**

**PROJECT**  
**10-21-24 CHIPOTLE #5173 NAVARRE, FL**

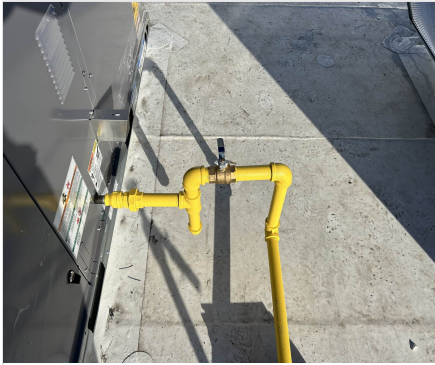
**Issue Name :** Gas Valves Closed  
**Description :** All rooftop gas valves are currently closed.  
**Created By :** National TAB                      **Assigned To :** National TAB - Will Turnbough  
**Status :** Open  
**Priority :** InfoOnly                                      **Asset Tag :** RTU 1  
**Originated Date :** 10/23/2024 - Mark Johnson - National TAB

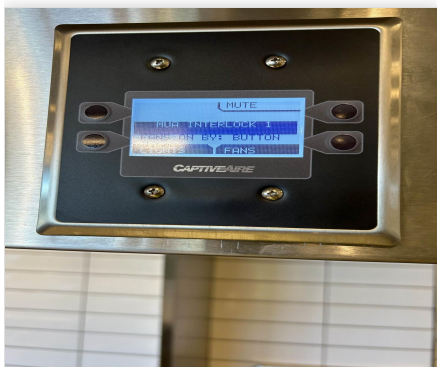
**Issue Name :** Hood Alarm - MUA Interlock 1  
**Description :** Hood exhaust fan and MUA will not run consistently due to the hood alarm "MUA Interlock 1." Hood powers down approximately 30 seconds after turning on. Cannot balance hood exhaust or MUA until resolved.  
**Created By :** National TAB                      **Assigned To :** National TAB - Will Turnbough  
**Status :** Open  
**Priority :** Urgent                                      **Asset Tag :** HD1  
**Originated Date :** 10/22/2024 - Mark Johnson - National TAB

- **10/23/2024 National TAB - Mark Johnson**
  - Alarm is still present, but hood exhaust now runs consistently and was successfully balanced. MUA unit remains not functional.

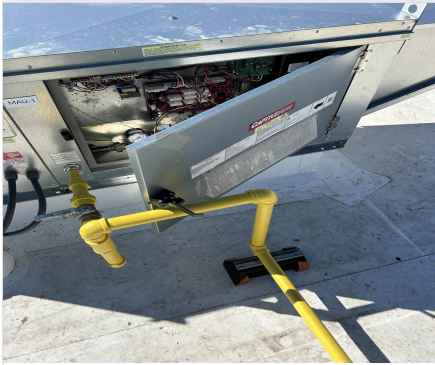
**Issue Name :** MUA Door Obstruction  
**Description :** The door to the MUA control panel cannot open fully due to location of gas piping. Access to MUA HMI is restricted.  
**Created By :** National TAB                      **Assigned To :** National TAB - Will Turnbough  
**Status :** Open  
**Priority :** Low                                      **Asset Tag :** MUA 1  
**Originated Date :** 10/22/2024 - Mark Johnson - National TAB

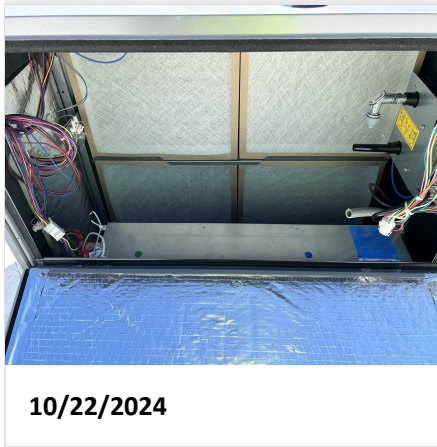
**Issue Name :** RTUs - Construction Filters  
**Description :** Both RTUs have temporary construction filters installed. Recommend installing required final filters.  
**Created By :** National TAB                      **Assigned To :** National TAB - Will Turnbough  
**Status :** Open  
**Priority :** Low                                      **Asset Tag :** RTU 1  
**Originated Date :** 10/22/2024 - Mark Johnson - National TAB
