Report: Deficiency Report
Function: Test, Adjust, & Balance
Date: 05/19/2025
Completed By: National TAB

05-19-25 WAWA #8196 POTTSTOWN, PA

157 EVERGREEN RD

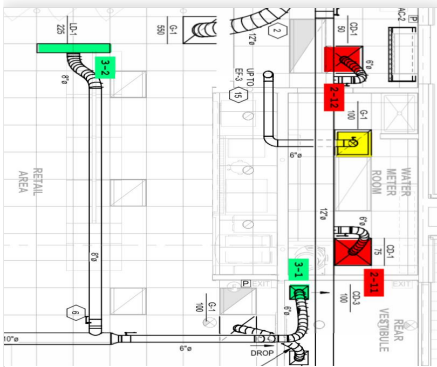
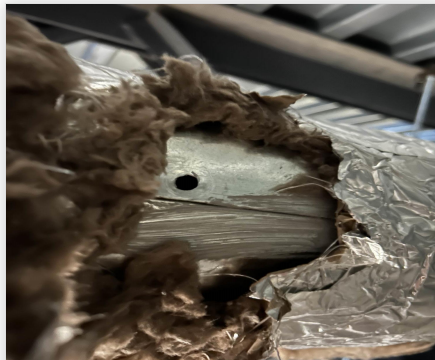
Issue Name : Diffuser 3-1 - Broken Damper
Description : The damper handle for diffuser 3-1 (rear vestibule) was broken while attempting to adjust. Damper blade is stuck and will not close sufficiently to adjusted the diffuser to design airflow. Diffuser is currently at 125 CFM (125% design) and cannot be adjusted further. Recommend damper repair.
Created By : National TAB **Assigned To :** National TAB - Will Turnbough
Status : Open
Priority : High **Asset Tag :**
Originated Date : 05/21/2025 - Mark Johnson - National TAB

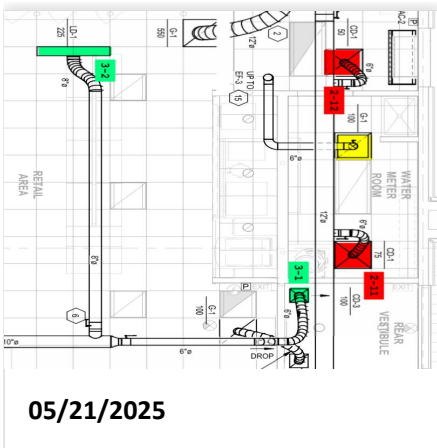
Issue Name : Diffuser 3-2 - Low Flow
Description : Diffuser 3-2 (retail area) is currently at 184 CFM (82% design). Damper is fully open and no ductwork deficiencies were noted. Not anticipated to cause comfort issues in the open retail space; however, it is expected that correcting the damper issue with diffuser 3-1 and closing it to design will improve this diffuser's airflow to be within design.
Created By : National TAB **Assigned To :** National TAB - Will Turnbough
Status : Open
Priority : Medium **Asset Tag :**
Originated Date : 05/21/2025 - Mark Johnson - National TAB

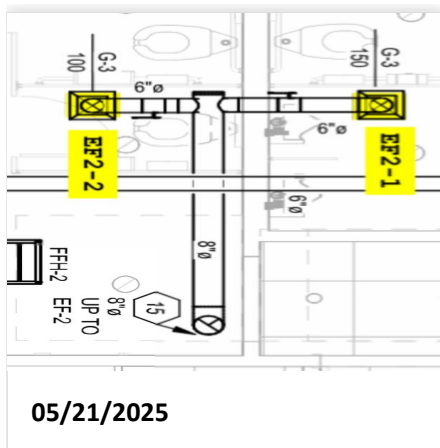
Issue Name : EF 2 - Low Flow
Description : EF 2 (restrooms) is currently at a total of 115 CFM (46% design). Dampers are fully open, including backdraft damper. Mechanical inspection showed no ductwork deficiencies and confirmed the fan is running at max speed. Recommend further inspection of fan to determine possible causes.
Created By : National TAB **Assigned To :** National TAB - Will Turnbough
Status : Open
Priority : Urgent **Asset Tag :** EF2
Originated Date : 05/21/2025 - Mark Johnson - National TAB
