Report: Deficiency Report
Function: Test, Adjust, & Balance
Date: 05/19/2025
Completed By: National TAB

05-19-25 WAWA #8196 POTTSTOWN, PA

157 EVERGREEN RD

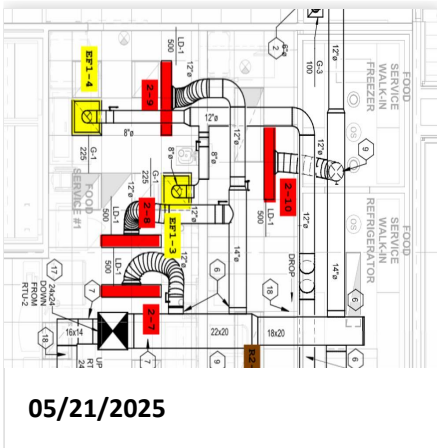
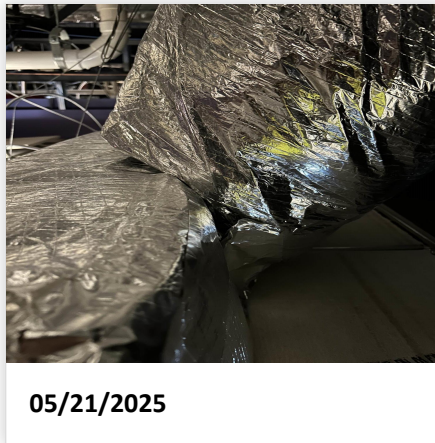
Issue Name : Diffuser 2-10 - Low Flow
Description : Diffuser 2-10 (food service) is currently at 343 CFM (69% design). Damper is fully open. Ductwork appears to be restricted at the diffuser takeoff. All other diffusers for RTU 2 are within design, and further balancing is not expected to improve this diffuser's airflow to design. Recommend mechanical inspection.
Created By : National TAB **Assigned To :** National TAB - Will Turnbough
Status : Open
Priority : High **Asset Tag :**
Originated Date : 05/21/2025 - Mark Johnson - National TAB

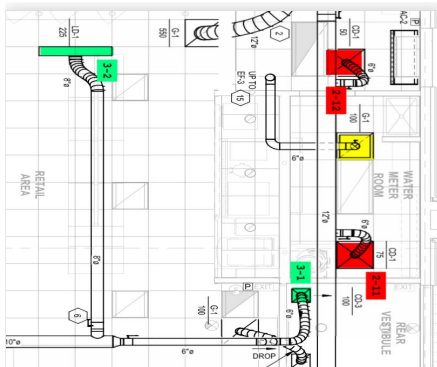
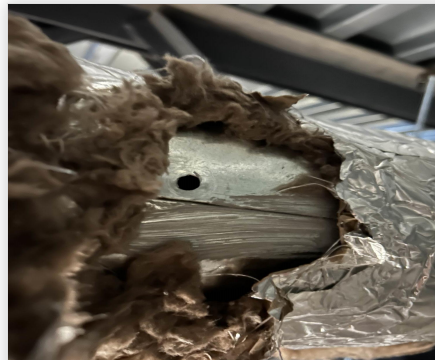
Issue Name : Diffuser 3-1 - Broken Damper
Description : The damper handle for diffuser 3-1 (rear vestibule) was broken while attempting to adjust. Damper blade is stuck inside duct and will not close sufficiently to adjust the diffuser to design airflow. Diffuser is currently at 125 CFM (125% design) and cannot be adjusted further. Recommend damper repair.
Created By : National TAB **Assigned To :** National TAB - Will Turnbough
Status : Open
Priority : High **Asset Tag :**
Originated Date : 05/21/2025 - Mark Johnson - National TAB

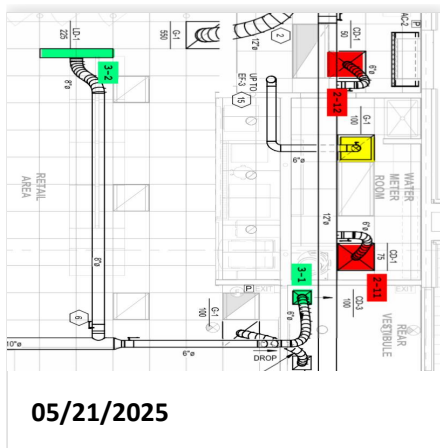
Issue Name : Diffuser 3-2 - Low Flow
Description : Diffuser 3-2 (retail area) is currently at 184 CFM (82% design). Damper is fully open and no ductwork deficiencies were noted. Not anticipated to cause comfort issues in the open retail space; however, it is expected that correcting the damper issue with diffuser 3-1 and closing it to design will improve this diffuser's airflow to be within design.
Created By : National TAB **Assigned To :** National TAB - Will Turnbough
Status : Open
Priority : Medium **Asset Tag :**
Originated Date : 05/21/2025 - Mark Johnson - National TAB

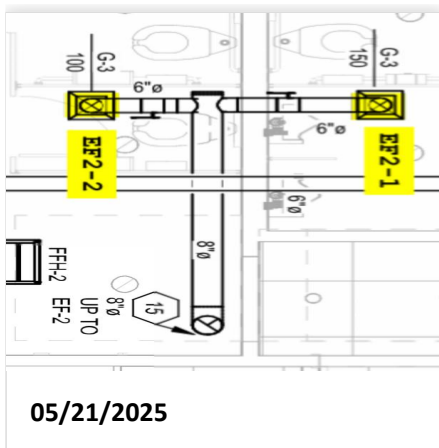
Issue Name : EF 2 - Low Flow
Description : EF 2 (restrooms) is currently at a total of 115 CFM (46% design). Dampers are fully open, including backdraft damper. Mechanical inspection showed no ductwork deficiencies and confirmed the fan is running at max speed. Recommend further inspection of fan to determine possible causes.
Created By : National TAB **Assigned To :** National TAB - Will Turnbough
Status : Open
Priority : Urgent **Asset Tag :** EF2
Originated Date : 05/21/2025 - Mark Johnson - National TAB
