Report: TAB Report
Function: Test, Adjust, & Balance
Date: 10/28/2025
Completed By: National TAB

PROJECT
10-13-25 QT #0591 OMAHA, NE

QUIKTRIP
4705 SOUTH 129TH EAST AVENUE
TULSA, OK 74134

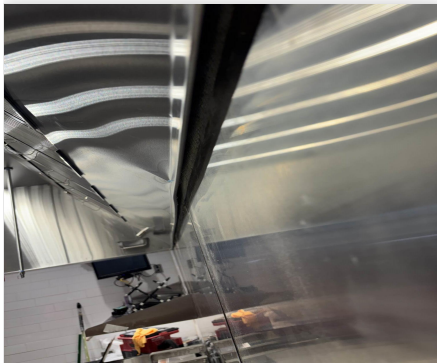
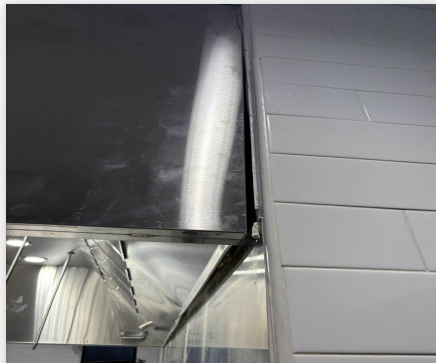
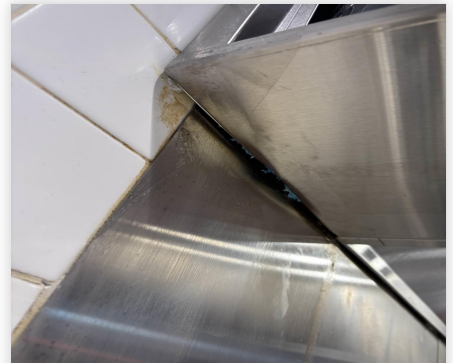
Issue Name : HOOD1: Missing Caulking
Description : The hood is missing caulking between the rear of hood and wall that it sets up against. The hood is also not properly aligned to the wall.
Created By : National TAB **Assigned To :** National TAB - Dan Hertenstein
Status : Open
Priority : Urgent **Asset Tag :** HD1
Originated Date : 10/28/2025 - Kalen Kemp - National TAB

Hood has minor dents along back side that runs against the wall/stainless steel. Hood is missing caulking between back of hood and wall.

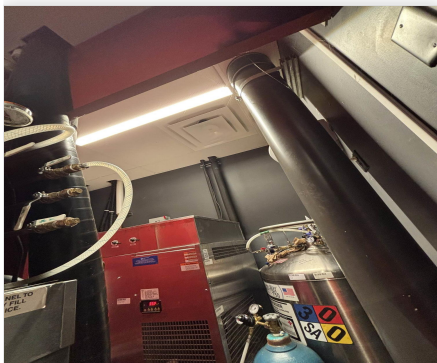
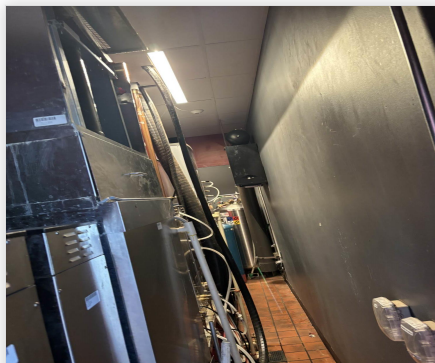
Issue Name : RT-2: Inaccessible diffuser
Description : Unable to access diffuser or duct for traverse. Closed damper for RTU total supply airflow. Then opened damper back to initial position. Noting for clarity on report.
Created By : National TAB **Assigned To :** National TAB - Dan Hertenstein
Status : Open
Priority : InfoOnly **Asset Tag :** SGRD10
Originated Date : 10/16/2025 - Kalen Kemp - National TAB

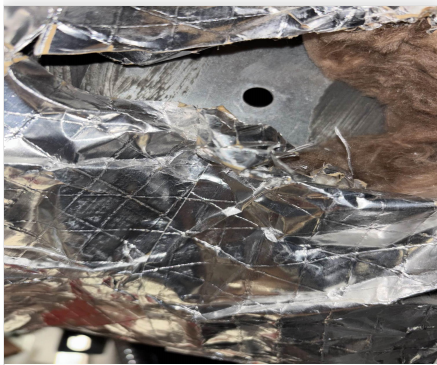
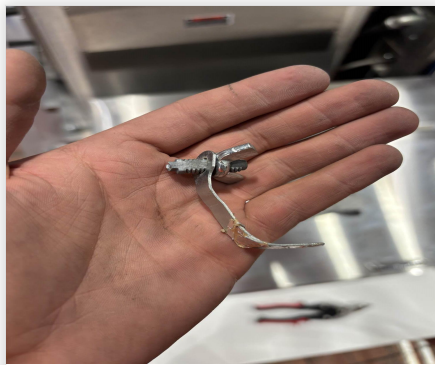
Issue Name : RT-3: Broken Damper Handle
Description : The damper handle is broken. The damper fell down into the duct and is obstructing airflow. Recommend replacing the damper.
Created By : National TAB **Assigned To :** National TAB - Dan Hertenstein
Status : Open
Priority : Urgent **Asset Tag :** SGRD3
Originated Date : 10/15/2025 - Kalen Kemp - National TAB

- OA ACTUATOR NOT RESPONDING TO EMERSON COMMANDS. OA DAMPER SET MANUALLY. LEFT IN HOODS ON POSITION.
- DIFFUSER 3-2 HAS BROKEN DAMPER HANDLE. DAMPER IS LAYING IN DUCT OBSTRUCTING AIRFLOW. UNABLE TO BALANCE AIRFLOW.

Asset	Notes	Date	Written By
SGRD2	[1] DAMPER HANDLE BROKEN	10/29/2025	Michael McDonnell

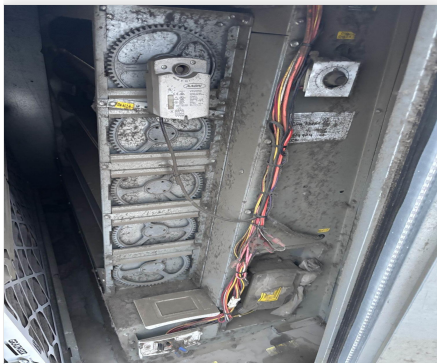
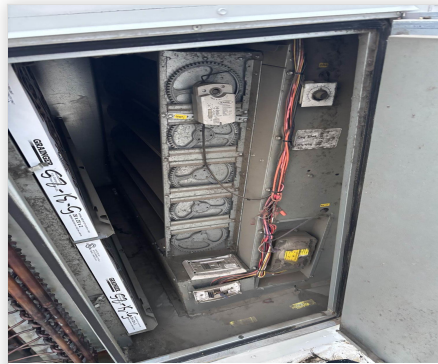
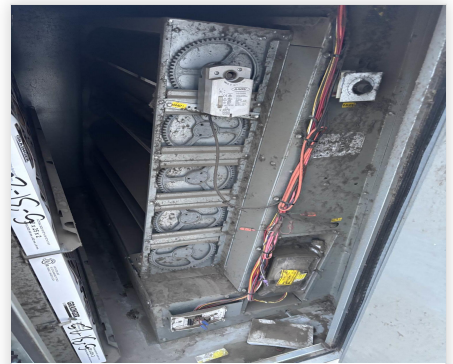
Issue Name : RTUs: Dirty Filter Compartment
Description : The filter compartments are very dirty. Recommend cleaning.
Created By : National TAB **Assigned To :** National TAB - Dan Hertenstein
Status : Open
Priority : Medium **Asset Tag :**
Originated Date : 10/16/2025 - Kalen Kemp - National TAB

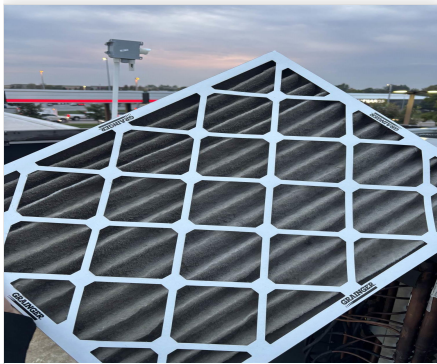
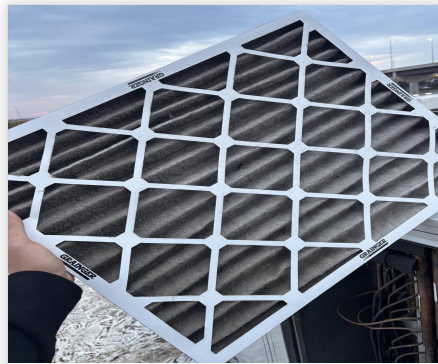
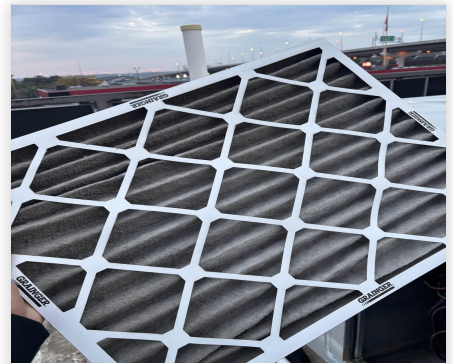
Issue Name : RTUs: Dirty Filters
Description : The filters for the RTUs are dirty. Recommend replacing.
Created By : National TAB **Assigned To :** National TAB - Dan Hertenstein
Status : Open
Priority : Low **Asset Tag :**
Originated Date : 10/16/2025 - Kalen Kemp - National TAB

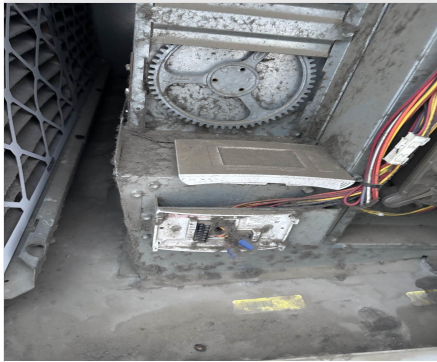
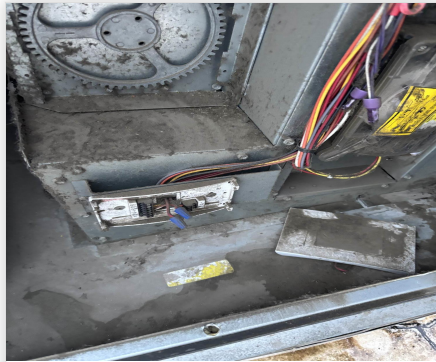
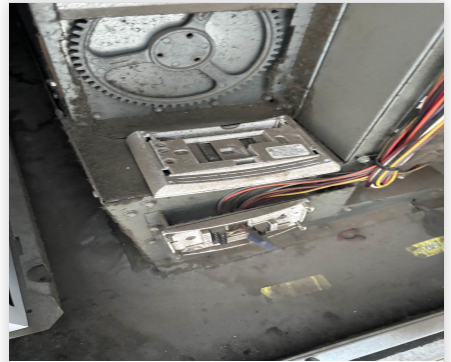
Issue Name : RTUs: Disconnected Thermostats
Description : The thermostats inside of the RTUs are disconnected. Recommend reconnecting and powering.
Created By : National TAB **Assigned To :** National TAB - Dan Hertenstein
Status : Open
Priority : Medium **Asset Tag :**
Originated Date : 10/16/2025 - Kalen Kemp - National TAB

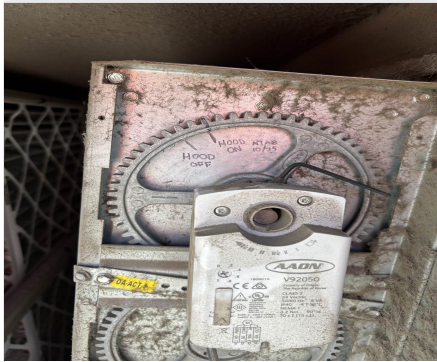
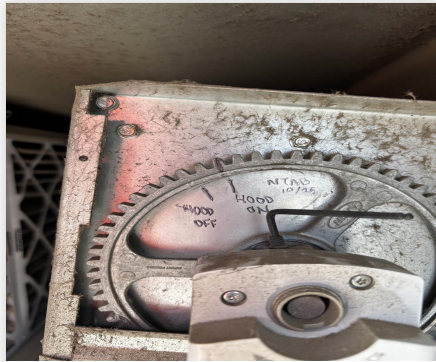
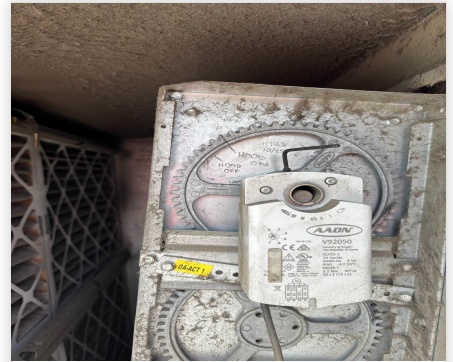
Issue Name : RTUs: OA Actuators
Description : The OA damper actuators are not responding to the Emerson controls. OA damper points had to be set manually. Recommend service.
Created By : National TAB **Assigned To :** National TAB - Dan Hertenstein
Status : Open
Priority : High **Asset Tag :**
Originated Date : 10/16/2025 - Kalen Kemp - National TAB

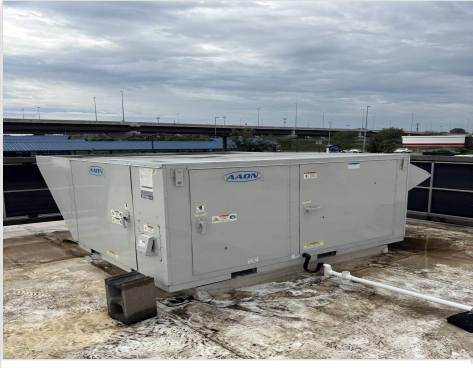
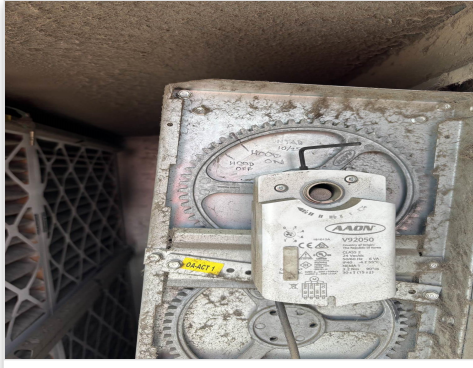
Asset: RT-1

- RT-2 IN THE EMERSON CONTROLS
- OA ACTUATOR NOT RESPONDING TO EMERSON COMMANDS. HAD TO MANUALLY SET OA DAMPER. LEFT IN HOODS ON POSITION.

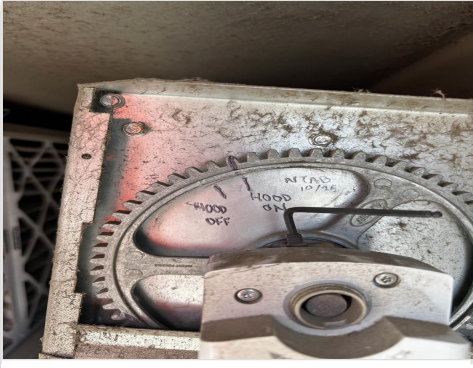
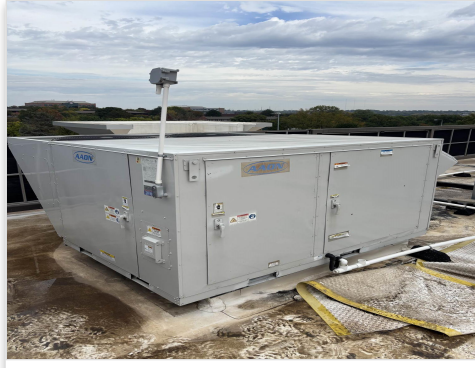
Asset: RT-2

- RT-1 IN THE EMERSON CONTROLS
- OA ACTUATOR NOT RESPONDING TO EMERSON CONTROLLER. OA DAMPER SET MANUALLY. LEFT IN HOODS ON POSITION.

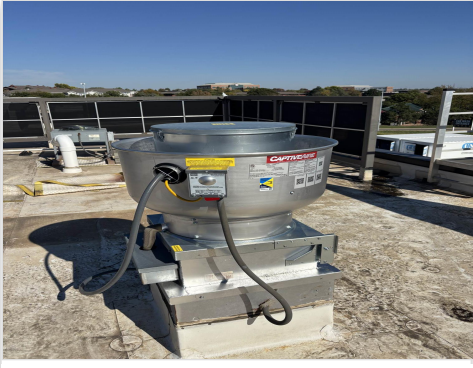
Asset: EF3

-UNABLE TO CONTROL FAN USING EMERSON. FAN SPEEDS SET THROUGH HMI IN CONTROL PANEL

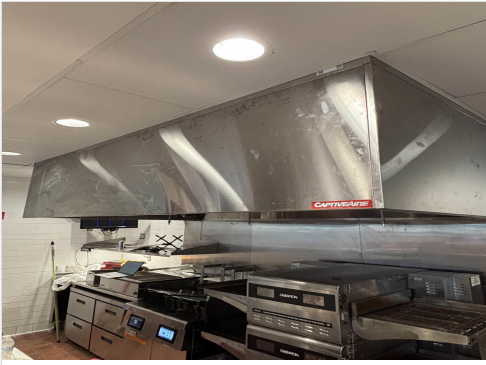
Asset: HD1

-UNABLE TO CONTROL FAN USING EMERSON. FAN SPEEDS SET THROUGH HMI IN CONTROL PANEL.
