**Report: REVIVE REPORT
Function: Test, Adjust, & Balance
Date: 01/11/2023**

**PROJECT
12-26 FREDDY'S - FAIRFAX, VA (REVIVE)**

Project: 12-26 FREDDY'S - FAIRFAX, VA (REVIVE)

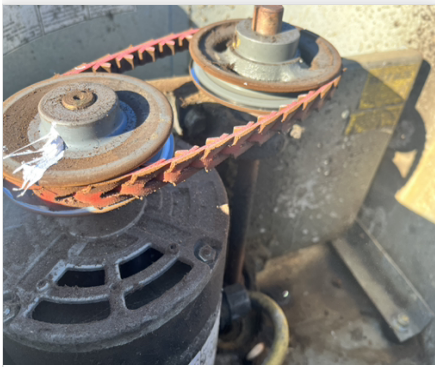
EF_adjustablebelt.jpe...

Issue Name : EF-1 and EF-2 should use proper COG belts

Description : EF-1 and EF-2 are running with adjustable belts. Recommend having belts replaced with proper COG belts.

1. KEF-1, KEF-2, and MUA belts need to be changed with permanent clogged V-belts.
2. MUA mesh intake filter is clogged. Recommend cleaning/replacement
3. RTU-1 outside air filter is not installed. Recommend installing to prevent debris and animals from entering the unit.
4. RTU-2 was found with grease inside the compartment from the smoke loss. Recommend cleaning and then monitoring to make sure it does not accumulate.
5. EF-2 disconnect is hanging from the unit and not properly secured. Recommend resolving.
6. MUA has one leg of electricity that was measured to have low voltage. This can mean that there is a loose electrical connection and can degrade the performance of the motor. The rated voltage is 208V but 184V was measured on one leg inside the MUA compartment. Recommend having an electrician inspect.
7. Men's restroom exhaust fan is not running. Recommend servicing or replacement.

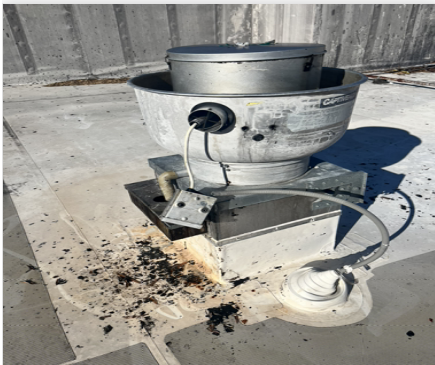
EF-2_disconnect.jpeg

Issue Name : EF-2 electrical disconnect is not properly secured to the unit

Description : EF-2 electrical disconnect was found hanging by the unit. The disconnect should be secured properly have maintenance re screw the disconnect to the unit.

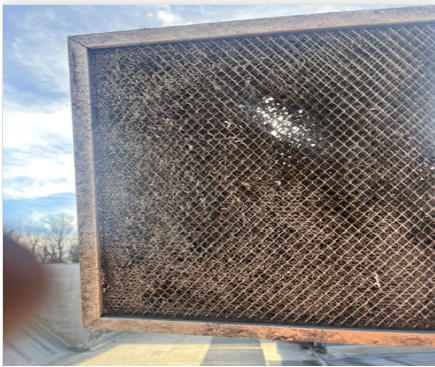
MUA_filter.jpeg

MUA airflow is low for the application. Appears to be due to clogged intake air filters. Recommend thoroughly cleaning or replacing the filters. There was also one leg of voltage and amperage that was measured to be low which could be affecting the motor speed.

Issue Name : MUA OA intake filters are dirty

Description : MUA outside wire filters are dirty. This affects airflow getting into the unit. Recommend having the filters cleaned.

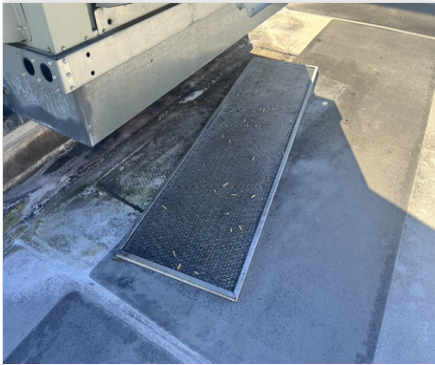
RTU-1_Filter.jpeg

Issue Name : RTU-1 OA filter is not properly secured on unit
Description : RTU-1 outside air filter was found on the ground and not properly secured to the unit.
Created By : National TAB **Assigned To :** National TAB - David Annan
Status : Open
Originated Date : 01/03/2023 - David Annan - National TAB

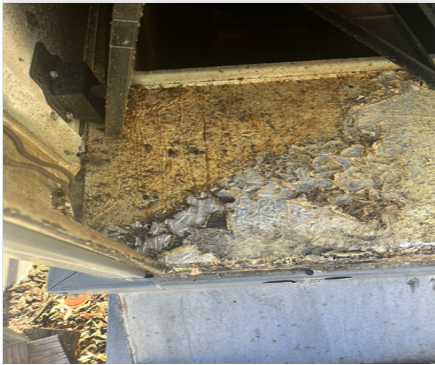
RTU-2_grease.jpeg

Issue Name : RTU-2: Grease inside filter compartment

Description : RTU-2 was found to have grease in the clean out door.
