**Report: TAB REPORT**  
**Function: Test, Adjust, & Balance**  
**Date: 6/22/2022**

## **05-02 BURLINGTON COAT FACTORY #597- PENNSDALE, PA**

Project: 05-02 BURLINGTON COAT FACTORY #597- PENNSDALE, PA

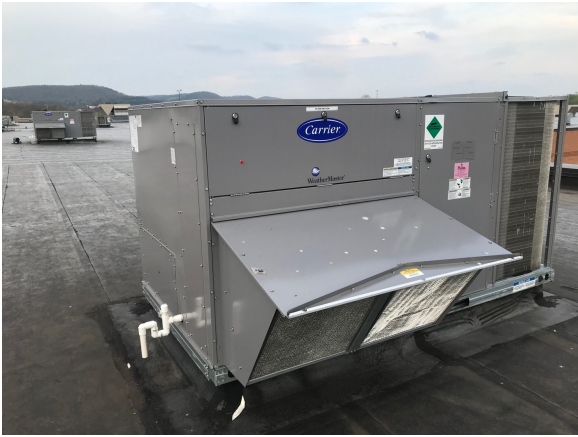
# RTU1

Test Data		
	Design	Actual
SF CFM	4000	4327
SF RPM	732	817
RA CFM	3400	3676
OA CFM	600	651
RL Voltage	-	489/489/488
RL Amperage	-	6.1 AVG.
SF Rotation	-	CCW
RA Damper Position	-	2 3/8"
Min OA Damper Position	-	4.7V / 5.2V

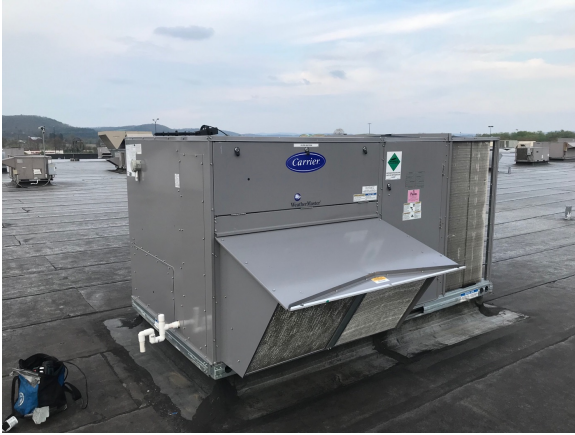
# RTU2

Test Data		
	Design	Actual
SF CFM	4000	4196
SF RPM	732	814
RA CFM	3400	3569
OA CFM	600	627
RL Voltage	-	489/488/487
RL Amperage	-	4.4/4.3/4.4
SF Rotation	-	CCW
RA Damper Position	-	2.5
Min OA Damper Position	-	4.5V / 5.3V
