Report: Test, Adjust, & Balance

Date: 5/16/2022

05-09 CULVERS - DECATUR, AL

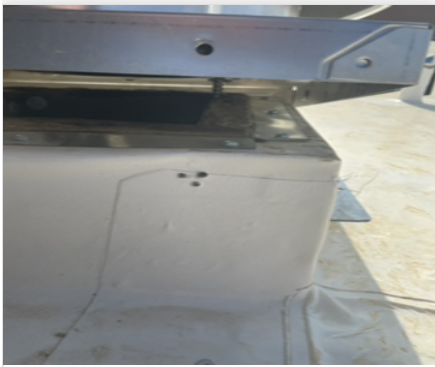
Issue Name : PRV1 conduit too short

Description : Conduit is too short to tilt fan back. Can only tilt fan an inch from curb

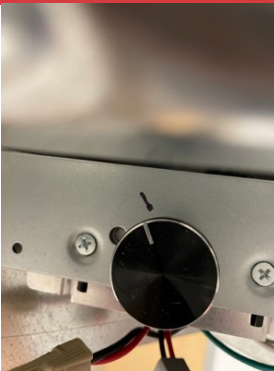
EF1A RR SETPOINT

Set point for speed controller on the exhaust fan in the employee restroom. Set to max

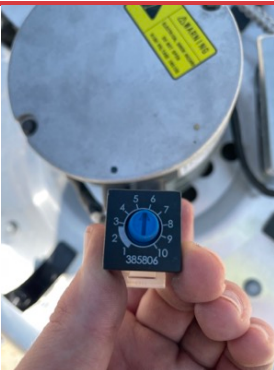
PRV1 RR SETPOINT

Speed Setpoint for restroom exhaust fan

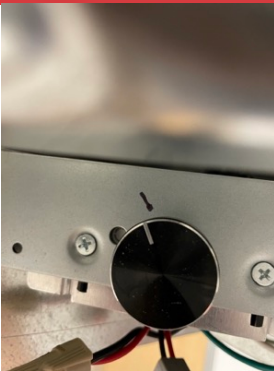
EF1A RR SETPOINT

Set point for speed controller on the exhaust fan in the employee restroom. Set to max

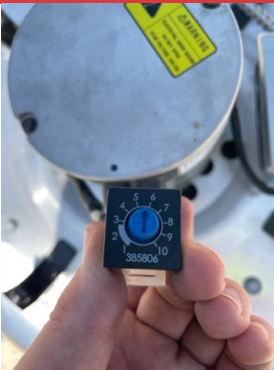
PRV1 RR SETPOINT

Speed Setpoint for restroom exhaust fan
