Report: TAB Report
Function: Test, Adjust, & Balance
Date: 01/13/2026
Completed By: National TAB

PROJECT
01-05-26 APPLEBEES GREENACRES, FL

Project: 01-05-26 APPLEBEES GREENACRES, FL

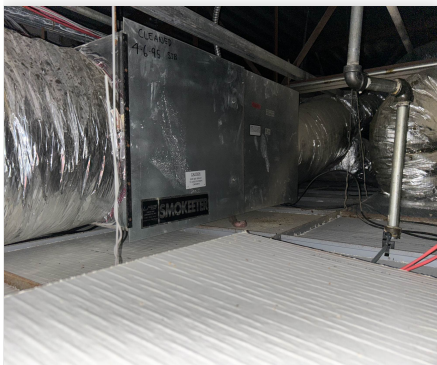
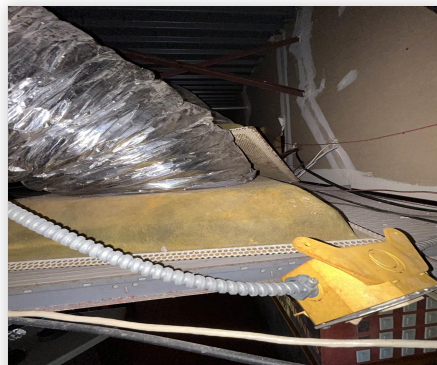
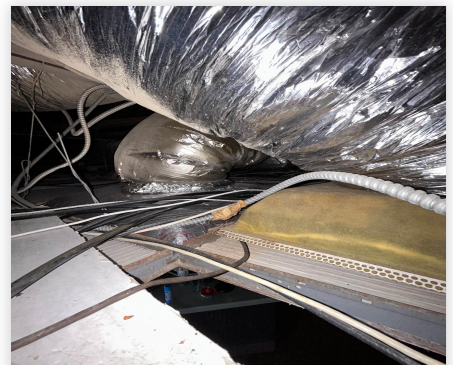
Issue Name : AHU - Extra Diffusers
Description : The air purifying unit inside the ceiling is operational. There are several diffusers hidden inside the ceiling, and not placed in the ceiling grid. Recommend mechanical inspection.
Created By : National TAB **Assigned To :** National TAB - Dan Hertenstein
Status : Open
Priority : High **Asset Tag :**
Originated Date : 01/06/2026 - Mark Johnson - National TAB

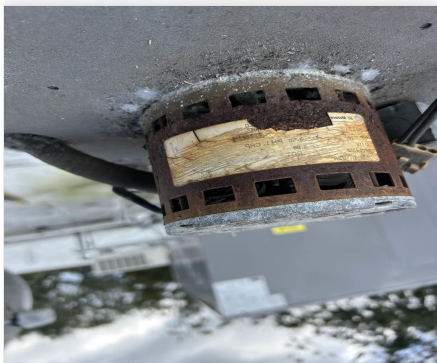
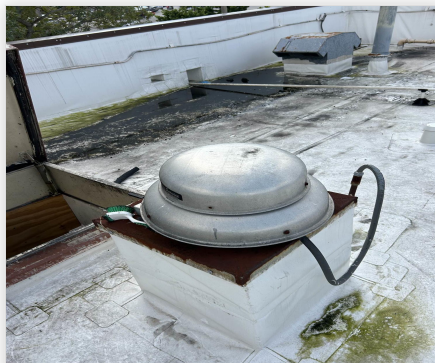
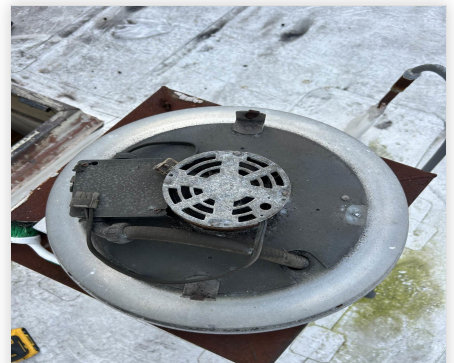
Issue Name : EF 3 Not Functional
Description : EF 3 (prep hood) is not functional. The fan is severely degraded and detached from the curb, and will likely need replaced. Steam from the prep oven spreads throughout the kitchen due to the fan not running.
Created By : National TAB **Assigned To :** National TAB - Dan Hertenstein
Status : Open
Priority : Urgent **Asset Tag :**
Originated Date : 01/06/2026 - Mark Johnson - National TAB

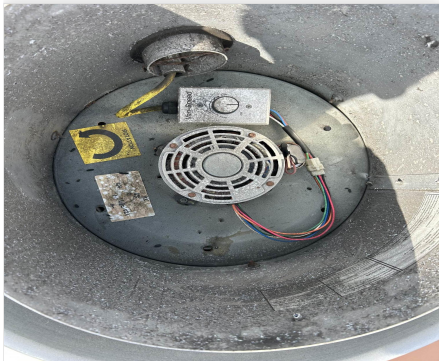
Issue Name : EF 4 Not Functional
Description : EF 4 (dishwasher) is not functional. Speed controller and roof disconnect are turned on, but the motor is not powering on. Recommend service; steam from the dishwasher spreads throughout the kitchen as a result of the fan not running.
Created By : National TAB **Assigned To :** National TAB - Dan Hertenstein
Status : Open
Priority : Urgent **Asset Tag :**
Originated Date : 01/06/2026 - Mark Johnson - National TAB

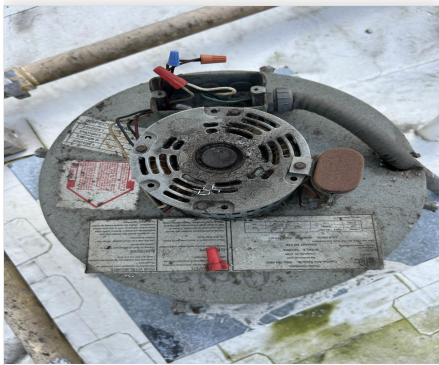
Issue Name : EF 5 Not Functional
Description : EF 5 (restrooms) is not functional. Fan is degraded and receiving no power. Recommend service/replacement.
Created By : National TAB **Assigned To :** National TAB - Dan Hertenstein
Status : Open
Priority : Urgent **Asset Tag :**
Originated Date : 01/06/2026 - Mark Johnson - National TAB

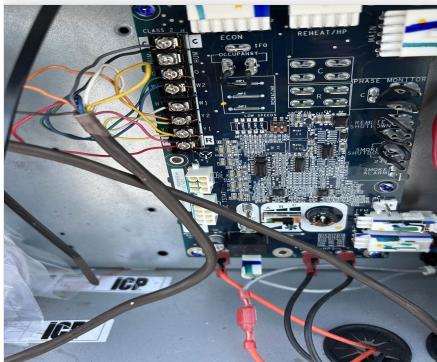
Issue Name : RTU Dehumidification
Description : RTUs do not have dehumidification options installed.
Created By : National TAB **Assigned To :** National TAB - Dan Hertenstein
Status : Open
Priority : InfoOnly **Asset Tag :**
Originated Date : 01/06/2026 - Mark Johnson - National TAB

NO DEHUMIDIFICATION OPTION

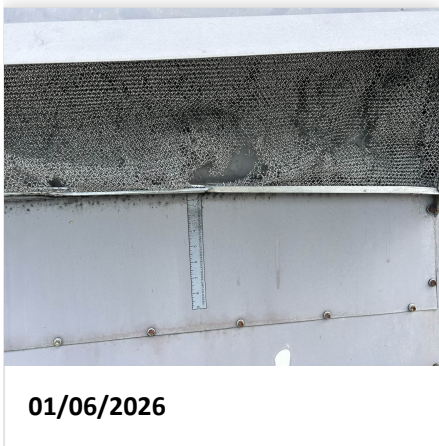
Issue Name : RTUs 1,3 - OA Filters
Description : Outside air intake filters are damaged on RTUs 1 and 3. Recommend service.
Created By : National TAB **Assigned To :** National TAB - Dan Hertenstein
Status : Open
Priority : Medium **Asset Tag :**
Originated Date : 01/06/2026 - Mark Johnson - National TAB

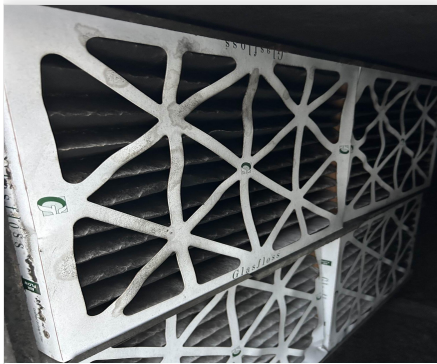
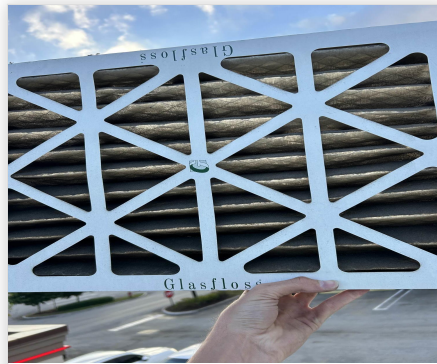
Issue Name : RTUs 1-3 - Dirty Filters
Description : Filters in RTUs 1-3 are dirty and need replaced soon.
Created By : National TAB **Assigned To :** National TAB - Dan Hertenstein
Status : Open
Priority : Medium **Asset Tag :**
Originated Date : 01/06/2026 - Mark Johnson - National TAB

RTUs 1-3 - FILTERS ARE DIRTY

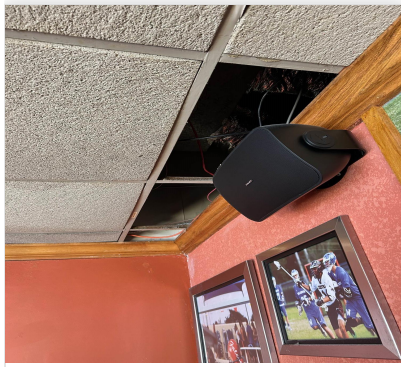
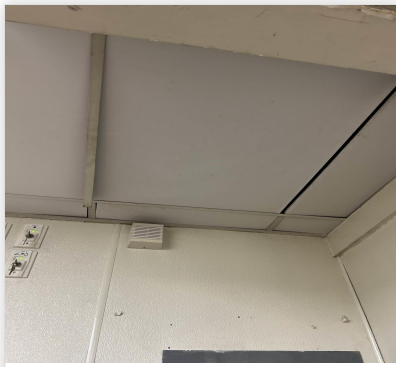
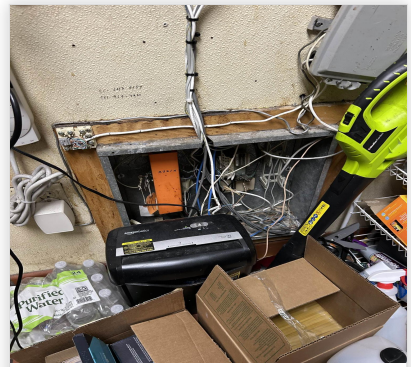
DAMAGED CEILING GRID NEAR OFFICE. OPEN PANEL WITH LIVE WIRES INSIDE OFFICE. OPEN TILES IN BACK OF DINING AREA.

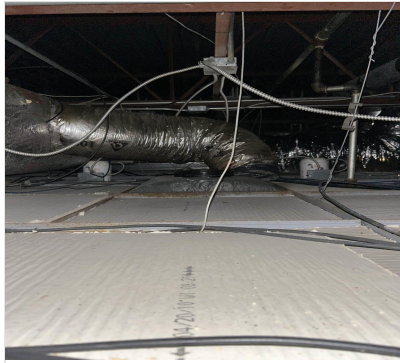
ONE DUCT RUN WAS LOOSE ABOVE CEILING, DISCONNECTED FROM BAR DIFFUSER. CORRECTED ON SITE BY TAB TECHNICIAN.

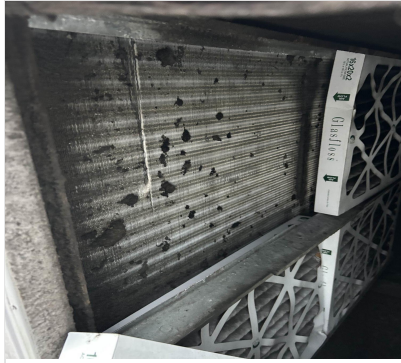
RTUs 1-3 - COILS ARE DIRTY AND IN NEED OF CLEANING

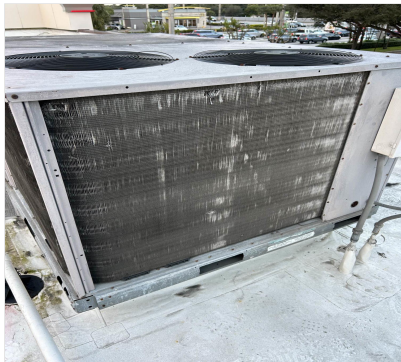
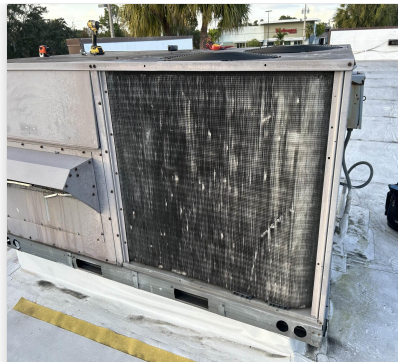
RTUs 1, 3 - SOME FIN DAMAGE

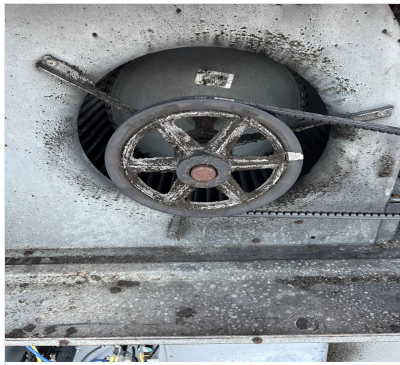
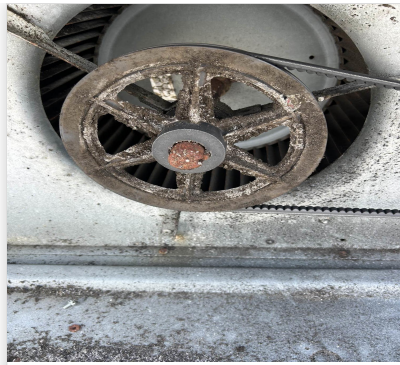
RTUs 1, 3 - BLOWER PULLEYS ARE DEGRADED

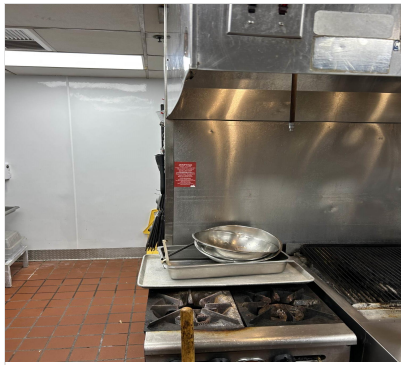
STOVE SURFACE EXTENDS BEYOND LEFT EDGE OF HOOD

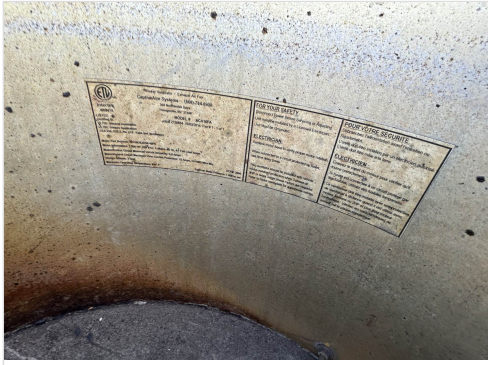
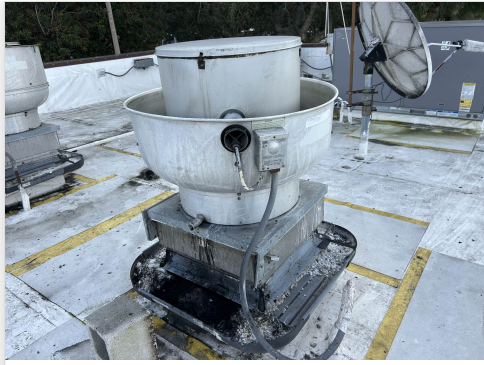
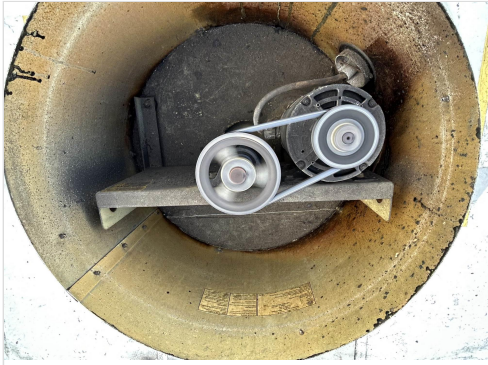
Asset: EF2

CANNOT SAFELY MEASURE AMPS ON LINES 2 AND 3 DUE TO SHORT WIRE LENGTH.

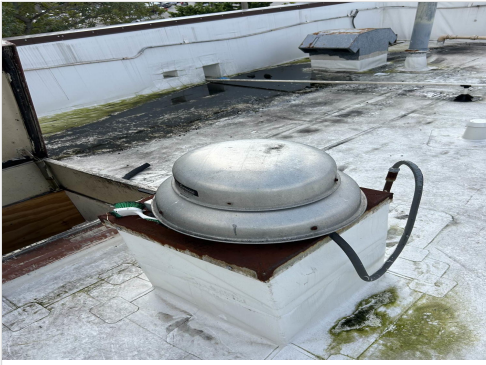
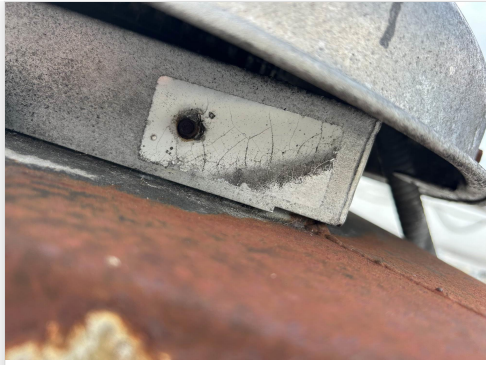
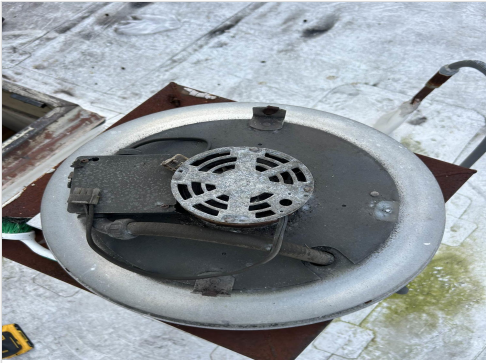
Asset: EF3

Test Data	
	Actual
CFM	0
Fan RPM	0
Motor RPM	0
System SetPt	N/A
RL Voltage	0
RL Amperage	0

Notes:
NAMEPLATE NOT LEGIBLE
