**Report: REMARKS**  
**Function: Test, Adjust, & Balance**  
**Date: 03/05/2026**  
**Completed By: National TAB**

**PROJECT**  
**03-02-26 CULVERS - MESA, AZ**

Project: 03-02-26 CULVERS - MESA, AZ

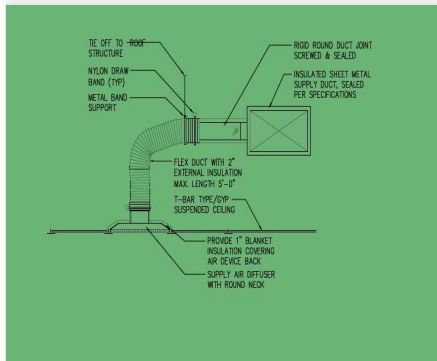
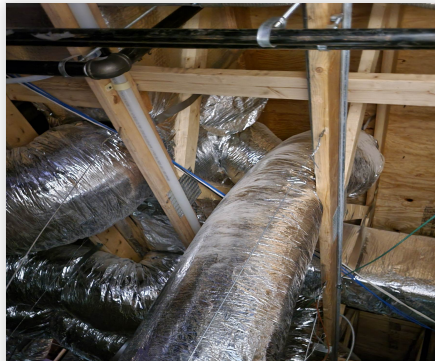
**Issue Name :** RIGID DUCT NOT INSTALLED  
**Description :** MSET details cookline duct flex to come from a rigid straight pipe. Duct is flex only on some branches and is not straight. Recommend installing straight pipe from main supply drop and duct coming down straight, not in a curve, so no smoke issues arise in kitchen and flow balances properly.
