**Report: TAB REPORT**  
**Function: Test, Adjust, & Balance**  
**Date: 04/05/2023**

**PROJECT**  
**03-27-23 FREDDY'S - JASPER, AL**

Project: 03-27-23 FREDDY'S - JASPER, AL

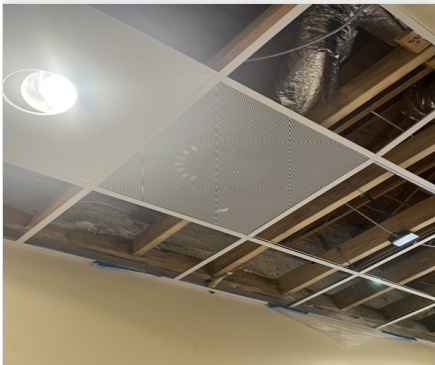
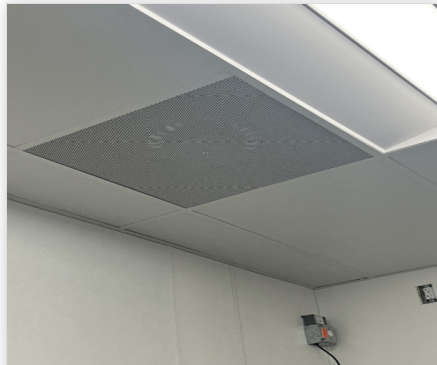
**Issue Name :** Diffuser 1-2 and 1-9 incorrect grille type.

**Description :** Both diffusers call for a type LDA diffuser. Currently PCD type diffusers are installed. Both diffusers are missing deflector plates if PCD were to remain. Diffusers have been ordered; temporary ones are in.

All diffusers and grilles are installed and match design?	NO. DIFFUSER 1-2 AND 1-9 DO NOT MATCH DESIGN. SUPER SAID THEY WILL BE INSTALLED ON A LATER DATE.
All hood filters installed and accounted for?	YES
Hoods are wired and have power?	YES
Hood is free of alarms?	YES
Thermostats have power?	YES
Have trades/general contractor been notified about any issues and are they created on FaciliBuild?	YES

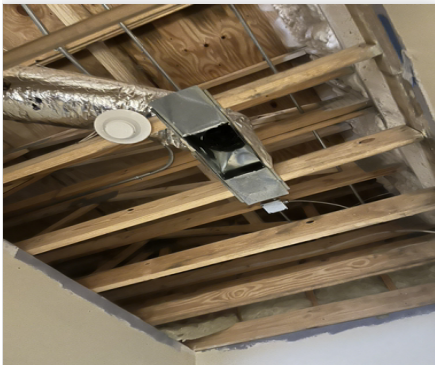
2-17.jpeg

**Issue Name :** Diffuser 2-17 incorrect placement

**Description :** Currently diffuser 2-17 is installed on ceiling when it should be on side of the wall. Diffuser face is currently not installed.

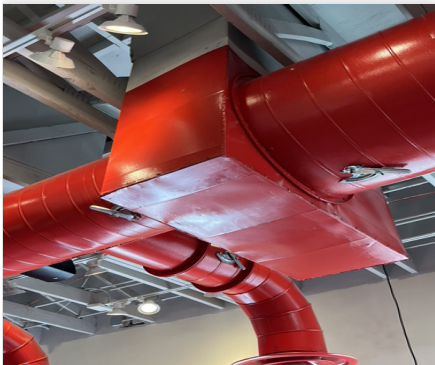
DOAS2Drop.jpeg

**Issue Name :** DOAS2 is below design CFM.

**Description :** Currently DOAS1 is at 3617 CFM when design is at 4800 CFM. Drop is not completely sealed off. Excessive leaking can be felt along edges of drops and around the collars of ductwork.

Is space free of drafting?	YES
Is space comfortable in all areas?	YES
Is the space free of ventilation noise?	NO, DOAS-2 LEAKAGE CAN BE HEARD IN THE SPACE.
If deviations from design were necessary to resolve 1-3 what were they? Otherwise put "NA".	NA

Notes: Diffuser balance incomplete due to excessive leakage in ductwork.

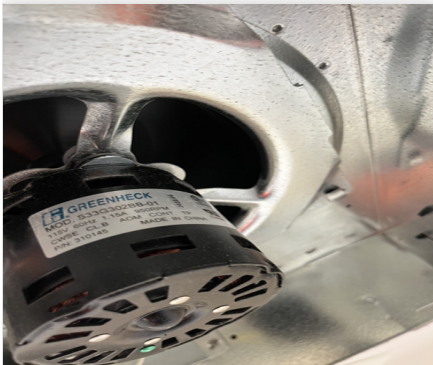
EF1.jpeg

**Issue Name :** EF1 and EF2 are above design CFM

**Description :** EF1 is currently at 174 CFM when design is at 150 CFM (116% of design). EF2 is currently at 116 CFM when design is at 90 CFM (129% of design). Fans are not adjustable and cannot be reduced to design airflow.

Notes: NO SPEED CONTROLLER

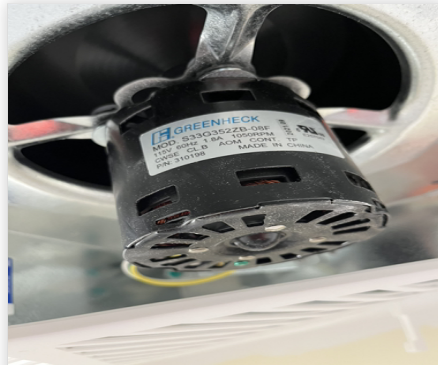
EF2.jpeg

Notes: NO SPEED CONTROLLER

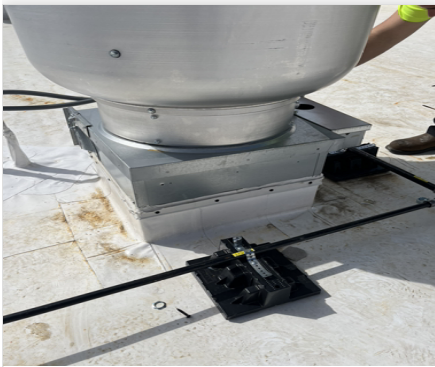
KEF2.jpeg

**Issue Name :** KEF1 & 2 is not secured to curb with screws.

**Description :** Recommended to install.

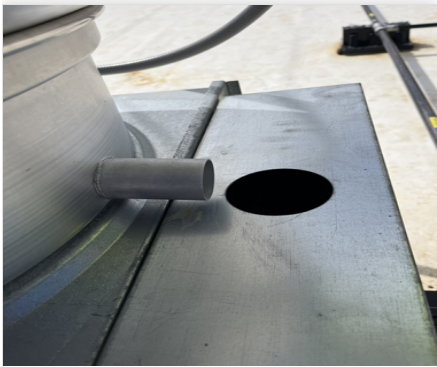
KEF2DrainPipe.jpeg

**Issue Name :** KEF2 drain pipe is not centered to drain pain.

**Description :** Recommended to complete drain pipe into center of hole.

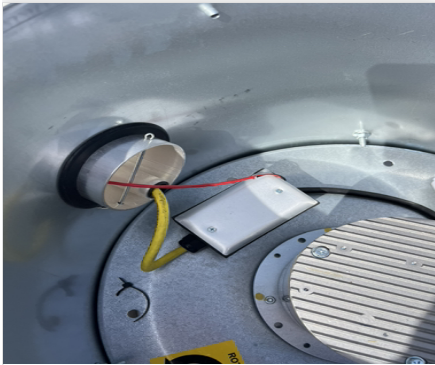
KEF2Conduit.jpeg

**Issue Name :** KEF2 wire is not ran through conduit

**Description :** Recommended to install conduit.
