**Report: TAB Survey**  
**Function: Test, Adjust, & Balance**  
**Date: 10/23/2025**  
**Completed By: National TAB**

**PROJECT**  
**10-20-25 APPLEBEES VENICE, FL TAB**  
**SURVEY**

4329 S Tamiami Trl

The scope of this project is to perform a survey of the existing RTU's, EF's, MUA, and hoods. This includes measuring as-is airflows, inspecting the equipment for maintenance issues, and providing additional insight as to the performance and condition.

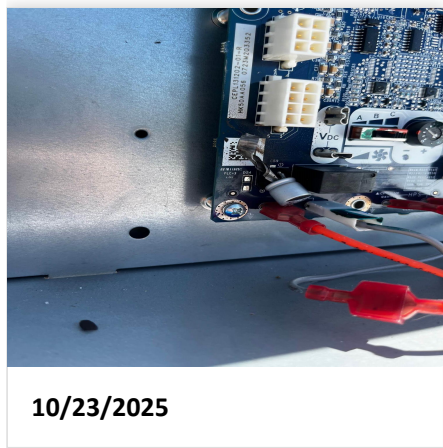
**Issue Name :** Blown capacitor RTU2 control board  
**Description :** There is a blown capacitor on RTU2 control board.  
**Created By :** National TAB                      **Assigned To :** National TAB - Dan Hertenstein  
**Status :** Open  
**Priority :** Low                                      **Asset Tag :**  
**Originated Date :** 10/22/2025 - Jackson Gunnels - National TAB

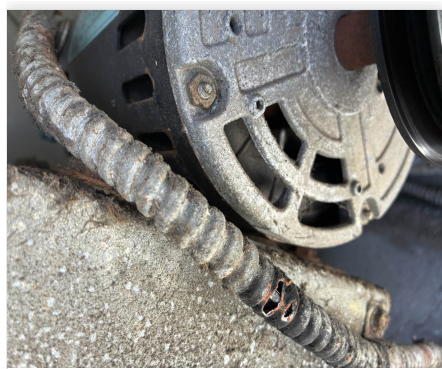
**Issue Name :** Damaged Conduit  
**Description :** Damaged conduit on the MAU from belt wear.  
**Created By :** National TAB                      **Assigned To :** National TAB - Dan Hertenstein  
**Status :** Open  
**Priority :** Urgent                                      **Asset Tag :**  
**Originated Date :** 10/23/2025 - Jackson Gunnels - National TAB

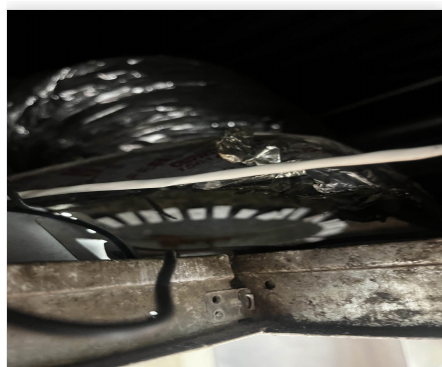
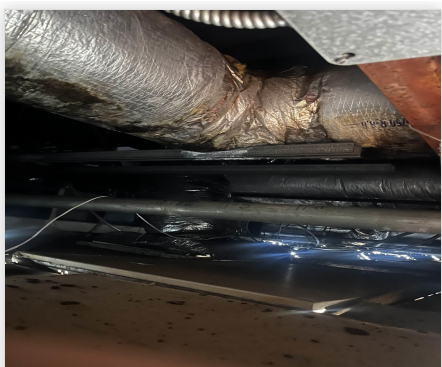
**Issue Name :** Ducts not sealed to diffusers.  
**Description :** Many ducts appear to not be fully sealed to their diffusers  
**Created By :** National TAB                      **Assigned To :** National TAB - Dan Hertenstein  
**Status :** Open  
**Priority :** Medium                      **Asset Tag :**  
**Originated Date :** 10/23/2025 - Jackson Gunnels - National TAB

Ductwork appears mostly intact. However the seal between duct and diffuser on most diffusers is not present/adequate

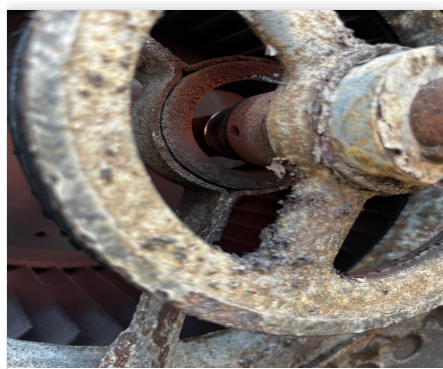
**Issue Name :** MAU missing bearing.  
**Description :** There is a bearing missing on the fan of the MAU  
**Created By :** National TAB                      **Assigned To :** National TAB - Dan Hertenstein  
**Status :** Open  
**Priority :** Urgent                                      **Asset Tag :**  
**Originated Date :** 10/23/2025 - Jackson Gunnels - National TAB

Fan side pulley rusted. Missing bearing on fan side.

Missing bearing on fan side.

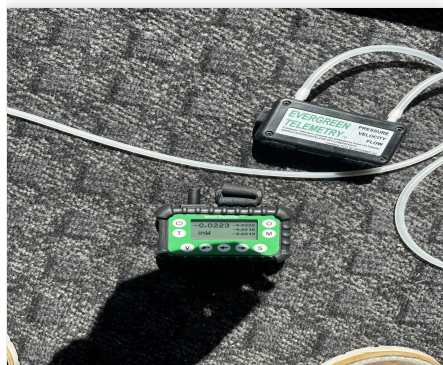
**Issue Name :** Negative building pressure  
**Description :** Building pressure is negative (-0.0223")  
**Created By :** National TAB  
**Assigned To :** National TAB - Dan Hertenstein  
**Status :** Open  
**Priority :** Medium  
**Asset Tag :**  
**Originated Date :** 10/22/2025 - Jackson Gunnels - National TAB

-0.0223", -0.0221",

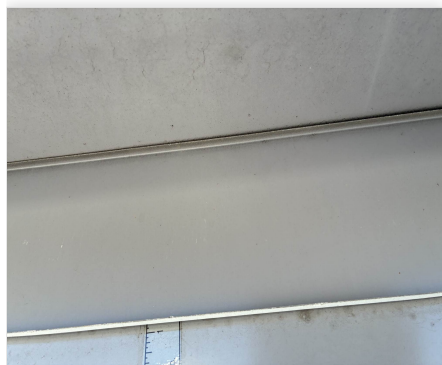
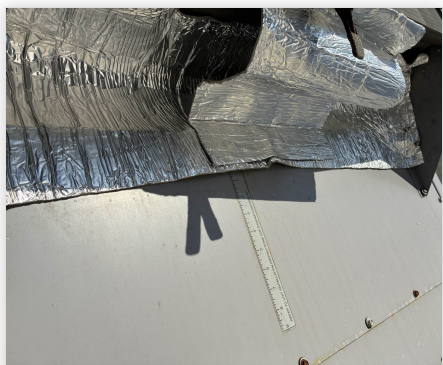
**Issue Name :** OA Filters RTUs 1 and 2  
**Description :** RTUs 1 (rooftop label 3) and 2 have no outside air filters.  
**Created By :** National TAB                      **Assigned To :** National TAB - Dan Hertenstein  
**Status :** Open  
**Priority :** Urgent                                      **Asset Tag :**  
**Originated Date :** 10/22/2025 - Jackson Gunnels - National TAB

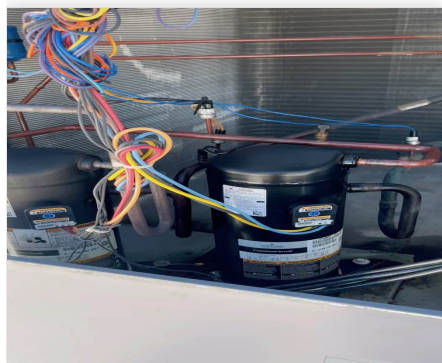
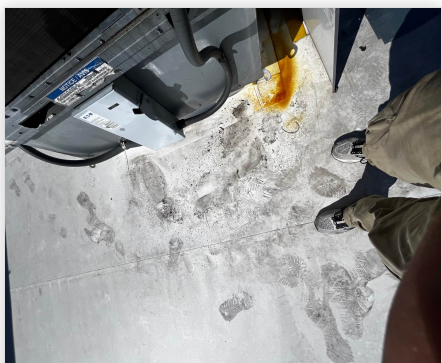
**Issue Name :** Possible compressor oil leak RTU 1  
**Description :** One of the compressors in RTU 1 (labelled as RTU3 on the roof) has a possible oil leak. There is a large amount of oil sitting around base of unit, and the compressors are short cycling.  
**Created By :** National TAB                      **Assigned To :** National TAB - Dan Hertenstein  
**Status :** Open  
**Priority :** Urgent                                      **Asset Tag :**  
**Originated Date :** 10/22/2025 - Jackson Gunnels - National TAB

RTU 1 has a short cycling compressor. There is a significant amount of oil around the unit. Unit 1 also has panel of insulation on blower door that has separated. Insulation placed in compressor compartment until repair can be made. RTU2 is not configured to run at one speed.

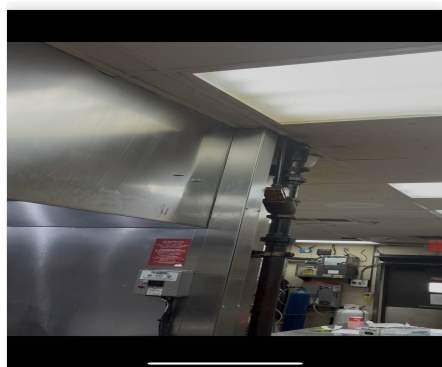
**Issue Name :** Right side hood not capturing all smoke  
**Description :** The right side hood is leaking smoke from fryers on the right side.  
**Created By :** National TAB                      **Assigned To :** National TAB - Dan Hertenstein  
**Status :** Open  
**Priority :** Urgent                                      **Asset Tag :**  
**Originated Date :** 10/23/2025 - Jackson Gunnels - National TAB

100% smoke capture on left hood. 70%-90% capture on right hood, to the right of the fryers.

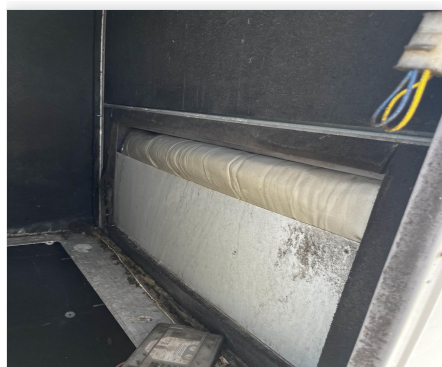
**Issue Name :** RTU 1 OA damper  
**Description :** Unit 1 (rooftop label 3) has no OA damper. Unit is sealed sealed.  
**Created By :** National TAB                      **Assigned To :** National TAB - Dan Hertenstein  
**Status :** Open  
**Priority :** Urgent                      **Asset Tag :**  
**Originated Date :** 10/22/2025 - Jackson Gunnels - National TAB

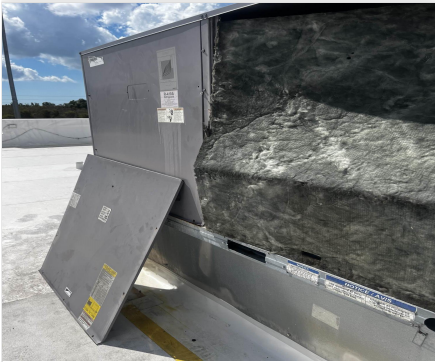
**Issue Name :** RTU1 Insulation  
**Description :** Insulation lining the blower compartment in RTU1 has separated. Insulation placed in compressor compartment until a repair can be made.  
**Created By :** National TAB **Assigned To :** National TAB - Dan Hertenstein  
**Status :** Open  
**Priority :** Medium **Asset Tag :**  
**Originated Date :** 10/23/2025 - Jackson Gunnels - National TAB

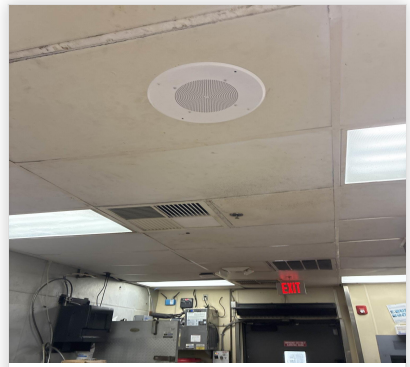
Most tiles on kitchen are dirty.

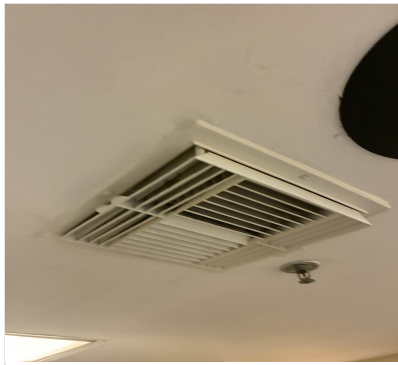
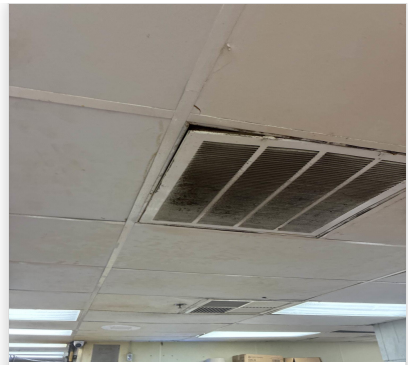
2 damaged returns in dining area. Damaged supply in women's RR. 1 damaged return in back of house.

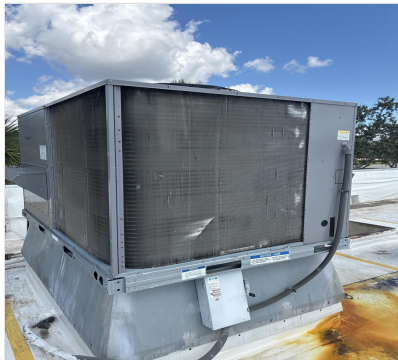
RTU4: Dirty Needs cleaning, some damage

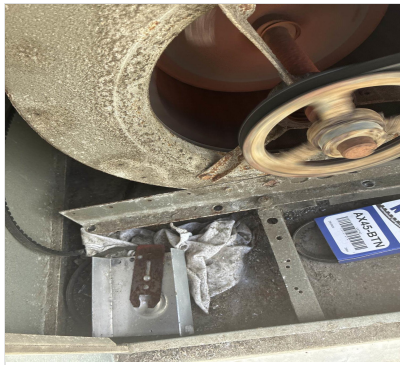
Internal compartments are not clean.

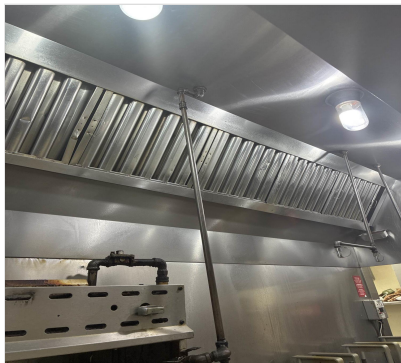
Hood filters are installed. Most are missing at least one handle, large gap in filters. One dented filter

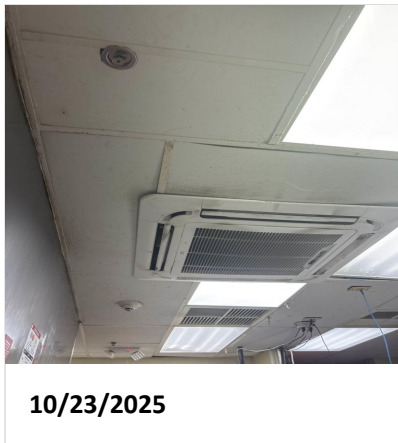
Are any of the ceiling tiles stained around the hood?
