**Report: TAB Survey**  
**Function: Test, Adjust, & Balance**  
**Date: 10/23/2025**  
**Completed By: National TAB**

**PROJECT**  
**10-20-25 APPLEBEES VENICE, FL TAB**  
**SURVEY**

The scope of this project is to perform a survey of the existing RTU's, EF's, MUA, and hoods. This includes measuring as-is airflows, inspecting the equipment for maintenance issues, and providing additional insight as to the performance and condition.

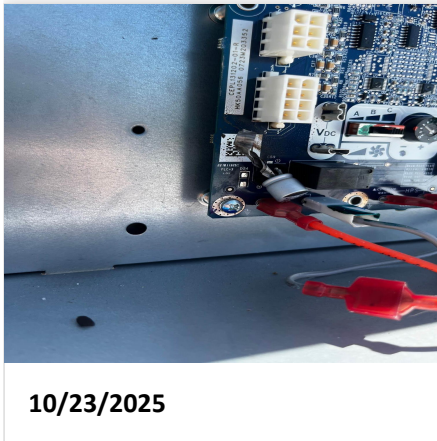
**Issue Name :** Blown capacitor RTU2 control board  
**Description :** There is a blown capacitor on RTU2 control board.  
**Created By :** National TAB                      **Assigned To :** National TAB - Dan Hertenstein  
**Status :** Open  
**Priority :** Low                                      **Asset Tag :**  
**Originated Date :** 10/22/2025 - Jackson Gunnels - National TAB

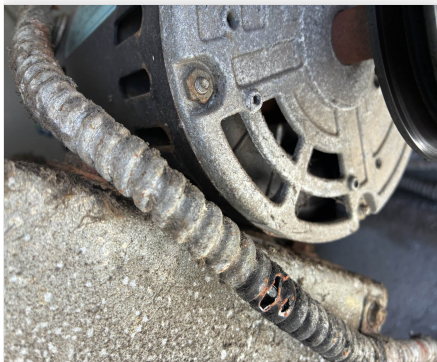
**Issue Name :** Damaged Conduit  
**Description :** Damaged conduit on the MAU from belt wear.  
**Created By :** National TAB                      **Assigned To :** National TAB - Dan Hertenstein  
**Status :** Open  
**Priority :** Urgent                                      **Asset Tag :**  
**Originated Date :** 10/23/2025 - Jackson Gunnels - National TAB

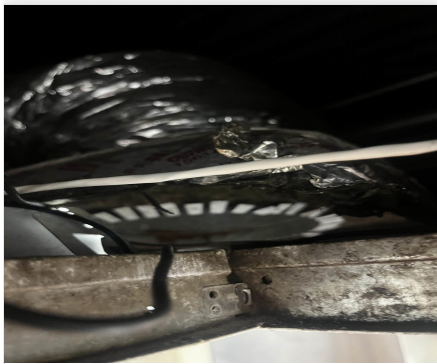
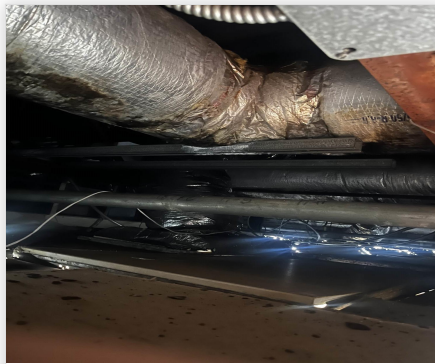
**Issue Name :** Ducts not sealed to diffusers.  
**Description :** Many ducts appear to not be fully sealed to their diffusers  
**Created By :** National TAB                      **Assigned To :** National TAB - Dan Hertenstein  
**Status :** Open  
**Priority :** Medium                                      **Asset Tag :**  
**Originated Date :** 10/23/2025 - Jackson Gunnels - National TAB

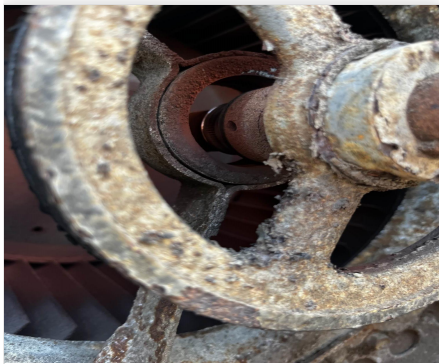
**Issue Name :** MAU missing bearing.  
**Description :** There is a bearing missing on the fan of the MAU  
**Created By :** National TAB                      **Assigned To :** National TAB - Dan Hertenstein  
**Status :** Open  
**Priority :** Urgent                                      **Asset Tag :**  
**Originated Date :** 10/23/2025 - Jackson Gunnels - National TAB

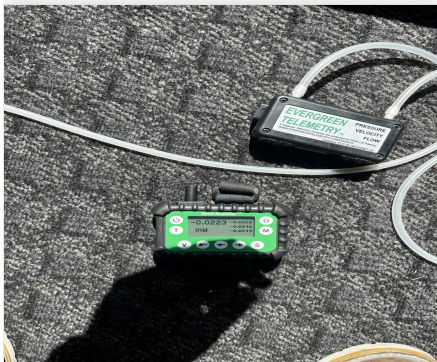
**Issue Name :** Negative building pressure  
**Description :** Building pressure is negative (-0.0223")  
**Created By :** National TAB                      **Assigned To :** National TAB - Dan Hertenstein  
**Status :** Open  
**Priority :** Medium                                      **Asset Tag :**  
**Originated Date :** 10/22/2025 - Jackson Gunnels - National TAB

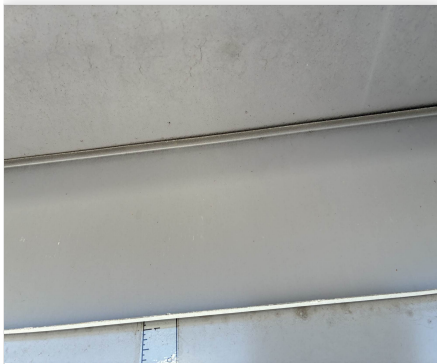
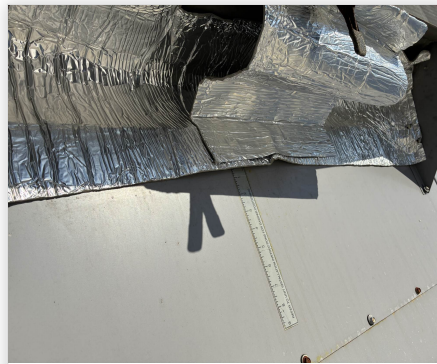
**Issue Name :** OA Filters RTUs 1 and 2  
**Description :** RTUs 1 (rooftop label 3) and 2 have no outside air filters.  
**Created By :** National TAB                      **Assigned To :** National TAB - Dan Hertenstein  
**Status :** Open  
**Priority :** Urgent                                      **Asset Tag :**  
**Originated Date :** 10/22/2025 - Jackson Gunnels - National TAB

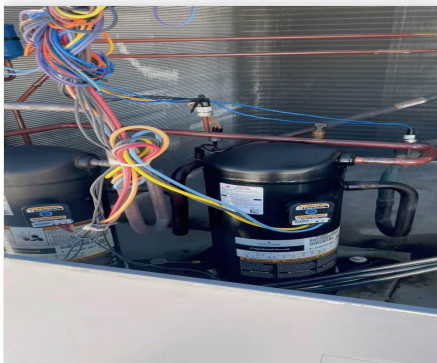
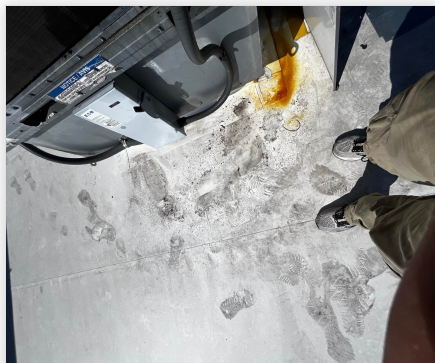
**Issue Name :** Possible compressor oil leak RTU 1  
**Description :** One of the compressors in RTU 1 (labelled as RTU3 on the roof) has a possible oil leak. There is a large amount of oil sitting around base of unit, and the compressors are short cycling.  
**Created By :** National TAB                      **Assigned To :** National TAB - Dan Hertenstein  
**Status :** Open  
**Priority :** Urgent                                      **Asset Tag :**  
**Originated Date :** 10/22/2025 - Jackson Gunnels - National TAB

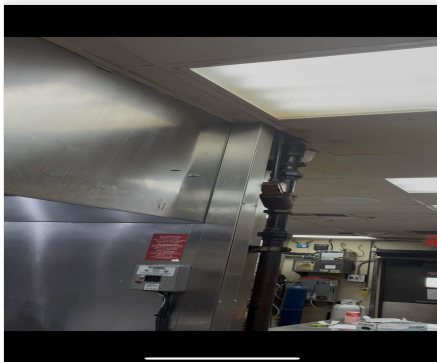
**Issue Name :** Right side hood not capturing all smoke  
**Description :** The right side hood is leaking smoke from fryers on the right side.  
**Created By :** National TAB                      **Assigned To :** National TAB - Dan Hertenstein  
**Status :** Open  
**Priority :** Urgent                                      **Asset Tag :**  
**Originated Date :** 10/23/2025 - Jackson Gunnels - National TAB

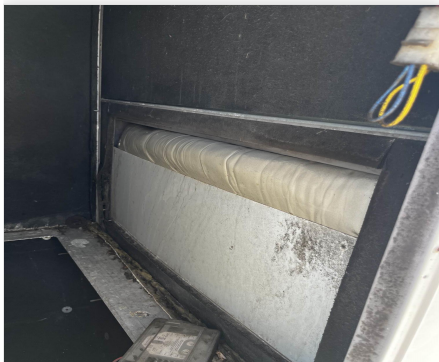
**Issue Name :** RTU 1 OA damper  
**Description :** Unit 1 (rooftop label 3) has no OA damper. Unit is sealed sealed.  
**Created By :** National TAB                      **Assigned To :** National TAB - Dan Hertenstein  
**Status :** Open  
**Priority :** Urgent                                      **Asset Tag :**  
**Originated Date :** 10/22/2025 - Jackson Gunnels - National TAB

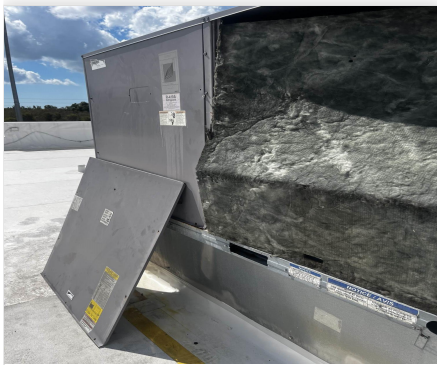
**Issue Name :** RTU1 Insulation  
**Description :** Insulation lining the blower compartment in RTU1 has separated. Insulation placed in compressor compartment until a repair can be made.  
**Created By :** National TAB                      **Assigned To :** National TAB - Dan Hertenstein  
**Status :** Open  
**Priority :** Medium                                      **Asset Tag :**  
**Originated Date :** 10/23/2025 - Jackson Gunnels - National TAB

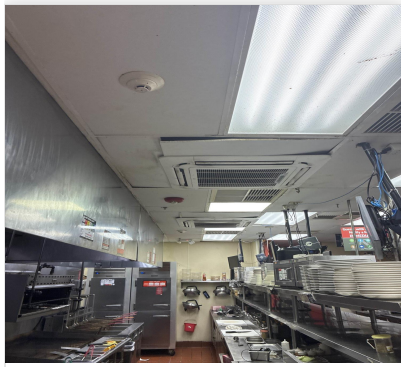
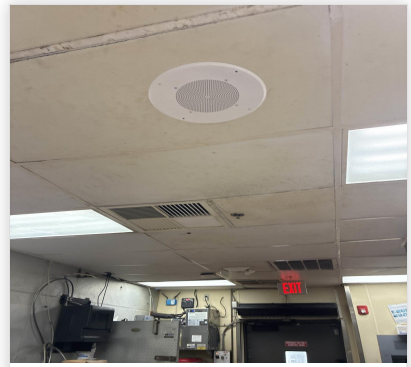
**Any additional areas of concern (stained tiles, rusted diffusers, etc)**

Most tiles on kitchen are dirty.

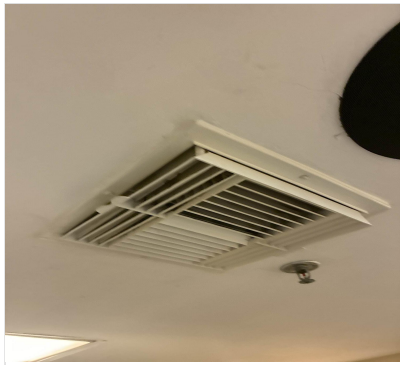
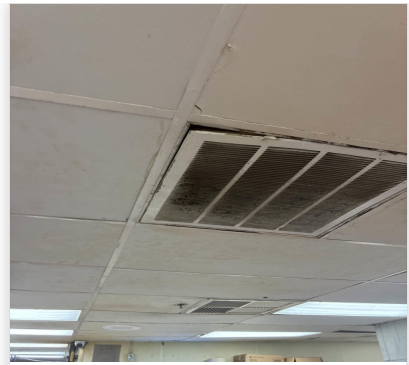
**Are all diffusers free of damage and rust?** Fail

2 damaged returns in dining area. Damaged supply in women's RR. 1 damaged return in back of house.

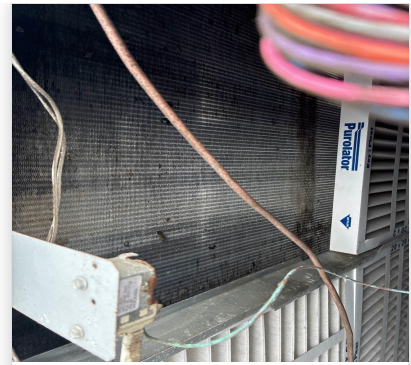
#### Evaporator coil is clean and in good condition

RTU1: Dirty RTU2: Dirty RTU3: Dirty RTU4: Dirty

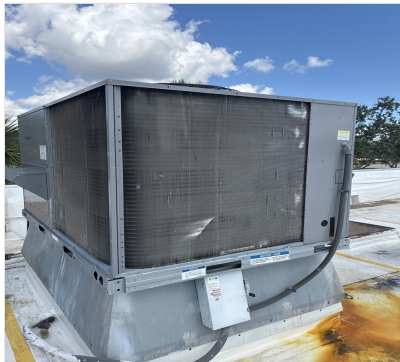
**Condenser coil is clean and in good condition**

RTU4: Dirty Needs cleaning, some damage

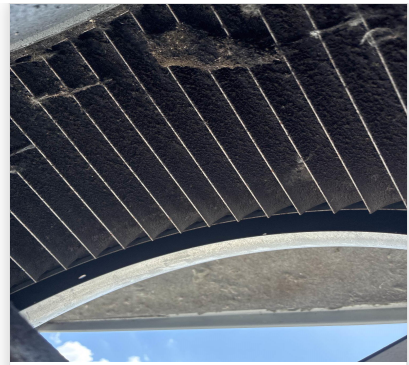
**Blower wheel is clean and in good condition**

RTU1: Wheel is dirty. RTU2: Wheel is dirty. RTU3: Wheel is dirty.

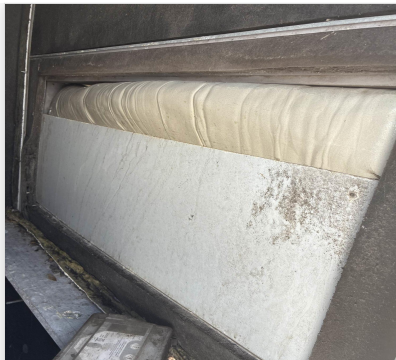
**Is an economizer installed and does it respond to adjustment?**

RTU1: No economizer, OA damper is sealed shut RTU2: No economizer, no OA filter, no outside air. RTU3: OA damper only, motor is decoupled from damper. RTU4: Manual OA only

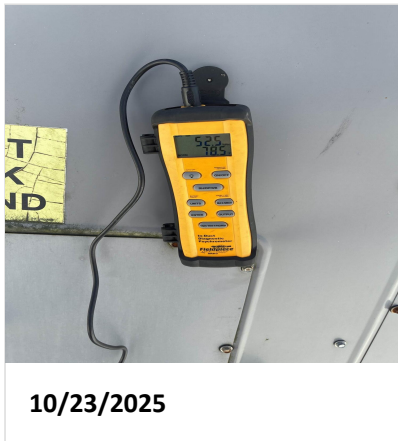
Cooling is functional

RTU1: 59.4F RTU2: 50.8F RTU3: 78.5F FAIL compressor is short cycling RTU4:58.4F

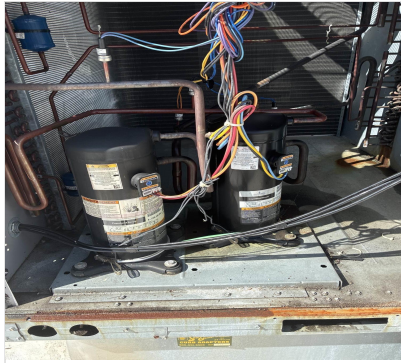
RTU 1 has a short cycling compressor. There is a significant amount of oil around the unit. Unit 1 also has panel of insulation on blower door that has separated. Insulation placed in compressor compartment until repair can be made. RTU2 is not configured to run at one speed.

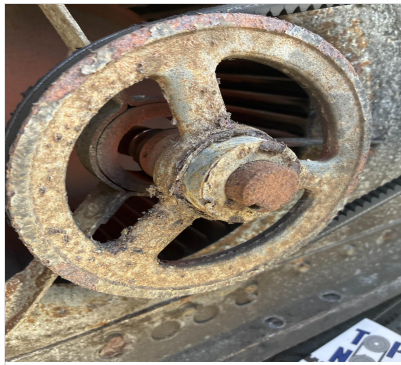
**If belt driven are the pulleys in good condition and not rusted?** Fail

Fan side pulley rusted. Missing bearing on fan side.

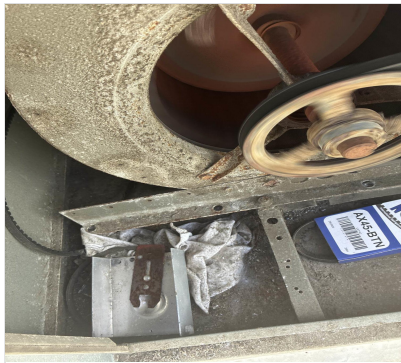
**Is the blower wheel clean and are internal compartments clean?**

Internal compartments are not clean.

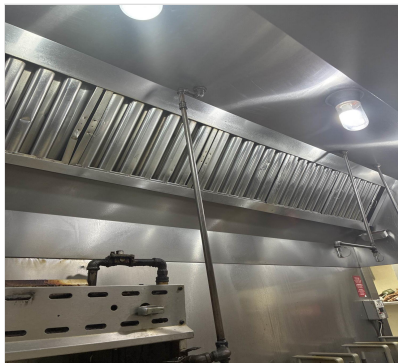
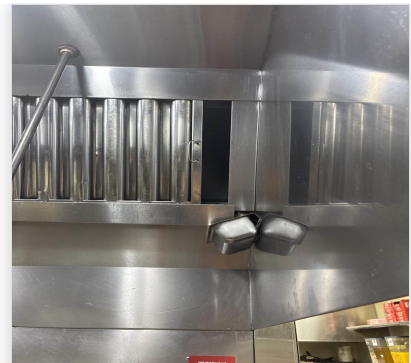
**Are all hood filters installed and free of damage?** Fail

Hood filters are installed. Most are missing at least one handle, large gap in filters. One dented filter

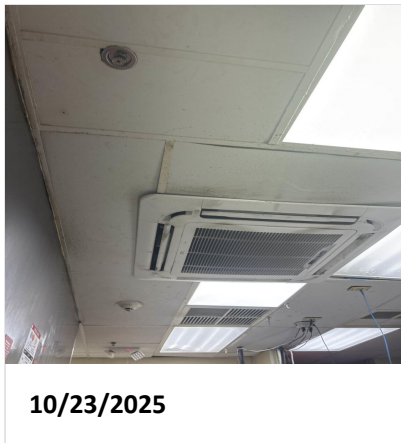
Are any of the ceiling tiles stained around the hood?
