Report: TAB Survey
Function: Test, Adjust, & Balance
Date: 10/23/2025
Completed By: National TAB

PROJECT
10-20-25 APPLEBEES VENICE, FL TAB
SURVEY

The scope of this project is to perform a survey of the existing RTU's, EF's, MUA, and hoods. This includes measuring as-is airflows, inspecting the equipment for maintenance issues, and providing additional insight as to the performance and condition.

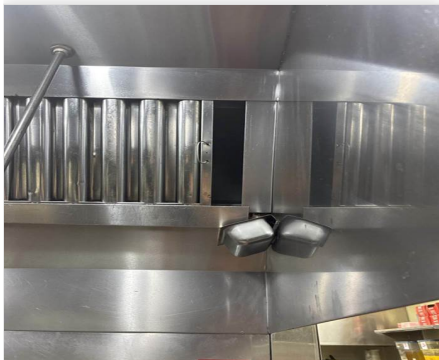
Issue Name : Hood filter sizing
Description : Replace hood filters so that hoods do not have any gaps in the filter bank.
Created By : National TAB **Assigned To :** National TAB - Dan Hertenstein
Status : Open
Priority : High **Asset Tag :**
Originated Date : 10/28/2025 - Will Turnbough - National TAB

Hood filters are installed. Most are missing at least one handle, large gap in filters. One dented filter

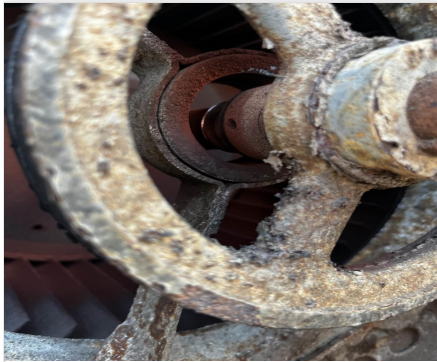
Issue Name : MAU missing bearing.
Description : There is a bearing missing on the fan of the MAU
Created By : National TAB **Assigned To :** National TAB - Dan Hertenstein
Status : Open
Priority : Urgent **Asset Tag :**
Originated Date : 10/23/2025 - Jackson Gunnels - National TAB

Fan side pulley rusted. Missing bearing on fan side.

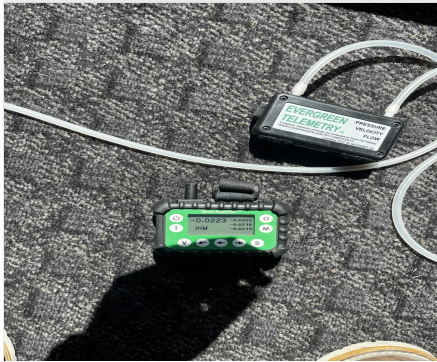
Issue Name : Negative building pressure
Description : Building pressure is negative (-0.0223")
Created By : National TAB **Assigned To :** National TAB - Dan Hertenstein
Status : Open
Priority : Medium **Asset Tag :**
Originated Date : 10/22/2025 - Jackson Gunnels - National TAB

DOOR TESTED	BUILDING PRESSURE MEASUREMENTS (IN. H ₂ O)
FRONT	-0.0221
SIDE	-0.0223
REAR	
AVERAGE	-0.0222

- ACTUAL NET AIRFLOW COINCIDES WITH DESIGN: ✘
- MEASURED PRESSURES COINCIDES WITH ACTUAL NET AIRFLOW: ✔
- PRESSURE FALLS WITHIN IMC TOLERANCE OF +/-0.02" W.C. ✘

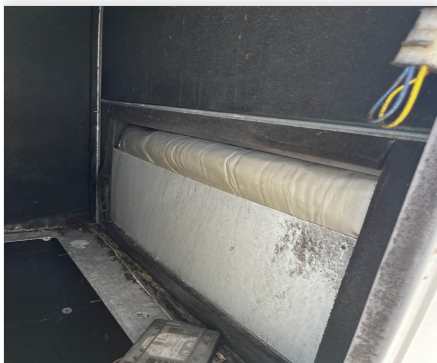
Issue Name : RTU 1 OA damper
Description : Unit 1 (rooftop label 3) has no OA damper. OA intake is sealed off. A proper OA intake needs to be installed to help relieve the negative building pressure.
Created By : National TAB **Assigned To :** National TAB - Dan Hertenstein
Status : Open
Priority : Urgent **Asset Tag :**
Originated Date : 10/22/2025 - Jackson Gunnels - National TAB

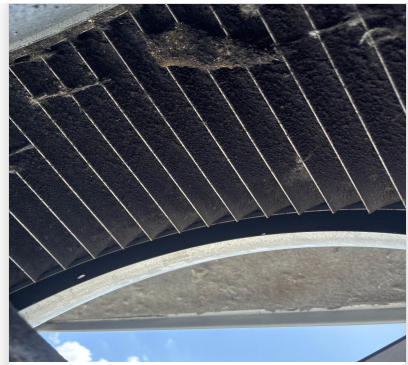
RTU1: Wheel is dirty. RTU2: Wheel is dirty. RTU3: Wheel is dirty.

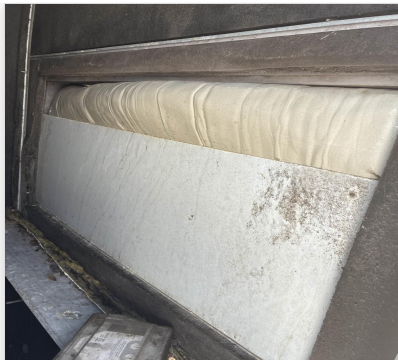
RTU1: No economizer, OA damper is sealed shut RTU2: No economizer, no OA filter, no outside air. RTU3: OA damper only, motor is decoupled from damper. RTU4: Manual OA only
