Issue List

04-14-25 ULTA 1697 SELMA, NC

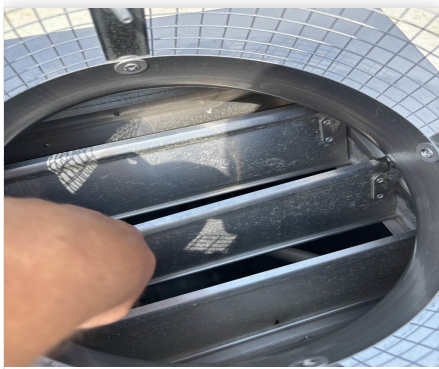
Issue Name : EF-1 damper constricted
Description : The backdraft damper on EF-1 on the roof is constricted by its placement. The damper can only open roughly 45%
Created By : National TAB **Assigned To :** National TAB - Dan Hertenstein
Status : Open
Priority : Urgent **Asset Tag :**
Originated Date : 07/08/2025 - Chistian Moller - National TAB
