**Report: TAB Report**  
**Function: Test, Adjust, & Balance**  
**Date: 07/18/2025**  
**Completed By: National TAB**

**PROJECT**  
**04-14-25 ULTA 1967 SELMA, NC**

640 SAINT MARK AVE

SELMA, NC 27576

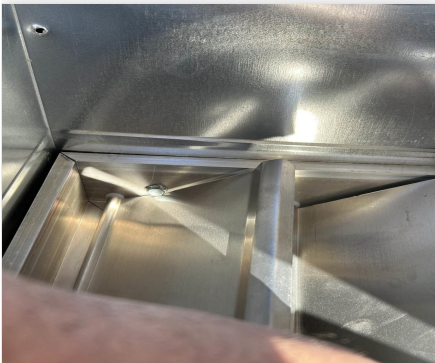
**Issue Name :** EF-1 backdraft damper  
**Description :** Screw, preventing backdraft damper to open fully.  
**Created By :** National TAB                      **Assigned To :** National TAB - Dan Hertenstein  
**Status :** Open  
**Priority :** Urgent                                      **Asset Tag :** EF1  
**Originated Date :** 01/08/2025 - Jearod Ferrette - National TAB

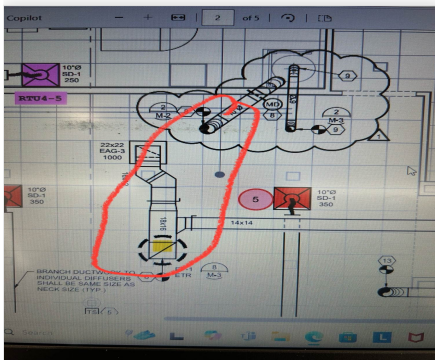
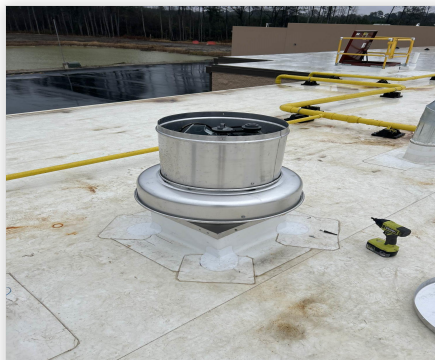
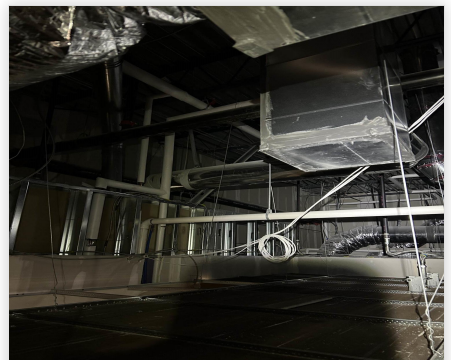
**Issue Name :** EF-1 curbed wrong  
**Description :** EF-1 fan curbed to the wrong ductwork. The fan is installed to the water heater exhaust. Also, the motor is at max amps, going to a 10" round duct. Currently getting 522 cfm. EF-1 is design for 1750 cfm. The Greenheck GB-130 website states that max flow is 1249 cfm.  
**Created By :** National TAB                      **Assigned To :** National TAB - Dan Hertenstein  
**Status :** Open  
**Priority :** Urgent                                      **Asset Tag :** EF1  
**Originated Date :** 01/08/2025 - Jearod Ferrette - National TAB

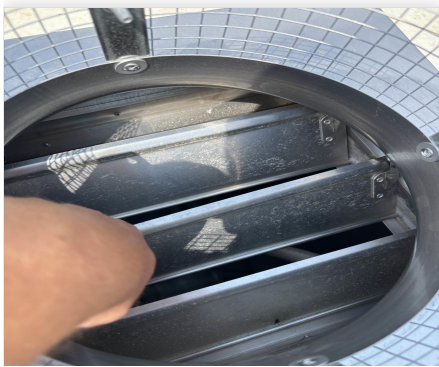
**Issue Name :** EF-1 damper constricted  
**Description :** The backdraft damper on EF-1 on the roof is constricted by its placement. The damper can only open roughly 45%  
**Created By :** National TAB                      **Assigned To :** National TAB - Dan Hertenstein  
**Status :** Open  
**Priority :** Urgent                                      **Asset Tag :**  
**Originated Date :** 07/08/2025 - Chistian Moller - National TAB

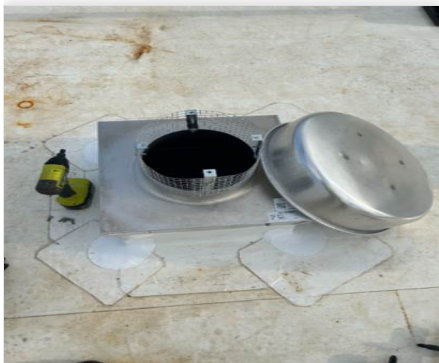
**Issue Name :** EF-1 not installed  
**Description :** EF-1 is not installed. Unable to balance the fan. It should be installed on 10/18.  
**Created By :** National TAB                      **Assigned To :** National TAB - Dan Hertenstein  
**Status :** Open  
**Priority :** Urgent                                      **Asset Tag :** EF1  
**Originated Date :** 10/14/2024 - Jearod Ferrette - National TAB

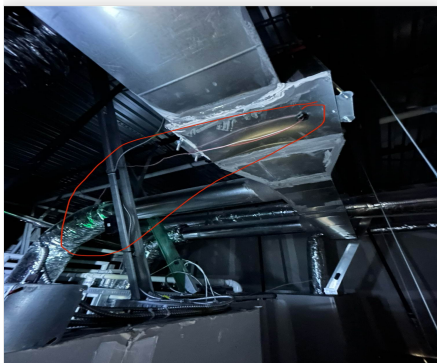
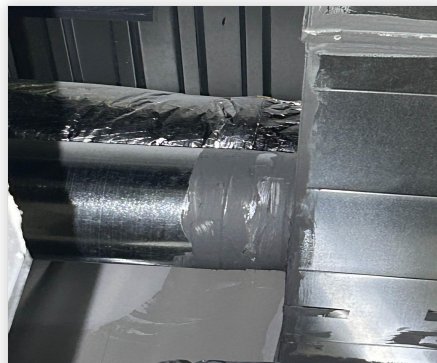
**Issue Name :** EF-2 Restroom fan unable to access  
**Description :** EF-2 speed controller is located above hard ceiling and is inaccessible. Unable to reach from other side with ladder due to piping obstructing access. The unit is running at 117% of design.  
**Created By :** National TAB                      **Assigned To :** National TAB - Dan Hertenstein  
**Status :** Open  
**Priority :** High                                      **Asset Tag :**  
**Originated Date :** 10/14/2024 - Jearod Ferrette - National TAB

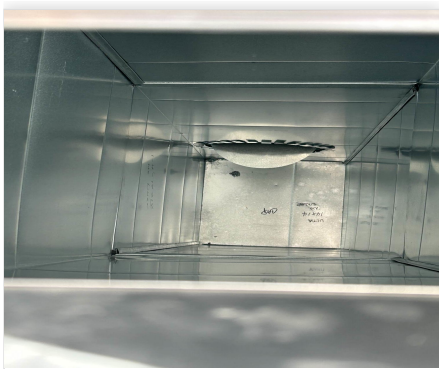
**Issue Name :** Missing Turning vane elbow  
**Description :** EF-1 doesn't has the provided turning elbow installed.  
**Created By :** National TAB                      **Assigned To :** National TAB - Dan Hertenstein  
**Status :** Open  
**Priority :** Urgent                                      **Asset Tag :** EF1  
**Originated Date :** 01/08/2025 - Jearod Ferrette - National TAB

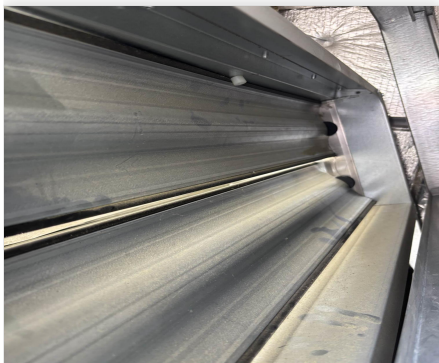
**Issue Name :** OA damper cannot fully open  
**Description :** There is a plastic piece hanging down above the damper that will not allow the damper to fully open. OA cannot be set while the piece is there.  
**Created By :** National TAB                      **Assigned To :** National TAB - Dan Hertenstein  
**Status :** Open  
**Priority :** Urgent                                      **Asset Tag :**  
**Originated Date :** 07/08/2025 - Chistian Moller - National TAB

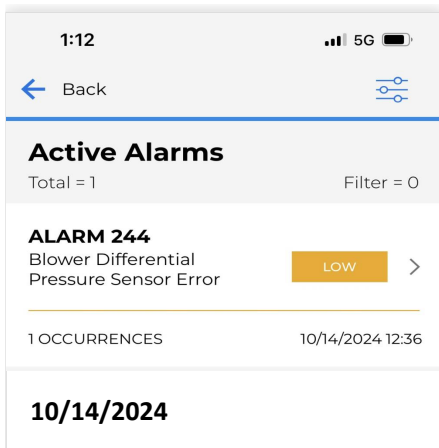
**Issue Name :** RTU -4 airflow is 149% of design  
**Description :** RTU-4 airflow is 149% of design. Unable to slow unit down with the CORE controller. There is an alarm code 244 (Blower differential pressure sensor error) that appears to be preventing speed adjustment.  
**Created By :** National TAB                      **Assigned To :** National TAB - Dan Hertenstein  
**Status :** Open  
**Priority :** High                                      **Asset Tag :** RTU4  
**Originated Date :** 10/14/2024 - Jearod Ferrette - National TAB

Notes:  
RTU-4 IN ALARM CODE 244 (BLOWER DIFFERENTIAL PRESURE SENSOR ERROR) UNABLE TO SLOW UNIT DOWN. ECONOMIZER BLOCKED, UNABLE TO SET OA.

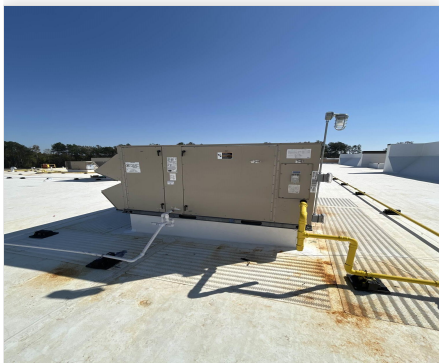
**Issue Name :** RTU-1 airflow is 84% of design  
**Description :** RTU-1 airflow is 84% of design. The pulley cannot be increased further without the belt sitting too high up on the pulley. A pulley change is recommended.  
**Created By :** National TAB                      **Assigned To :** National TAB - Dan Hertenstein  
**Status :** Open  
**Priority :** High                                      **Asset Tag :** RTU1  
**Originated Date :** 10/15/2024 - Jearod Ferrette - National TAB

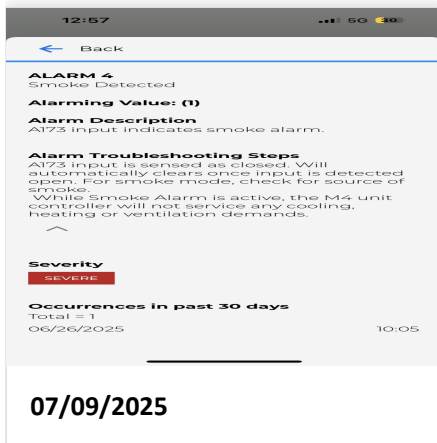
**Issue Name :** RTU-1 fire alarm  
**Description :** The RTU is giving a fire alarm that is keeping it from running. There is no smoke in the space, disconnected to balance the RTU. Possible the alarm needs to be physically reset, or wiring is wrong. NEEDS IMMEDIATE FIX.  
**Created By :** National TAB                      **Assigned To :** National TAB - Dan Hertenstein  
**Status :** Open  
**Priority :** Urgent                                      **Asset Tag :** RTU1  
**Originated Date :** 07/09/2025 - Chistian Moller - National TAB

Notes:  
THE UNIT IS NOT RUNNING DUE TO THE FIRE ALARM (SEE ISSUES)

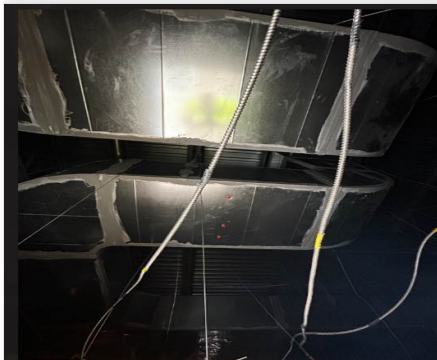
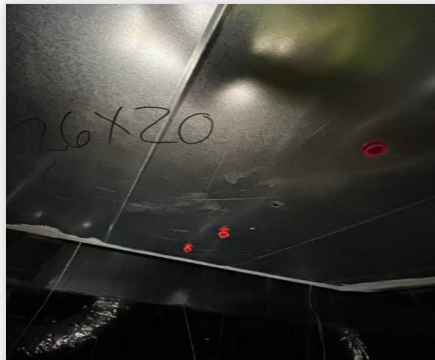
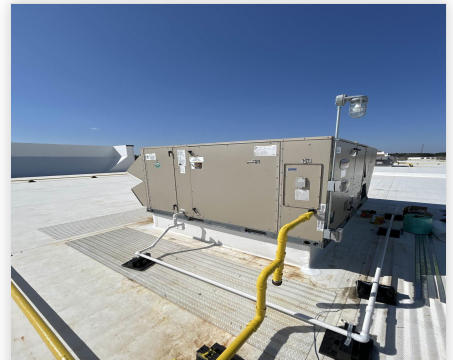
**Issue Name :** RTU-2 airflow is 72% of design  
**Description :** RTU-2 airflow is 72% of design (3435 CFM at diffusers) with motor at FLA. The duct is installed as 24"x18" inner dimensions but plans show 30"x20". Duct traversed as 3819 CFM. Velocity is 1273 FPM which is high. There is also an additional 90 degree transition installed. A larger motor would be required to achieve design.  
**Created By :** National TAB                      **Assigned To :** National TAB - Dan Hertenstein  
**Status :** Open  
**Priority :** Urgent                                      **Asset Tag :** RTU2  
**Originated Date :** 10/15/2024 - Jearod Ferrette - National TAB

Notes:  
DUCT IS INSTALLED AS SMALLER THAN DESIGNED AND AN ADDITIONAL 90 DEGREE ELBOW IS INSTALLED.

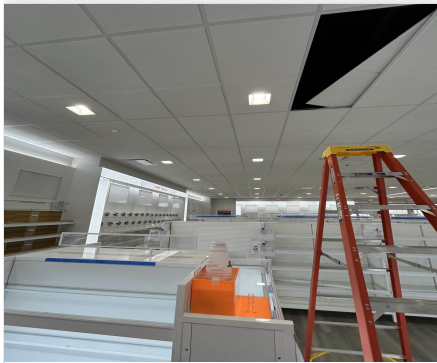
**Issue Name :** RTU-2 diffuser 24 damper is closed  
**Description :** Damper for diffuser 24 is closed and not accessible. There is a shelf that is directly underneath the damper. Damper is also installed on the top of the duct. It needs to be opened and a face accessible opposed blade damper is recommended in case further balancing is required.  
**Created By :** National TAB                      **Assigned To :** National TAB - Dan Hertenstein  
**Status :** Open  
**Priority :** Low                                      **Asset Tag :** RTU2  
**Originated Date :** 10/15/2024 - Jearod Ferrette - National TAB

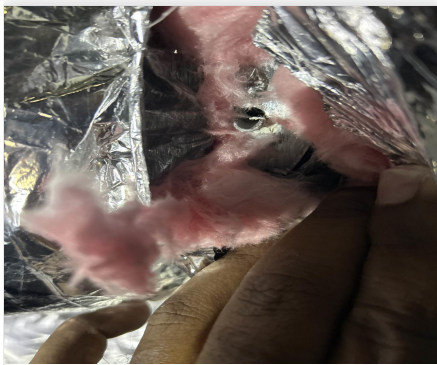
**Issue Name :** RTU-3 missing damper on supply diffuser SGRD2 & 7  
**Description :** Missing supply damper on RTU-3 SGRD 2 & SGRD 7. Needs to be installed to complete balancing.  
**Created By :** National TAB                      **Assigned To :** National TAB - Dan Hertenstein  
**Status :** Open  
**Priority :** High                                      **Asset Tag :** RTU3  
**Originated Date :** 10/15/2024 - Jearod Ferrette - National TAB

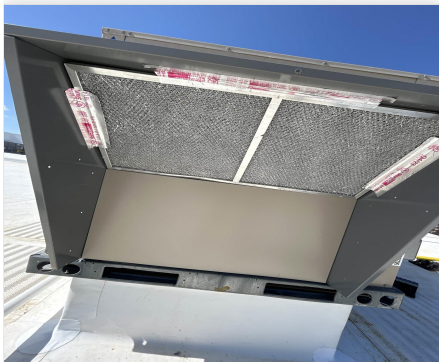
**Issue Name :** RTU-4 outside filters not properly installed  
**Description :** RTU 4 outside filters are not properly installed. Being held by tape.  
**Created By :** National TAB                      **Assigned To :** National TAB - Dan Hertenstein  
**Status :** Open  
**Priority :** Medium                                      **Asset Tag :** RTU4  
**Originated Date :** 10/14/2024 - Jearod Ferrette - National TAB

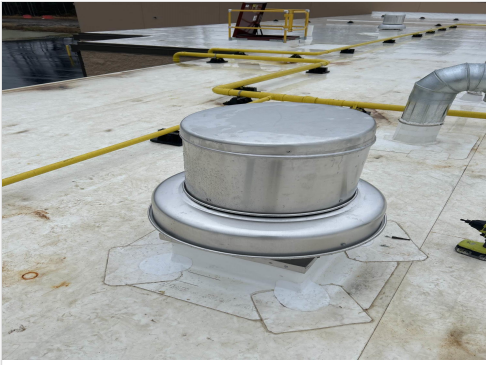
Notes:  
LOW FLOW SEE ISSUE  
(Rotation incorrect) (no disconnect)
