Issue List

10-14-24 ULTA 1697 SELMA, NC

Project Issue Information

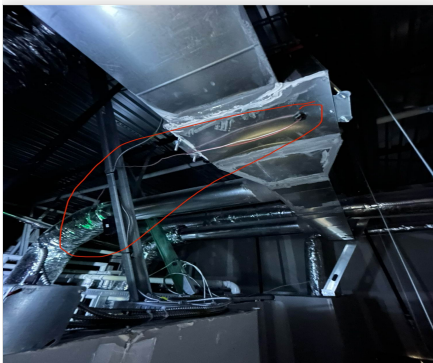
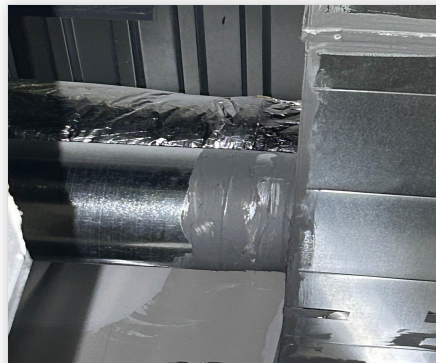
Issue Name : EF-2 Restroom fan unable to access
Description : I am unable to reach the controller for the restroom exhaust fan. The control is above hard ceiling. I am unable to reach from other side with ladder due to piping obstructing access. There are no dampers on either exhaust duct or face. The unit is running at 117% of design.
Created By : National TAB **Assigned To :** National TAB - Dan Hertenstein
Status : Open
Priority : High **Asset Tag :**
Originated Date : 10/14/2024 - Jearod Ferrette - National TAB

ON EF-1 THERE IS NOT A ROOF TOP MOTOR ON SITE, I DID NOT SEE A INLINE FAN ALSO. ON EF-2 UNABLE TO ACCESS MOTOR DUE TO HARD CEILING AND DUCTWORK PLACEMENT.

UNABLE TO VERIFY DUE TO MOTOR PLACEMENT AND NO ACCESS

NO ACCESS TO EF-2 CONTROLS TO SLOW UNIT DOWN. DAMPERS ARE NOT INSTALL. FAN IS 117% TOTAL AIRFLOW OF DESIGN.

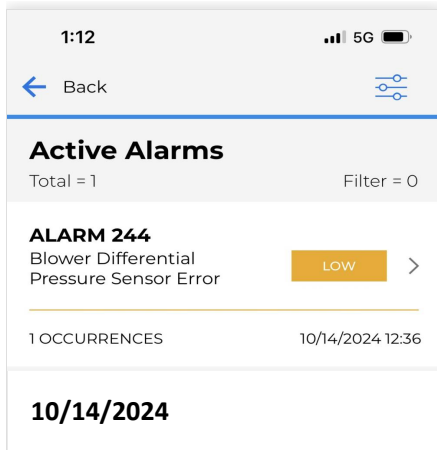
Issue Name : RTU -4 is currently an alarm.
Description : RTU-4 alarm code 244 (Blower differential pressure sensor error)
Created By : National TAB **Assigned To :** National TAB - Dan Hertenstein
Status : Open
Priority : High **Asset Tag :**
Originated Date : 10/14/2024 - Jearod Ferrette - National TAB

NO. RTU-4 HAS ALARM CODE 244 (BLOWER DIFFERENTIAL PRESSURE SENSOR ERROR) UNABLE TO LOWER SPEED TO UNIT.

RTU-4 IN ALARM CODE 244 (BLOWER DIFFERENTIAL PRESURE SENSOR ERROR) UNABLE TO SLOW UNIT DOWN. WE ARE GETTING (149%) TOTAL AIRFLOW TO DESIGN. HIGH WINDS ON THE ROOF MAY HAVE AFFECTED THE OUTSIDE AIR MEASUREMENT.

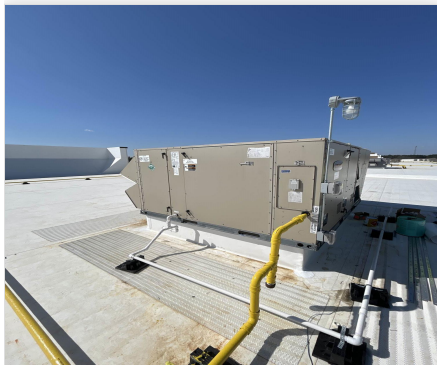
Issue Name : RTU 2 hitting max amps with low airflow
Description : RTU-2 unit is running at Max amps. The pulley is 5 turns out. After reading all supply diffusers. We are currently at 68% total airflow of design.
Created By : National TAB **Assigned To :** National TAB - Dan Hertenstein
Status : Open
Priority : Urgent **Asset Tag :**
Originated Date : 10/15/2024 - Jearod Ferrette - National TAB

RTU-2 IS RATED FOR 4 AMPS, IT IS CURRENTLY RUNNING AT 4.24 AMPS WITH MAX TURNS OUT ON PULLEY.

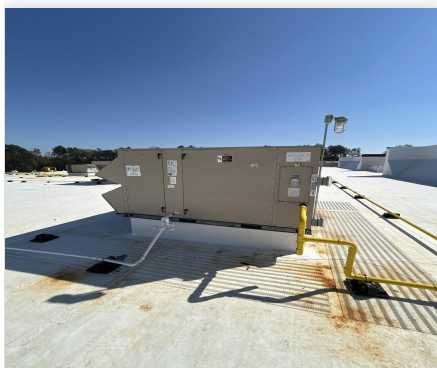
Issue Name : RTU-1 Motor at max amps. The Pulley is at 2 turns out with belt over hang.

Description : RTU-1 unit is running at Max amps. The pulley is 2 turns out. After reading all supply diffusers. We are currently at 84% total airflow of design.

THIS UNIT IS RUNNING AT 3.4 APMS WITH 2 TURNS OUT. THE MOTOR BELT HAS OVERHANG ON THE PULLY AND TIGHT. CURRENTLY AT 84% DESIGN OF AIRFLOW.

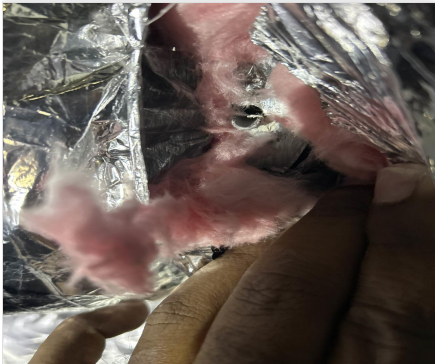
Issue Name : RTU-3 missing damper on supply diffuser SGRD2 & 7
Description : Missing supply damper on RTU 3 SGRD 2 & SGRD 7
Created By : National TAB **Assigned To :** National TAB - Dan Hertenstein
Status : Open
Priority : High **Asset Tag :**
Originated Date : 10/15/2024 - Jearod Ferrette - National TAB

RTU-3 SUPPLY DIFFUSERS ARE MISSING DAMPERS ON SGRD 3 AND SGRD 7. THIS UNIT IS SET TO TOTAL DESIGN AIRFLOW. ONCE DAMPERS ARE INSTALLED, IT CAN BE BALANCED. HIGH WINDS OF ROOF MAY HAVE AFFECTED THE OUTSIDE AIR MEASUREMENT.

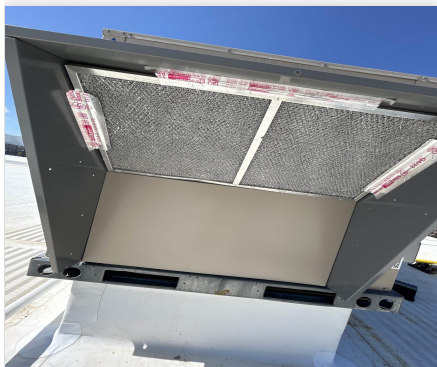
Issue Name : RTU-4 outside filters not properly attached
Description : RTU 4 outside filters are not properly attached to unit is being held by tape.
Created By : National TAB **Assigned To :** National TAB - Dan Hertenstein
Status : Open
Priority : Medium **Asset Tag :**
Originated Date : 10/14/2024 - Jearod Ferrette - National TAB

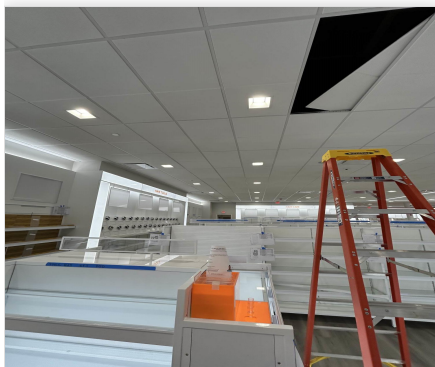
Issue Name : Unable to safely reach damper above ceiling on RTU-2
Description : On RTU-2 SGRD 24 Unable to access damper on supply diffuser safely. There is a makeup Shelf that has power ran to it, unable to move the shelf to assess ceiling tile.
Created By : National TAB **Assigned To :** National TAB - Dan Hertenstein
Status : Open
Priority : Low **Asset Tag :**
Originated Date : 10/15/2024 - Jearod Ferrette - National TAB

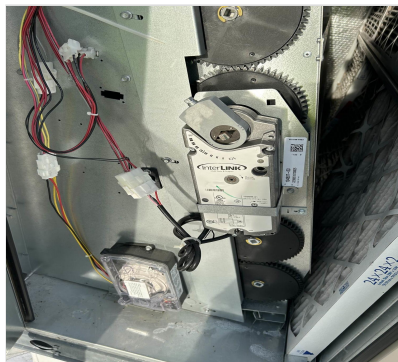
DCV Max damper opening position is set to minimum? No

ALL RTU'S DAMPERS ARE NON-OPERATIONAL. RTU 1/2 ARE MANUALLY SET AND MARKED
