Report: PRELIMINARY TAB REPORT

Function: Test, Adjust, & Balance

10-14-24 ULTA 1697 SELMA, NC

Rectenwald Brothers Construction

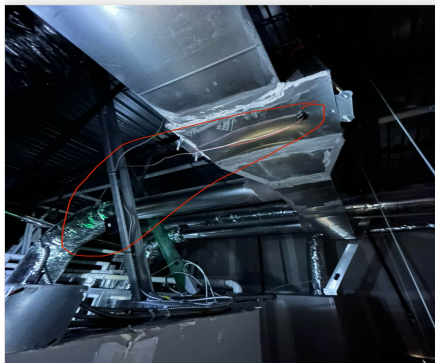
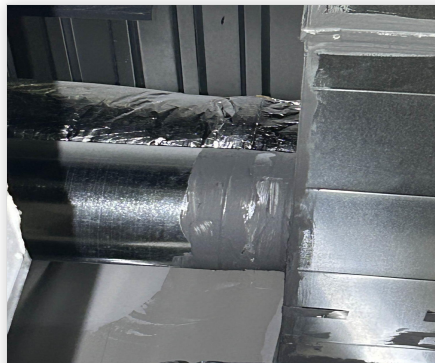
Issue Name : EF-2 Restroom fan unable to access
Description : EF-2 speed controller is located above hard ceiling and is inaccessible. Unable to reach from other side with ladder due to piping obstructing access. The unit is running at 117% of design.
Created By : National TAB **Assigned To :** National TAB - Dan Hertenstein
Status : Open
Priority : High **Asset Tag :**
Originated Date : 10/14/2024 - Jearod Ferrette - National TAB

NO ACCESS TO EF-2 CONTROLS TO SLOW UNIT DOWN. DAMPERS ARE NOT INSTALL. FAN IS 117% TOTAL AIRFLOW OF DESIGN. THE FAN CAN BE BALANCED TO DESIGN ONCE AN ACCESSILBE SPEED CONTROLLER IS INSTALLED.

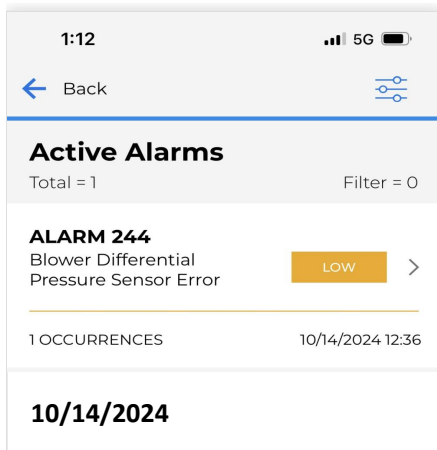
Issue Name : RTU -4 airflow is 149% of design
Description : RTU-4 airflow is 149% of design. Unable to slow unit down with the CORE controller. There is an alarm code 244 (Blower differential pressure sensor error) that appears to be preventing speed adjustment.
Created By : National TAB **Assigned To :** National TAB - Dan Hertenstein
Status : Open
Priority : High **Asset Tag :** RTU4
Originated Date : 10/14/2024 - Jearod Ferrette - National TAB

Notes:
RTU-4 IN ALARM CODE 244 (BLOWER DIFFERENTIAL PRESURE SENSOR ERROR) UNABLE TO SLOW UNIT DOWN. WE ARE GETTING (149%) TOTAL AIRFLOW TO DESIGN. HIGH WINDS ON THE ROOF MAY HAVE AFFECTED THE OUTSIDE AIR MEASUREMENT. WE EXPECT TO BE ABLE TO REDUCE FAN SPEED ONCE SENSOR IS REPAIRED.

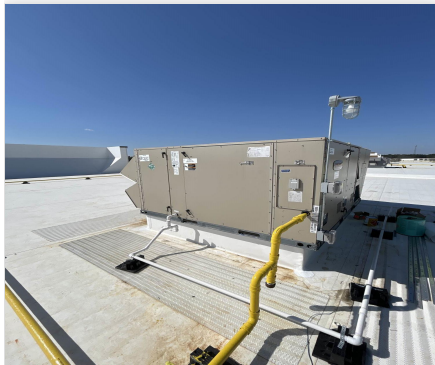
Issue Name : RTU 2 airflow is 72% of design
Description : RTU-2 airflow is 72% of design (3435 CFM at diffusers) with motor at FLA. The duct is installed as 24"x18" inner dimensions but plans show 30"x20". Duct traversed as 3819 CFM. Velocity is 1273 FPM which is high. There is also an additional 90 degree transition installed. A larger motor would be required to achieve design.

Traversed RTU-2 from the main drop and was reading 4245 CFM's. Suggest inspection for leakage due to difference in CFM's. DIFFUSER 24 DAMPER IS CLOSED AND UNACCESSILBE.

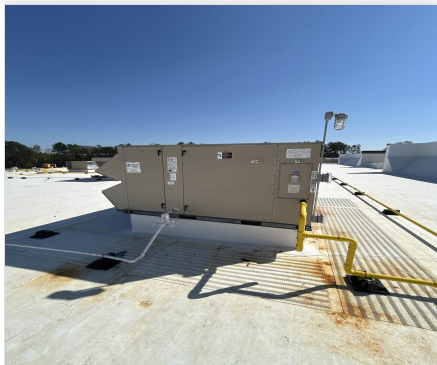
Issue Name : RTU-1 airflow is 84% of design
Description : RTU-1 airflow is 84% of design. The pulley cannot be increased further without the belt sitting too high up on the pulley. A pulley change is recommended.
Created By : National TAB **Assigned To :** National TAB - Dan Hertenstein
Status : Open
Priority : High **Asset Tag :** RTU1
Originated Date : 10/15/2024 - Jearod Ferrette - National TAB

THIS UNIT IS RUNNING AT 3.4 APMS WITH 2 TURNS OUT. THE MOTOR BELT HAS OVERHANG ON THE PULLEY AND TIGHT. CURRENTLY AT 84% DESIGN OF AIRFLOW. DIFFUSERS 3,8 AND 9 ARE READING LOW. ALL DAMPERS ARE 100% OPEN.

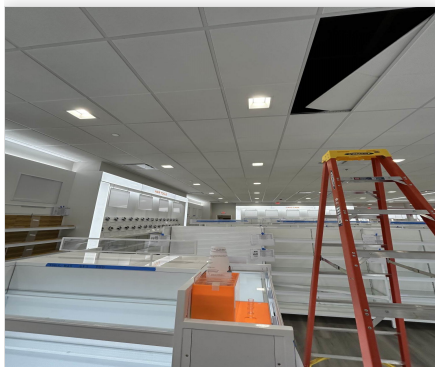
Issue Name : RTU-2 diffuser 24 damper is closed
Description : Damper for diffuser 24 is closed and not accessible. There is a shelf that is directly underneath the damper. Damper is also installed on the top of the duct. It needs to be opened and a face accessible opposed blade damper is recommended in case further balancing is required.
Created By : National TAB **Assigned To :** National TAB - Dan Hertenstein
Status : Open
Priority : Low **Asset Tag :** RTU2
Originated Date : 10/15/2024 - Jearod Ferrette - National TAB

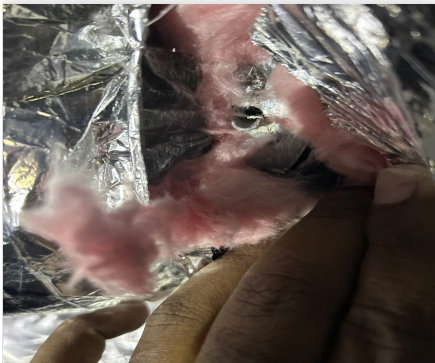
Issue Name : RTU-3 missing damper on supply diffuser SGRD2 & 7
Description : Missing supply damper on RTU-3 SGRD 2 & SGRD 7. Needs to be installed to complete balancing.
Created By : National TAB **Assigned To :** National TAB - Dan Hertenstein
Status : Open
Priority : High **Asset Tag :** RTU3
Originated Date : 10/15/2024 - Jearod Ferrette - National TAB

Notes:
RTU-3 SUPPLY DIFFUSERS ARE MISSING DAMPERS ON SGRD 3 AND SGRD 7. THIS UNIT IS SET TO TOTAL DESIGN AIRFLOW. ONCE DAMPERS ARE INSTALLED, IT CAN BE BALANCED. HIGH WINDS OF ROOF MAY HAVE AFFECTED THE OUTSIDE AIR MEASUREMENT.

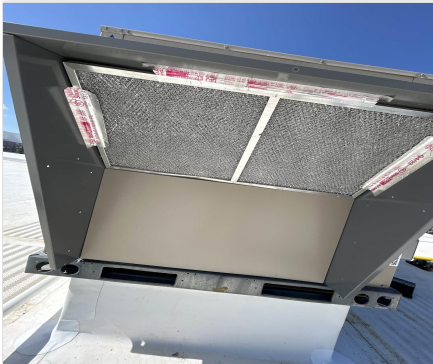
Issue Name : RTU-4 outside filters not properly installed
Description : RTU 4 outside filters are not properly installed. Being held by tape.
Created By : National TAB **Assigned To :** National TAB - Dan Hertenstein
Status : Open
Priority : Medium **Asset Tag :** RTU4
Originated Date : 10/14/2024 - Jearod Ferrette - National TAB

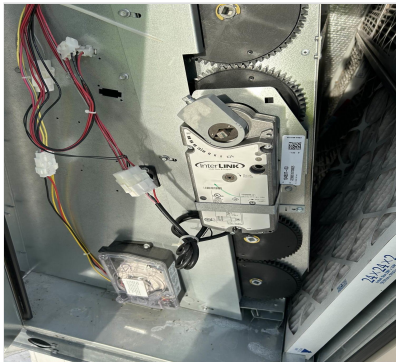
ALL RTU'S DAMPERS ARE NON-OPERATIONAL. RTU 1/2 ARE MANUALLY SET AND MARKED

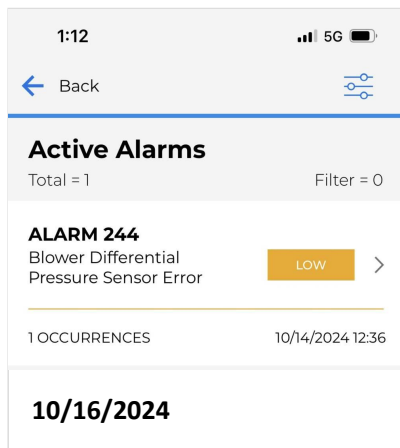
NO. RTU-4 HAS ALARM CODE 244 (BLOWER DIFFERENTIAL PRESSURE SENSOR ERROR) UNABLE TO LOWER SPEED TO UNIT.

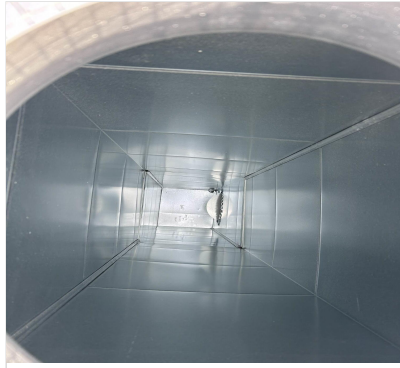
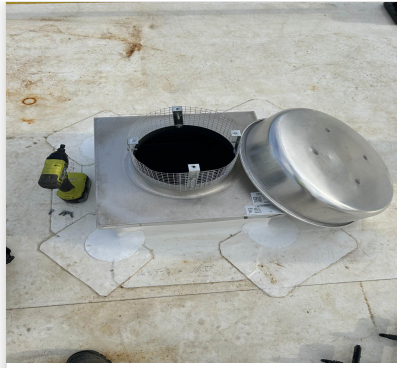
ON EF-1 THERE IS NOT A ROOF TOP MOTOR ON SITE, I DID NOT SEE A INLINE FAN ALSO. ON EF-2 UNABLE TO ACCESS MOTOR DUE TO HARD CEILING AND DUCTWORK PLACEMENT.
