Final TAB Punchlist

Jan 21, 2025

L05792_North Platte FSU (NE)

1902 South Jeffers Street, North Platte, Nebraska

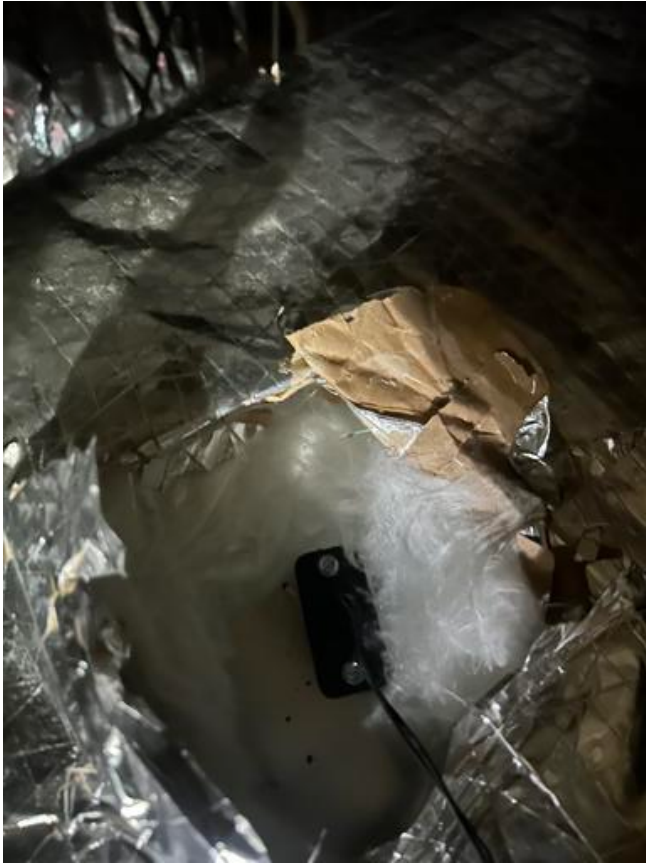
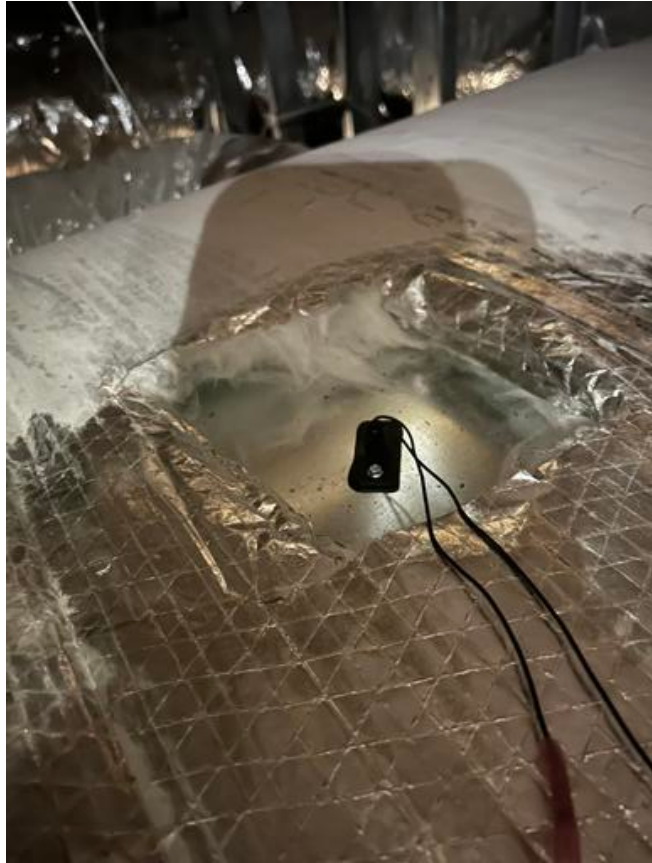
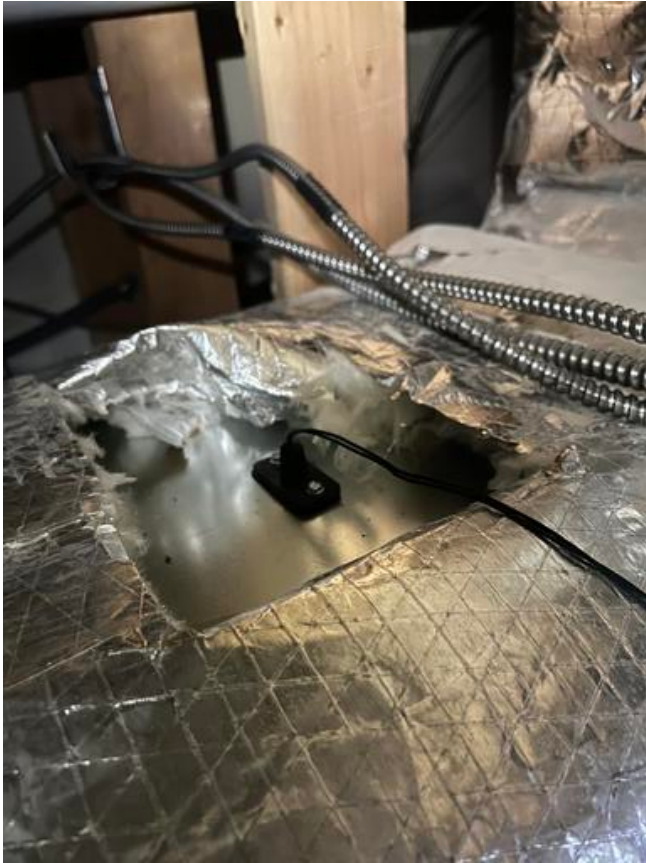
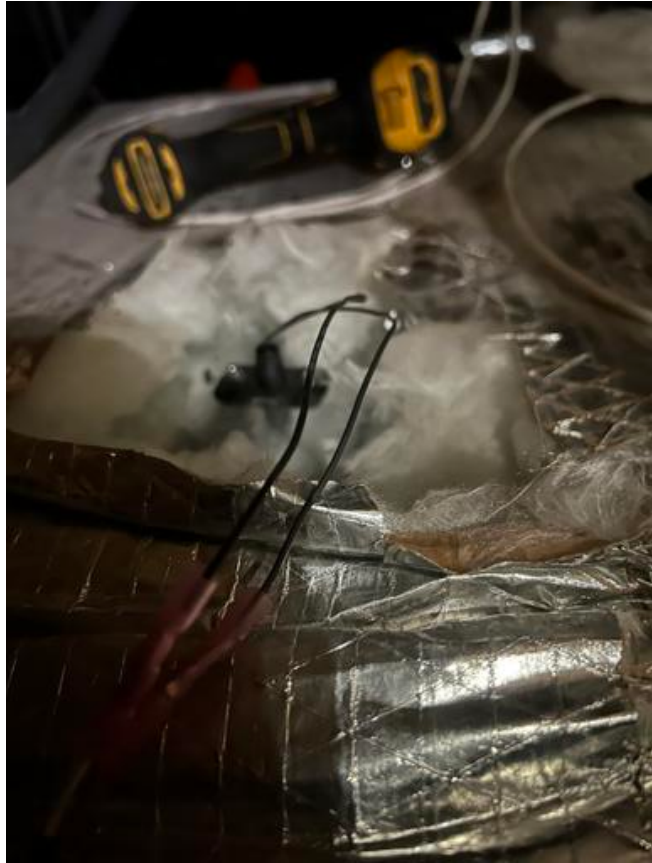
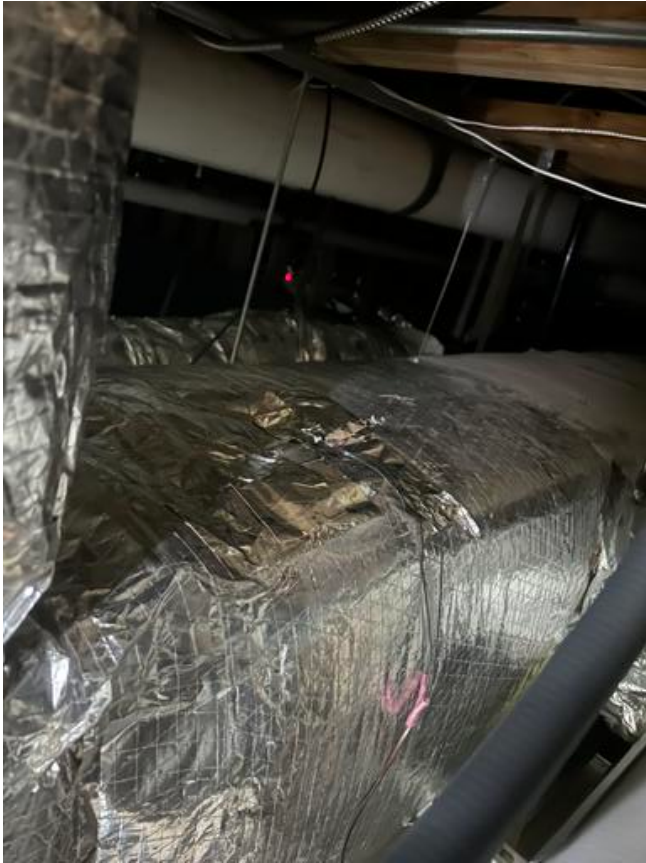
Units with Fresh Air Tempering kits are to have the discharge sensor routed per specification into the discharge duct via wiring portal. If Lennox turn on FAH and set parameter #156 to 60 in Kitchen, 62 in Drive-Thru/Serving, & 63 in Dining/Play Area; then set parameters #157 to 14 & #158 to 300 on all.

all 4 sensors have been moved past the first elbow, wired back into the units and sensors covered with insulation. Settings on RTU's have been checked

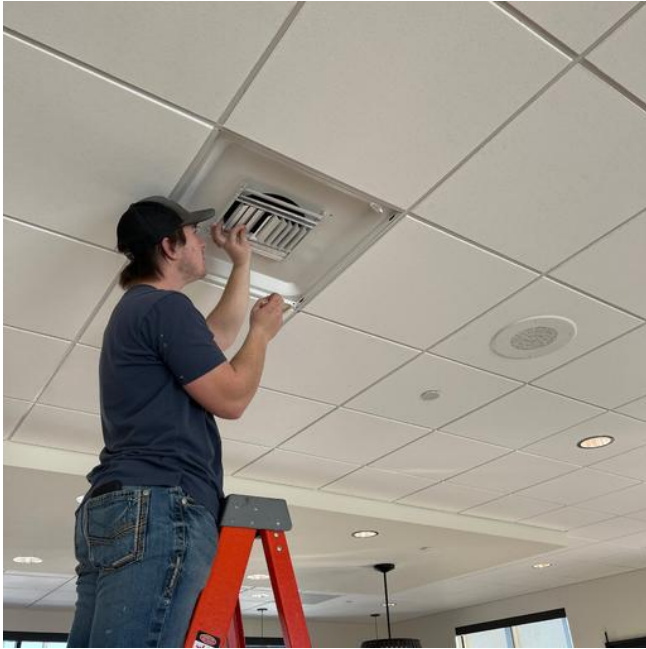
IMG_5391

Air pattern deflections are called to be changed on plans by MC to adhere to design intent. General note 4 on M-001 states "UNLESS NOTED OTHERWISE, MC TO ADJUST ALL DIFFUSER AIR PATTERN DEFLECTORS TO THROW HORIZONTALLY ALONG THE CEILING."

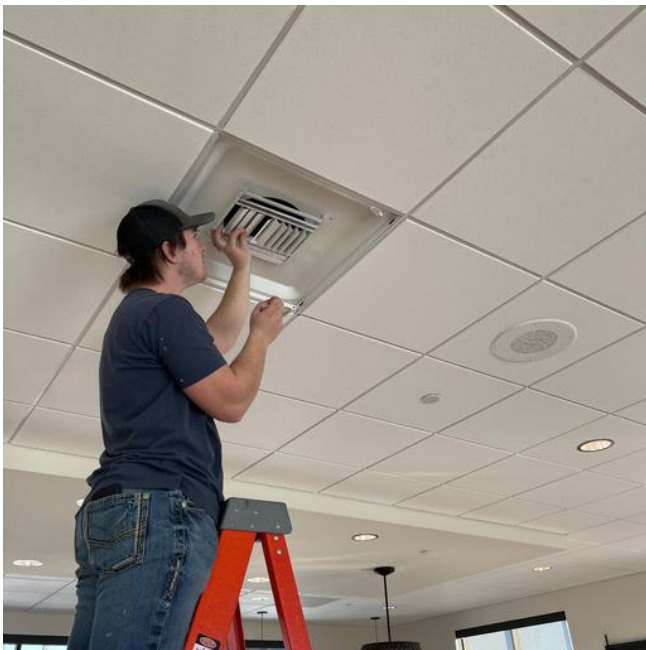
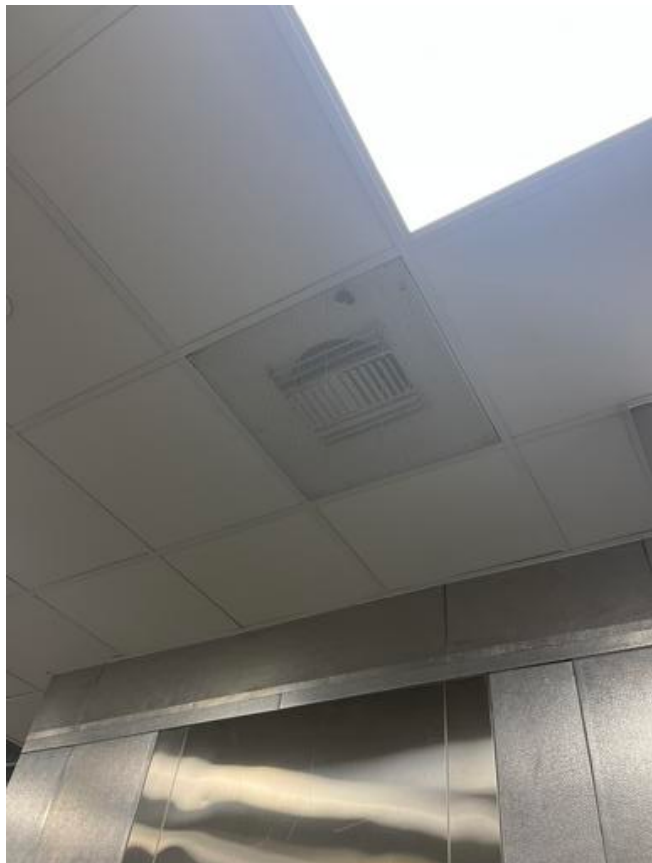
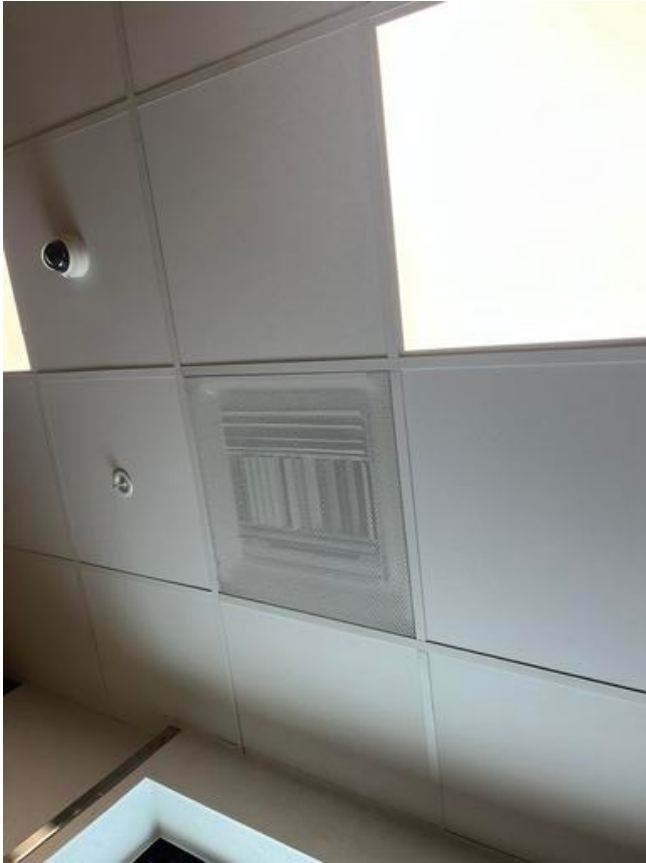
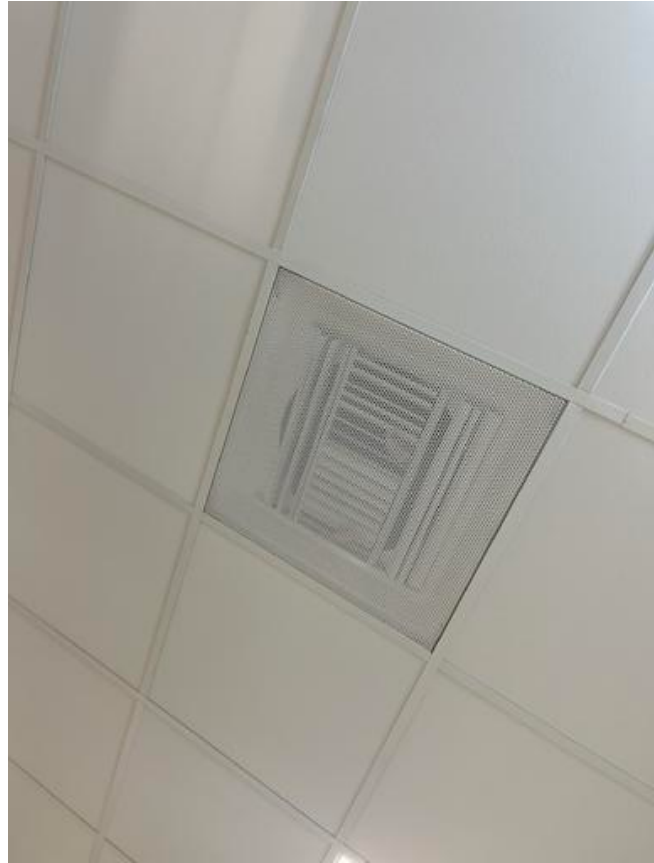
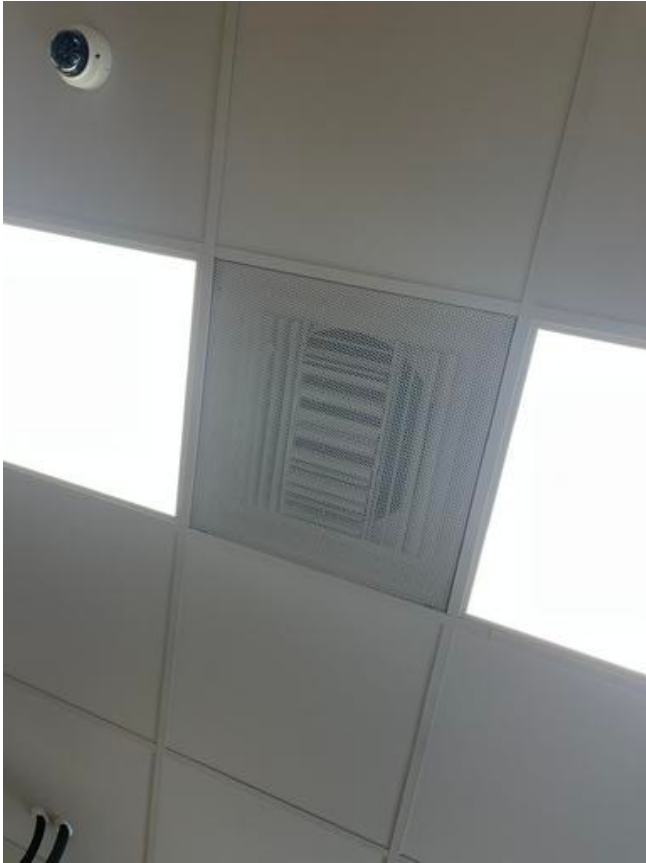
There is debris in the face of many of the diffusers. Go through and make sure grilles are clear of insulation and debris.

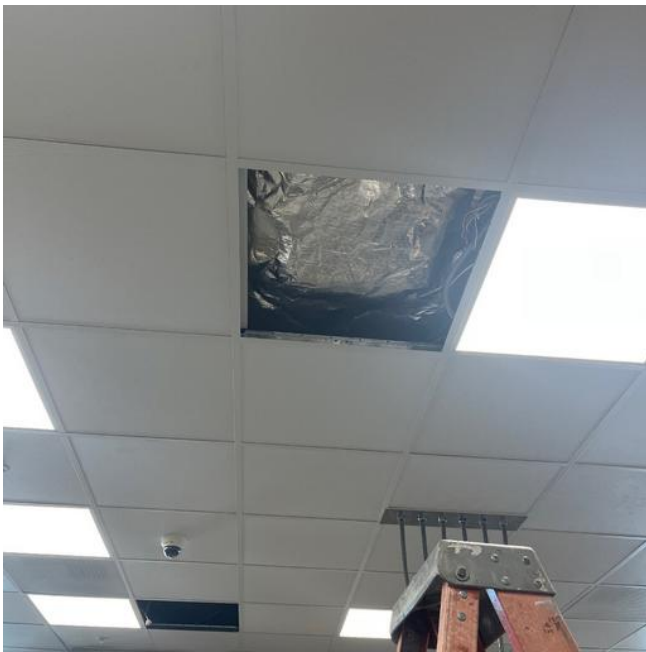
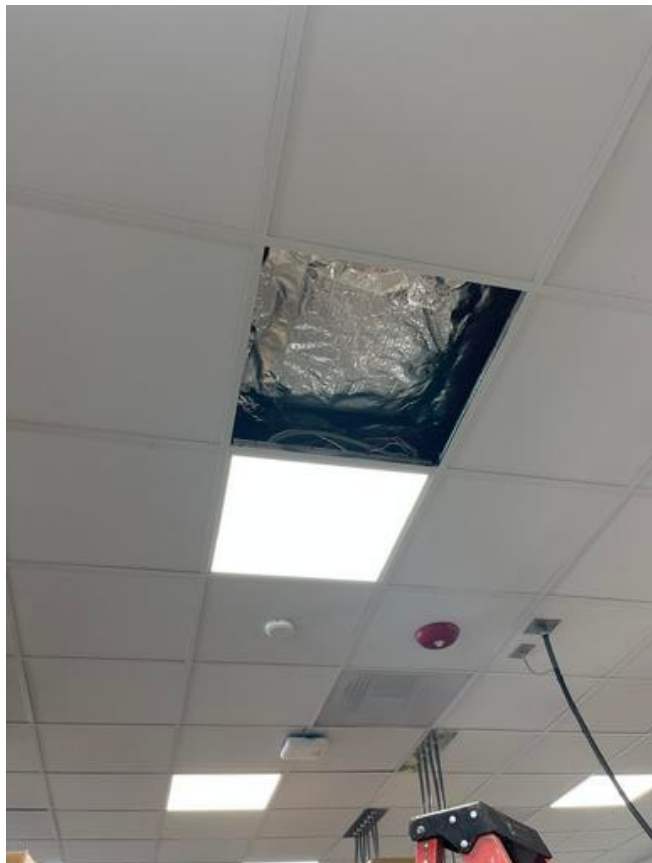
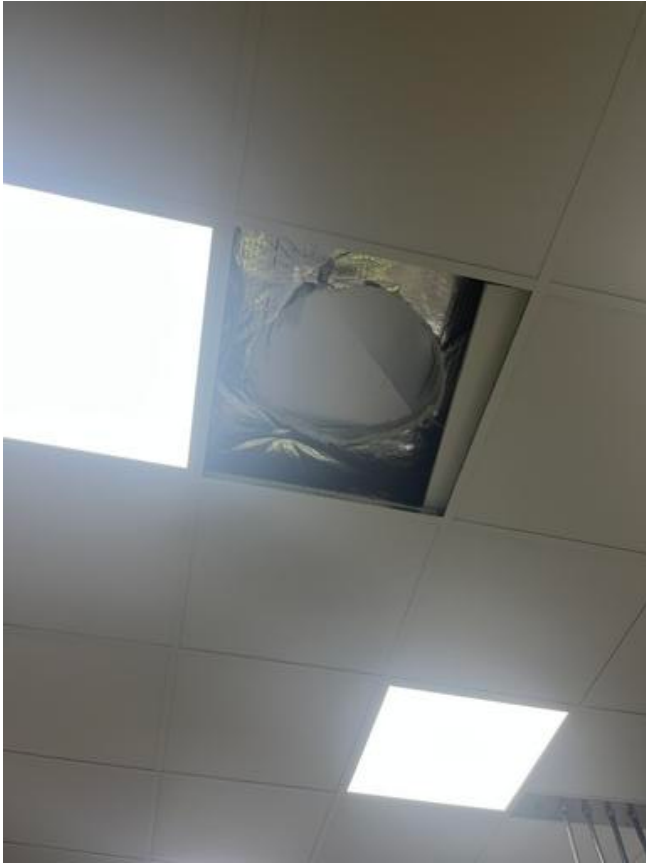
Ductwork has exposed metal ductwork in some areas needs to be fully wrapped.

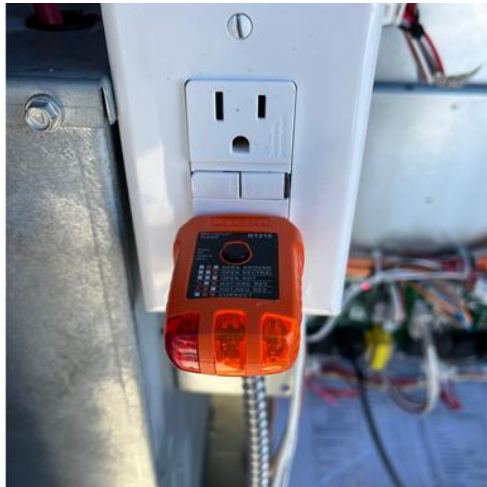
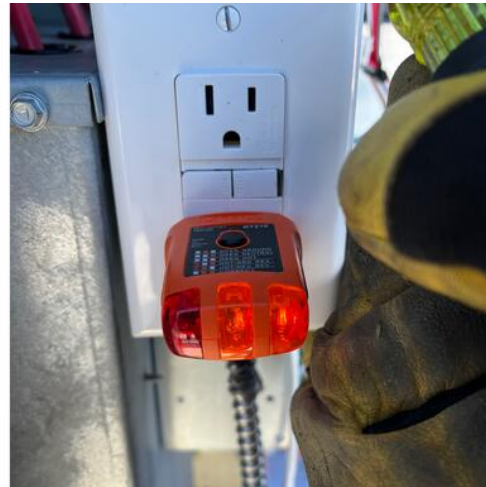
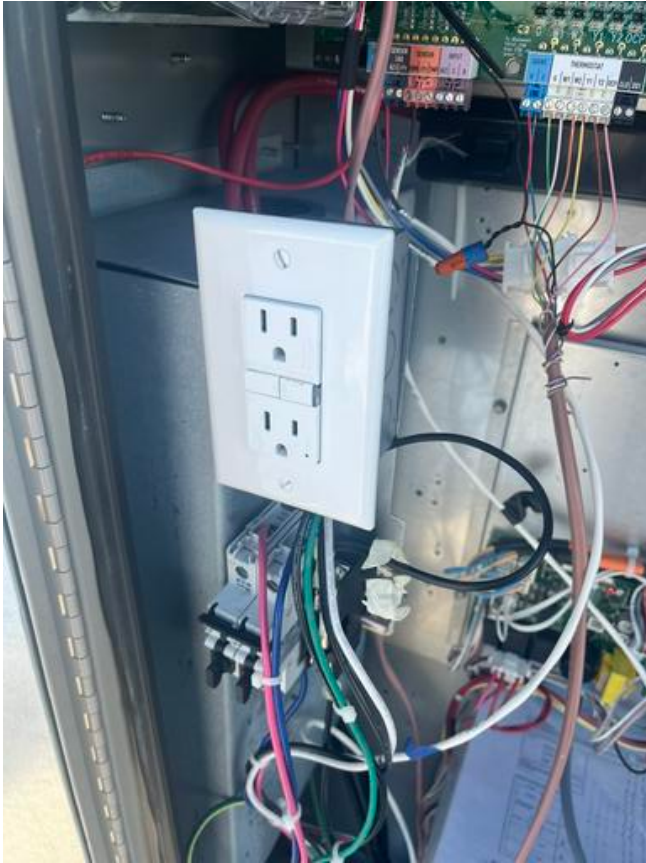
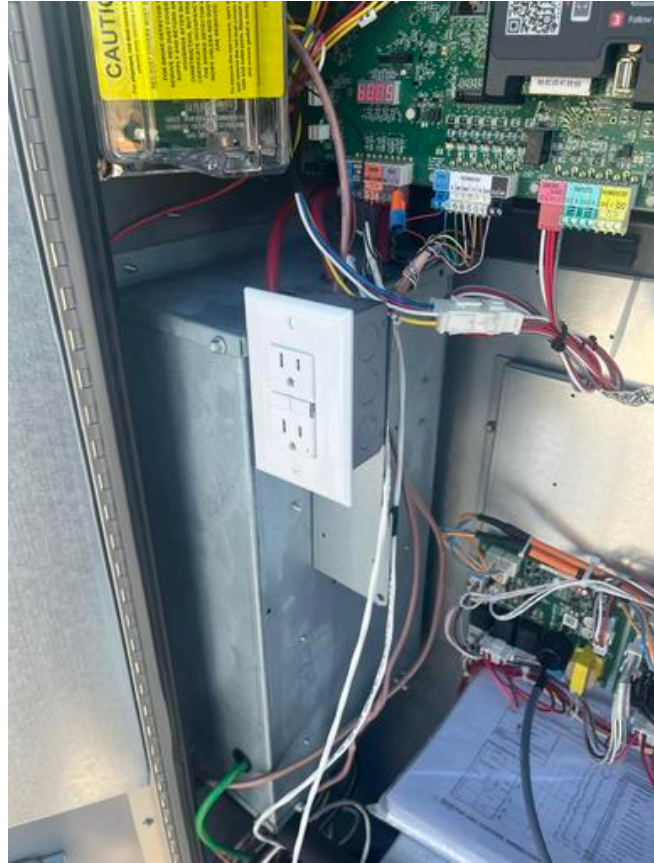
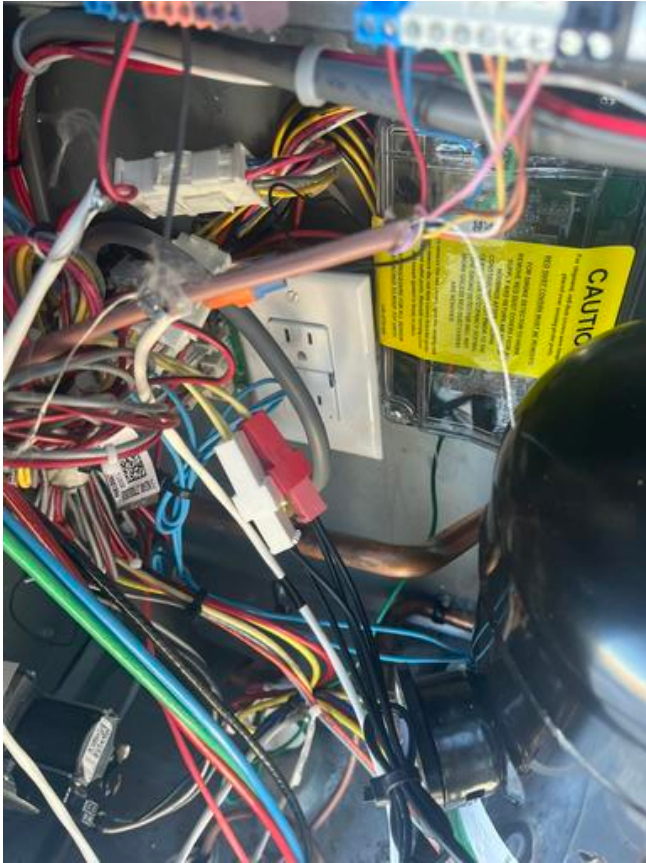
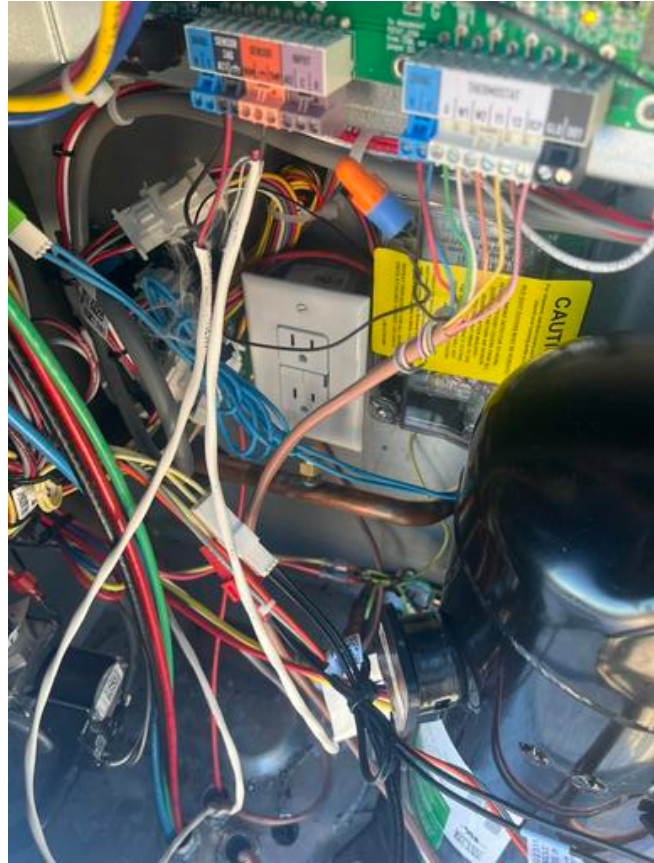
Equipment GFI outlet missing components (GFI itself, din rail with fuses) or not terminated/operational. Per the AC unit schedule, each unit should have a factory installed GFI outlet with a separate 115V circuit provided by the electrical contractor.

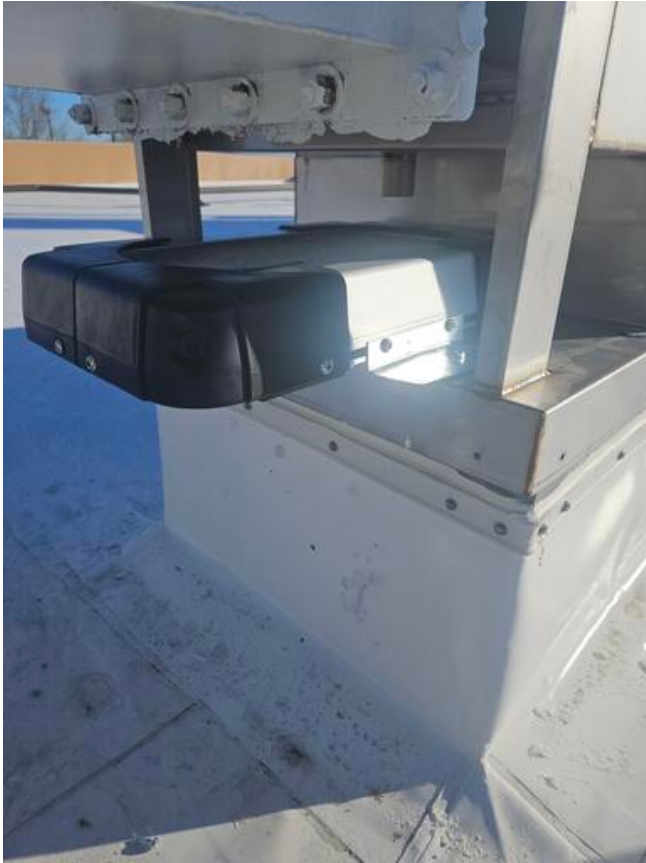
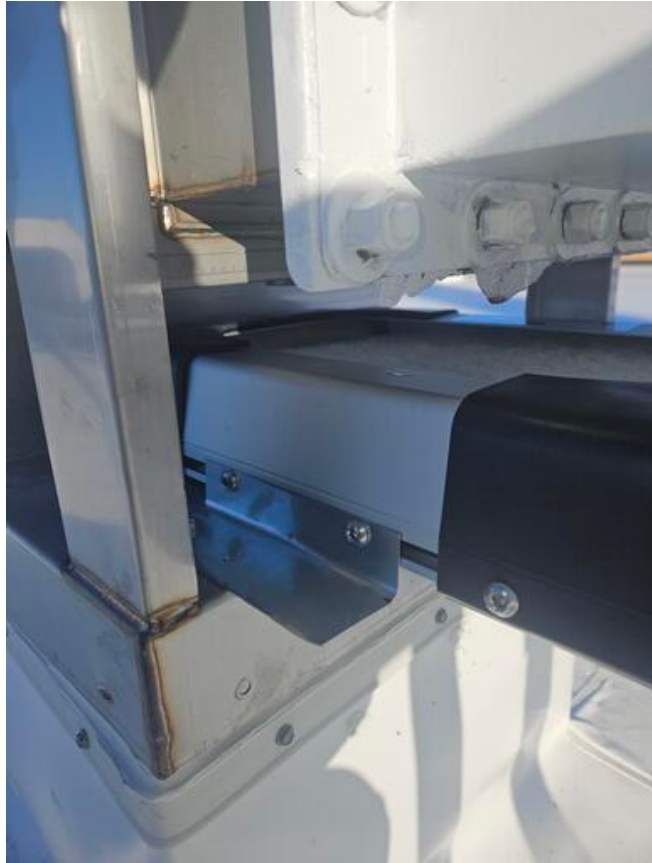
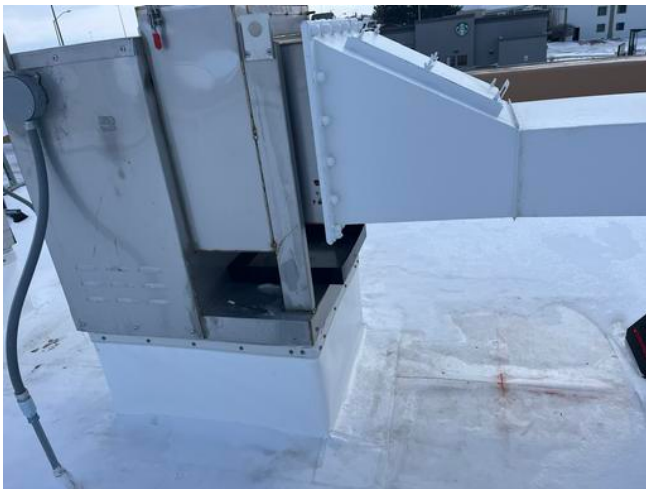
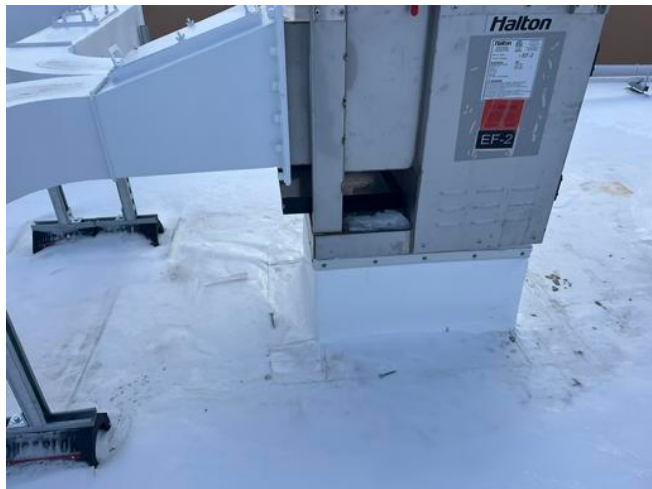
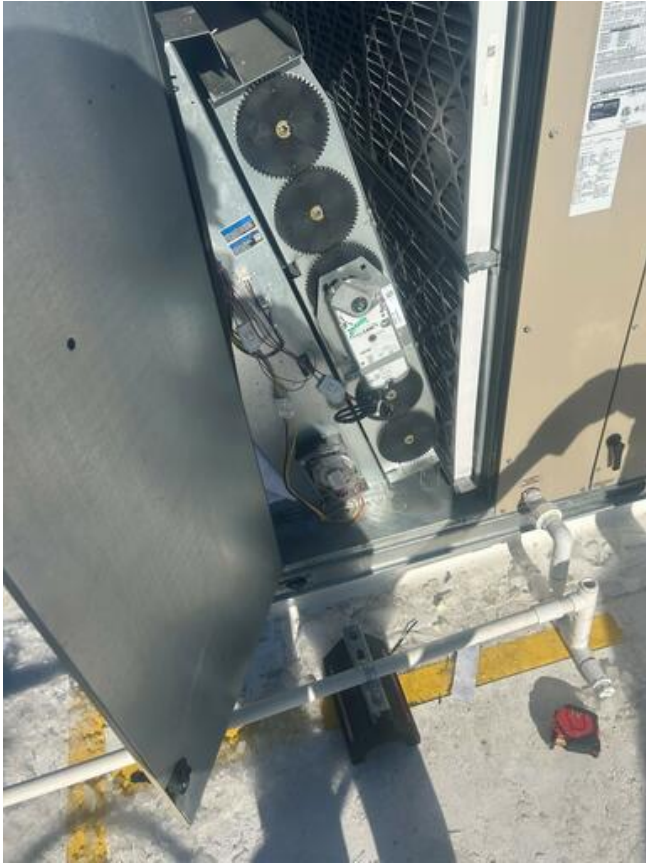
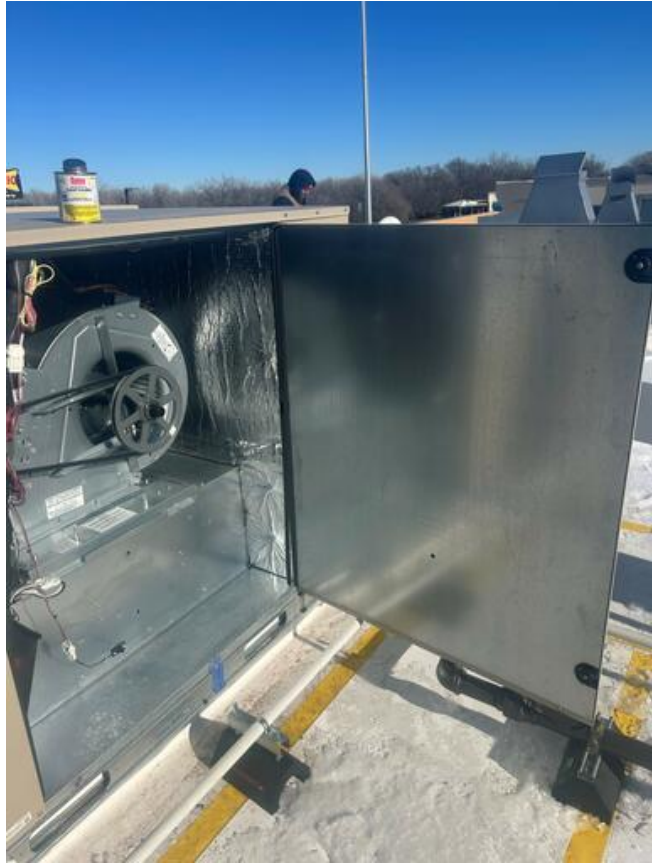
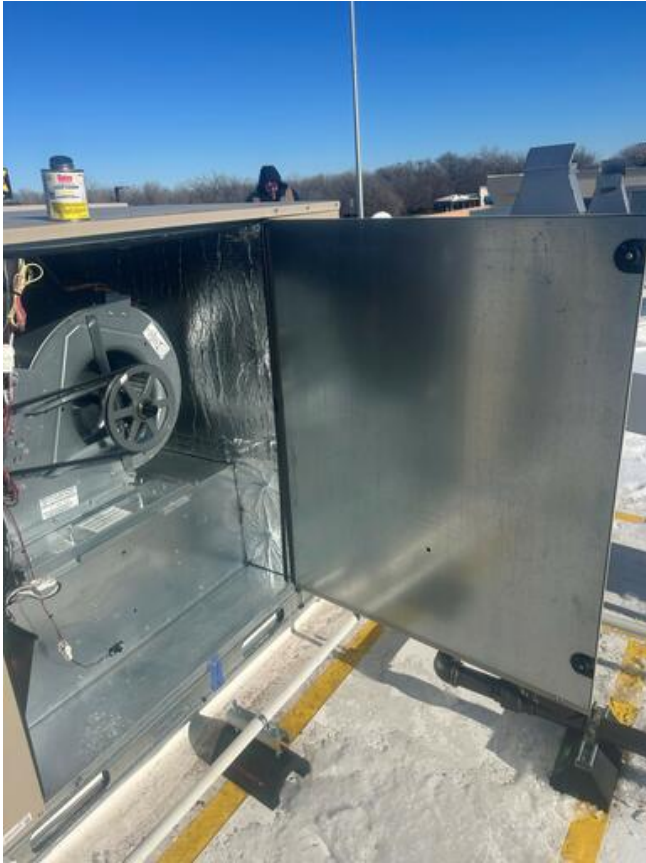
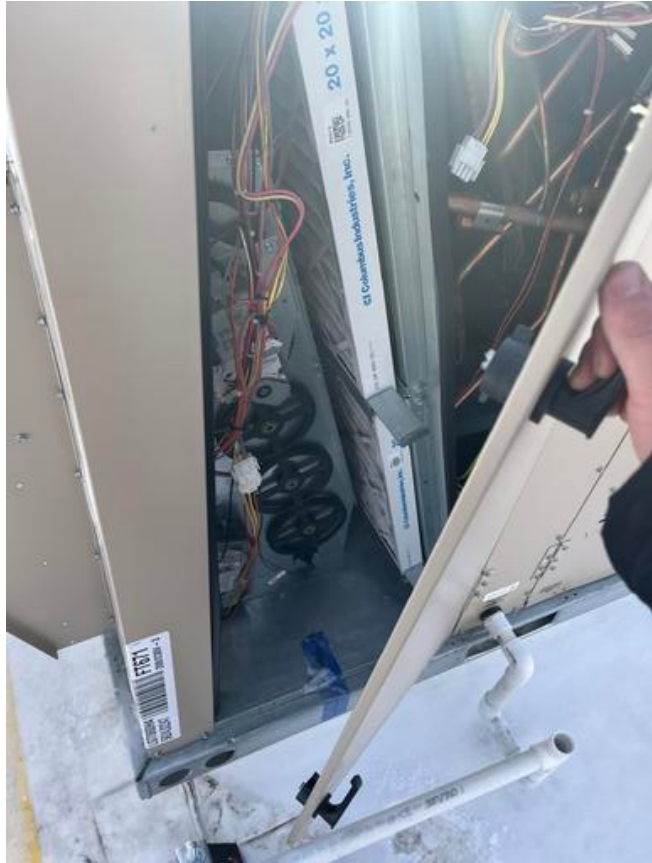
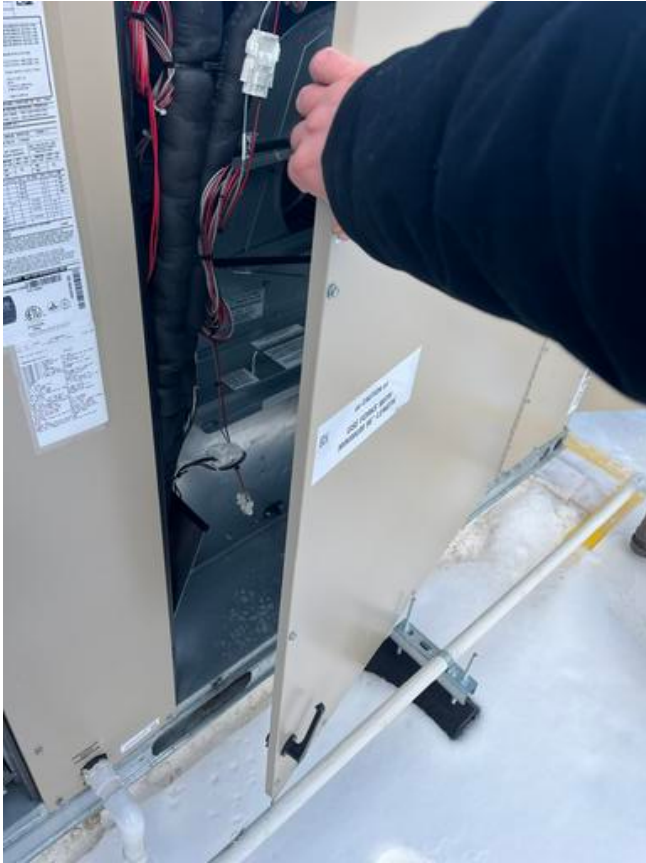
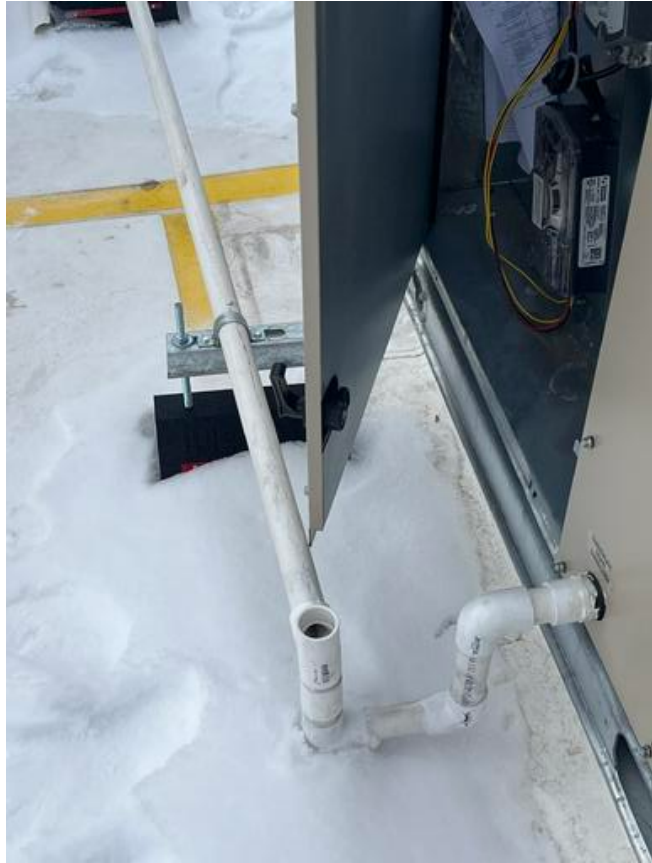
Description
Exhaust fan G2 Drip Guard is missing.

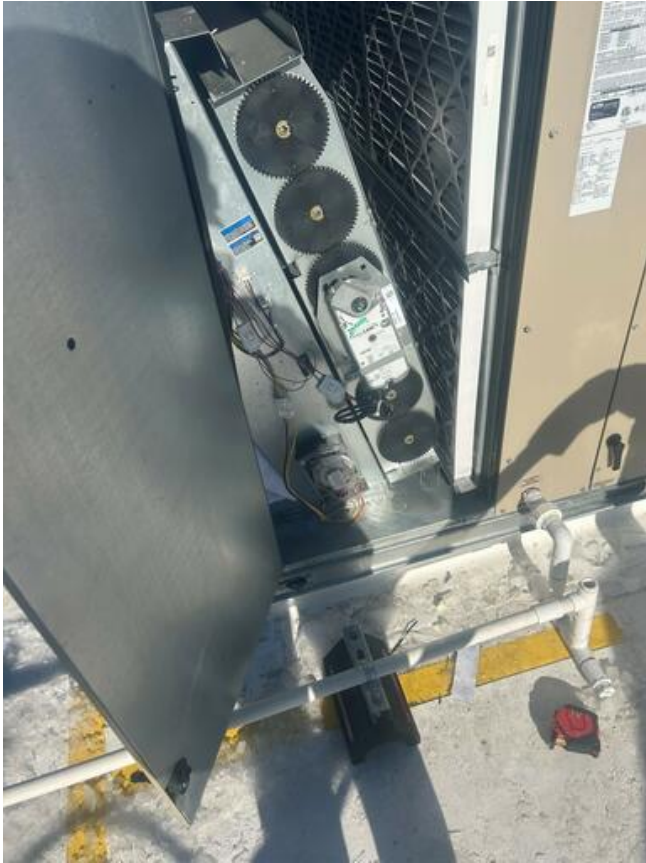
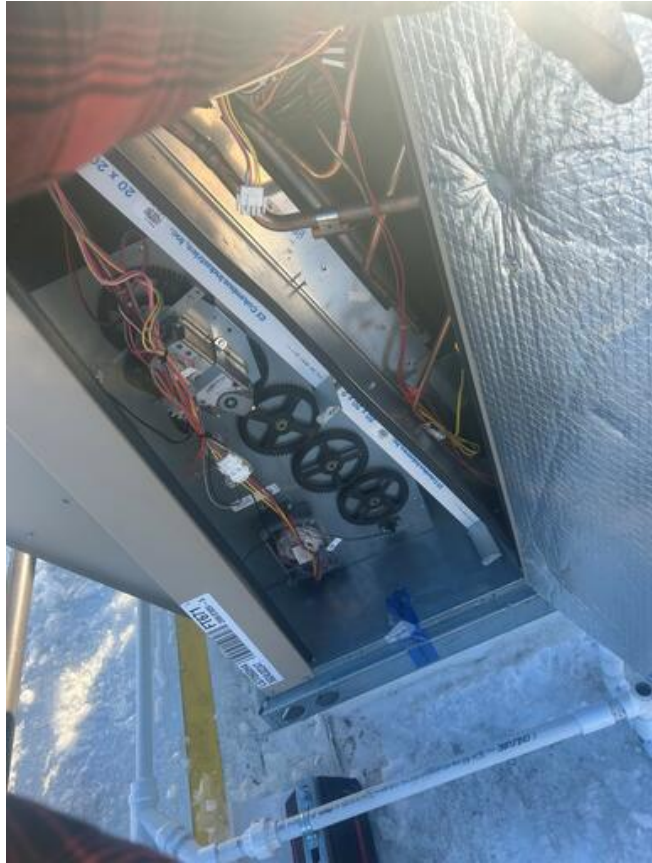
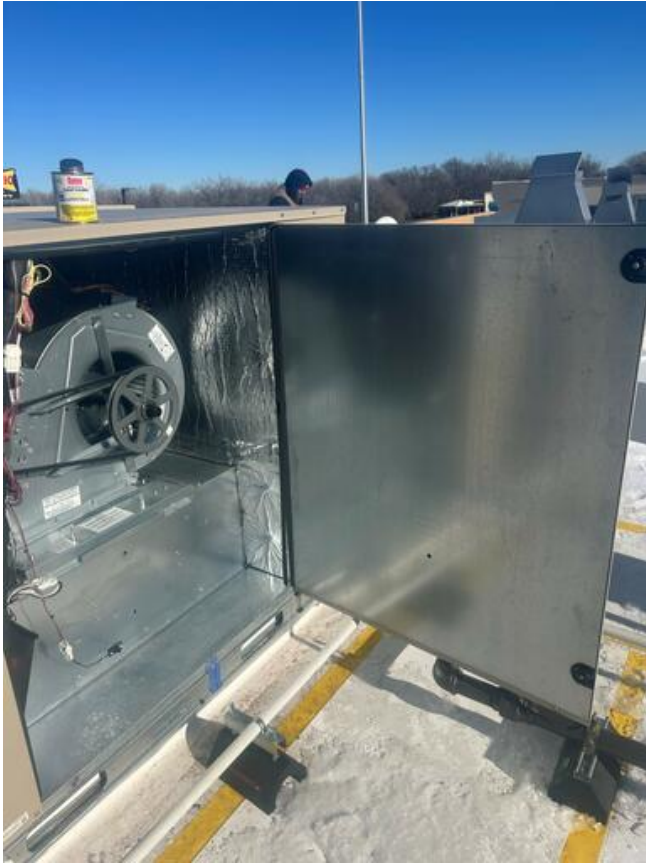
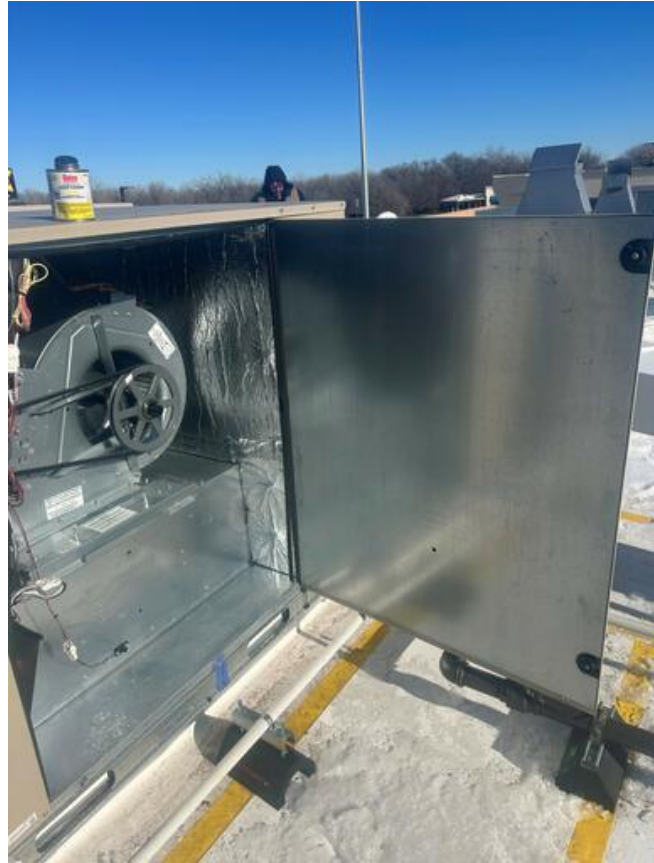
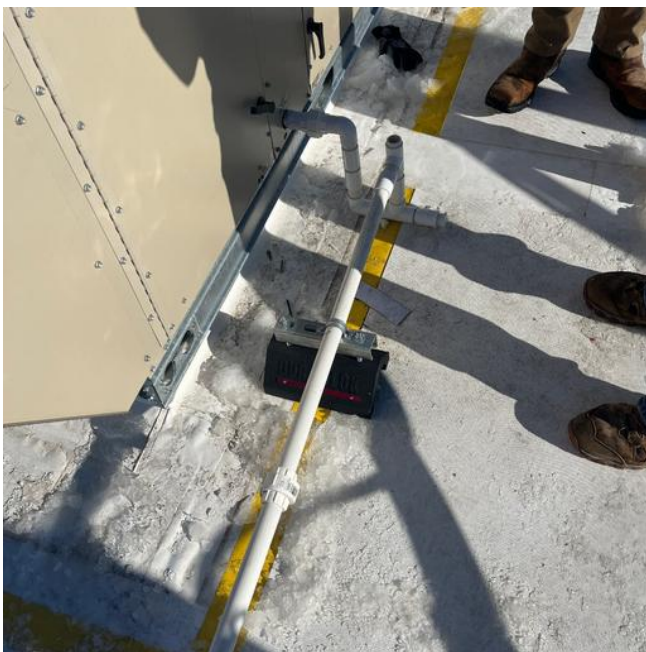
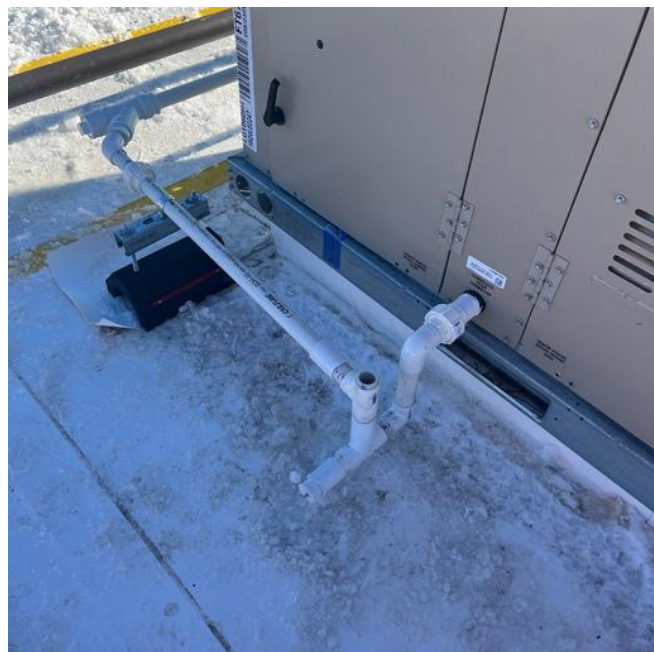
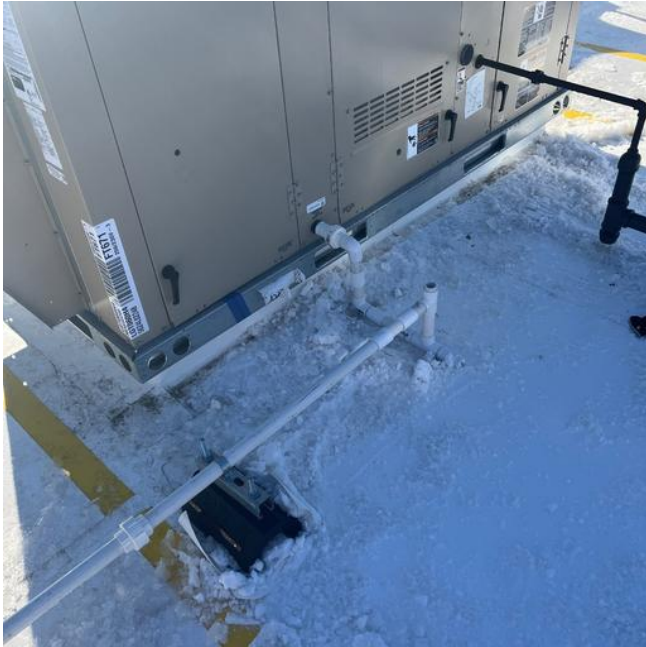
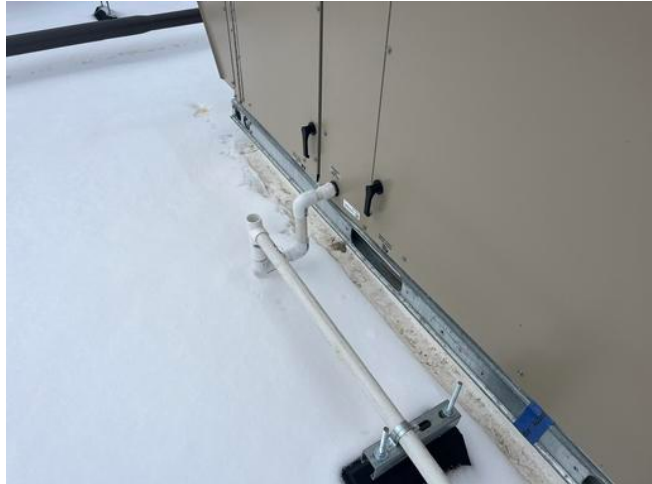
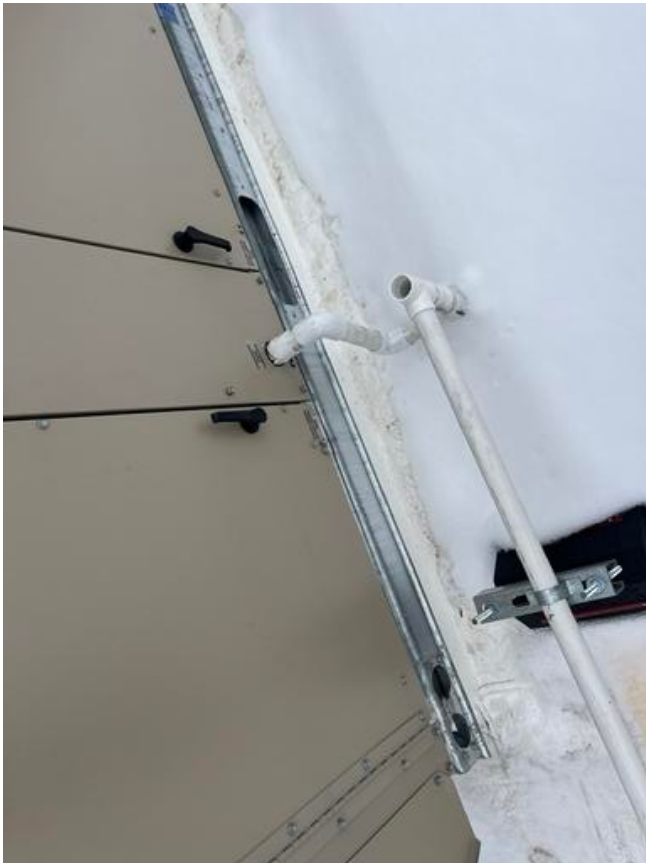
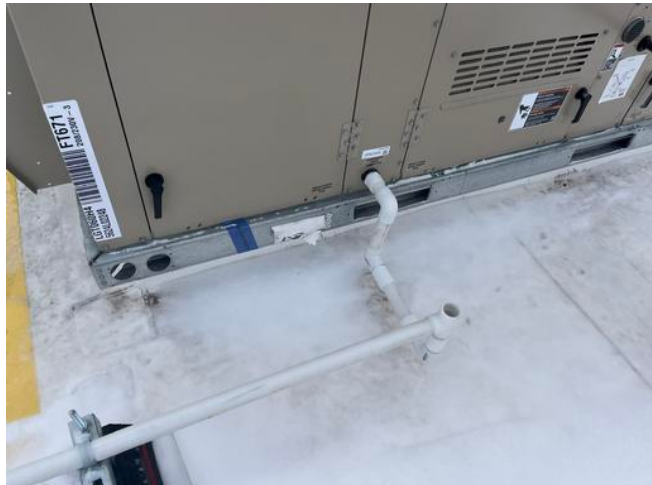
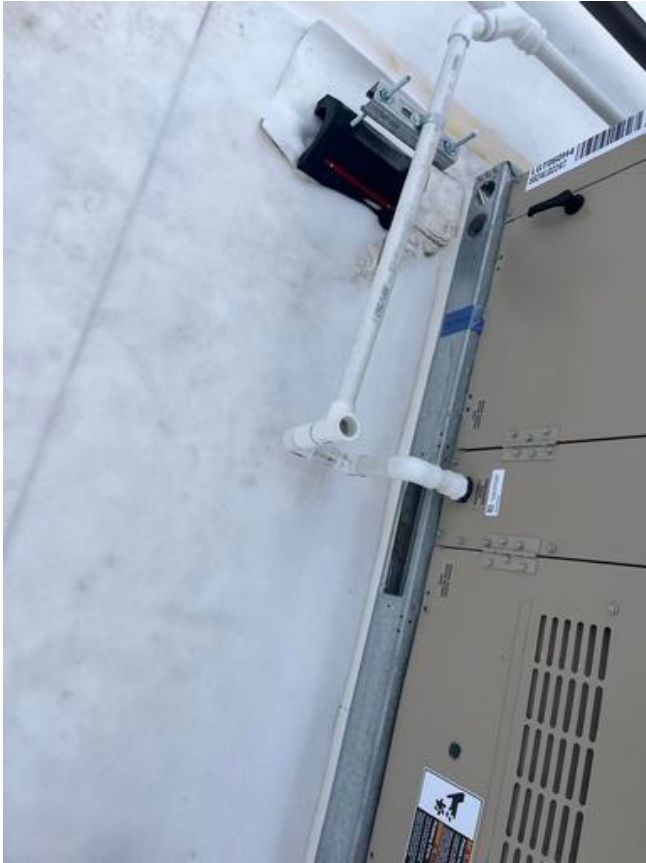
Description
Equipment condensate piping or p-trap is not constructed per normal CFA specifications.

Redid condensate lines
