Final TAB Punchlist

Prepared by Jacob Davidson

Jan 21, 2025

L05792_North Platte FSU (NE)

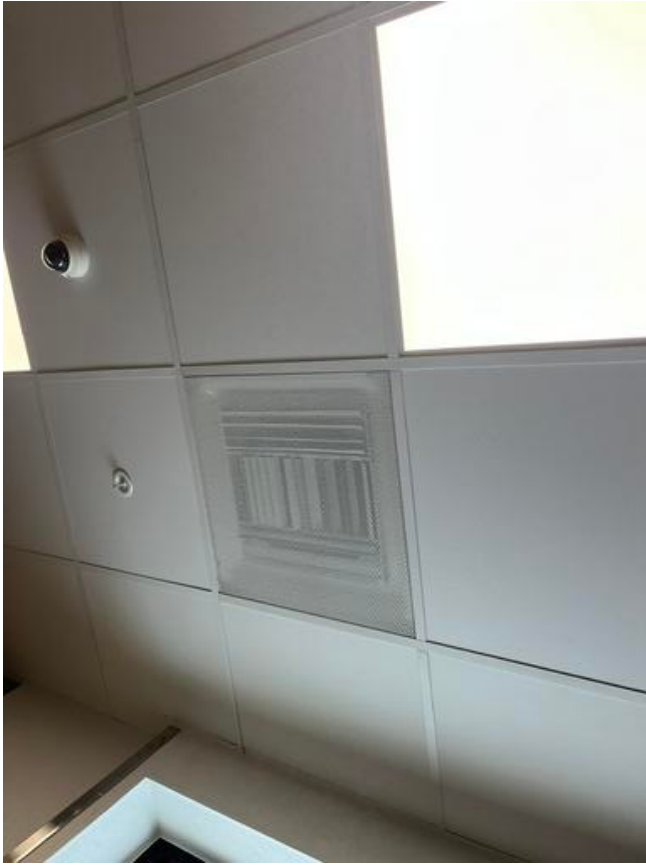
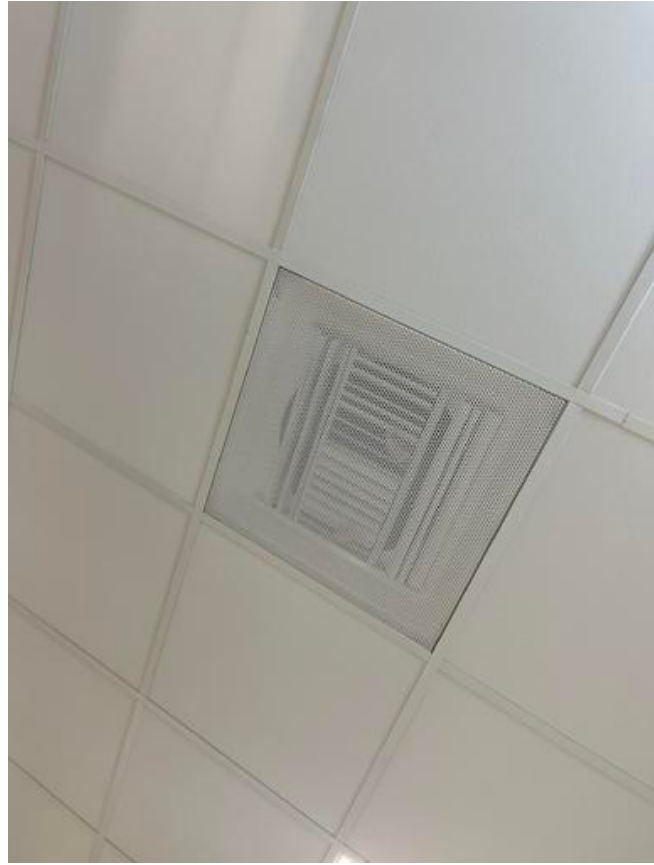
There is debris in the face of many of the diffusers. Go through and make sure grilles are clear of insulation and debris.

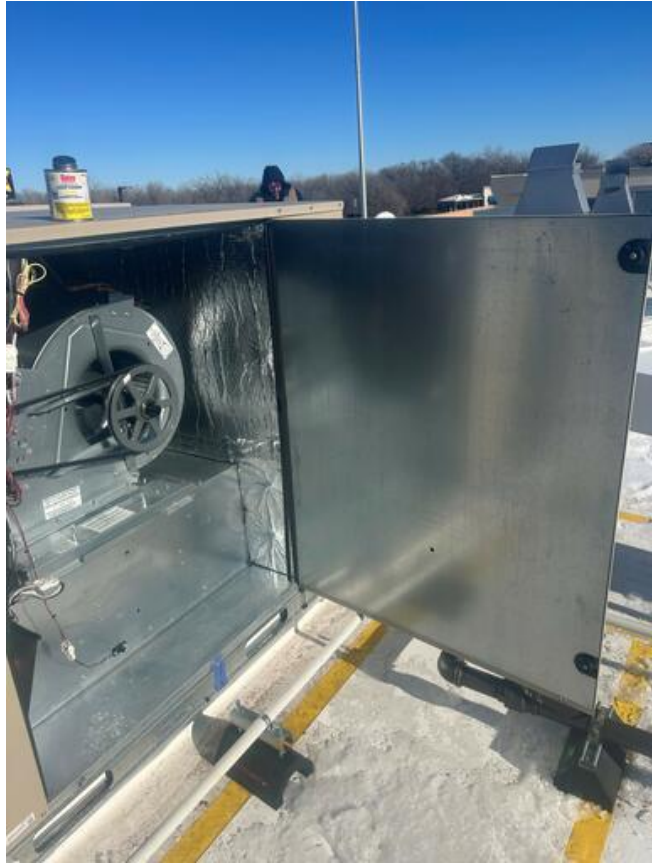
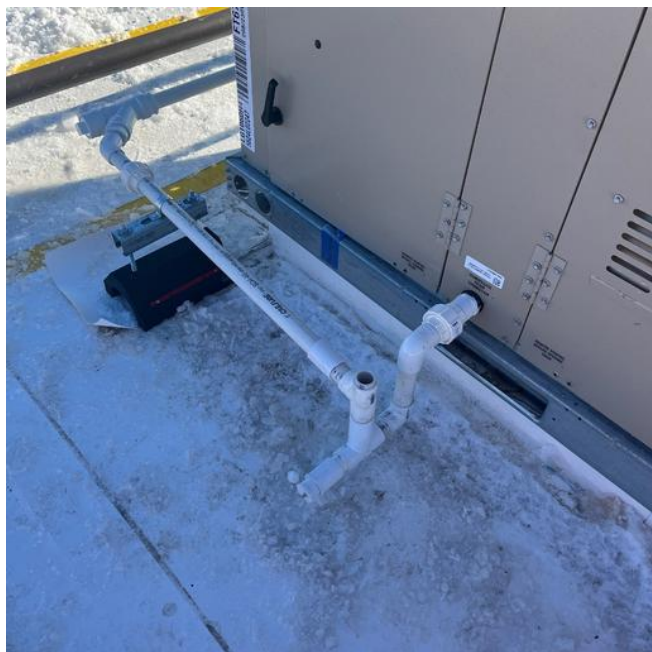
Description
Equipment condensate piping or p-trap is not constructed per normal CFA specifications.

Redid condensate lines
