# 2212 Pre-Grid Punchlist

Prepared by Ben Searles

Apr 3, 2025

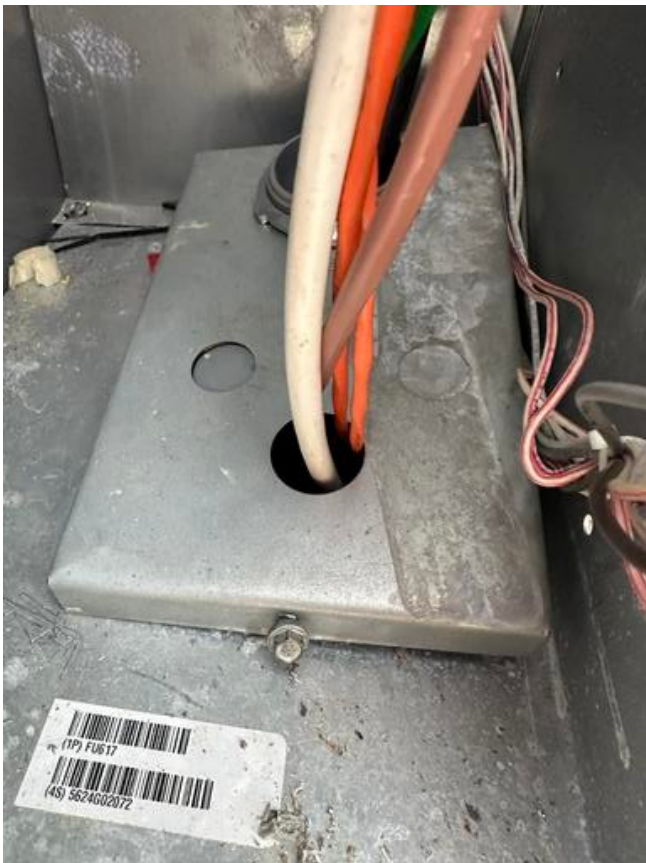
IMG\_0691

## #253 [UNIT 505] [NEW] Equipment wiring portals.

Low voltage wiring  
grommets need to be used  
to protect wiring from shorts.

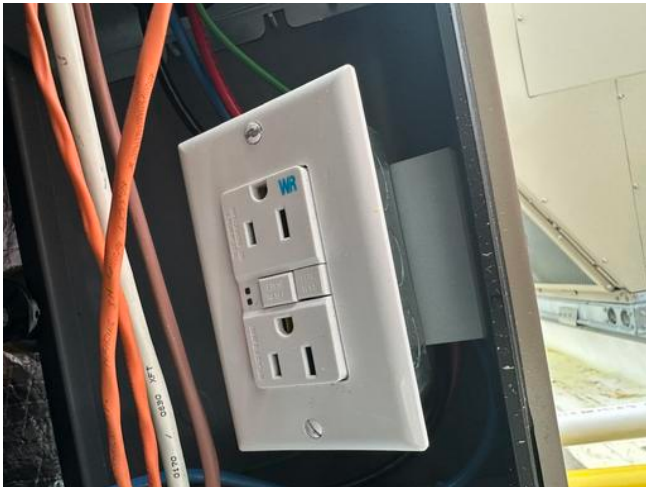
IMG\_0692

## #252 [UNIT 506] [NEW] Equipment GFI outlets.

AC2, AC4, and AC6 GFI outlets are missing wiring.
