TAB Punchlist

Prepared by David Annan

Jan 6, 2025

#339 Existing AC-2: Inaccessible damper

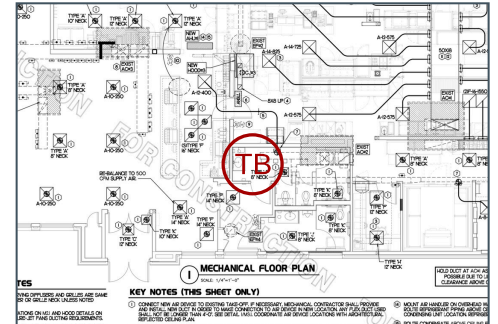
Unable to access damper for SGRD 2-2 (lobby supply diffuser) due to the restroom hard ceiling. Supply diffuser is currently 117% above design.

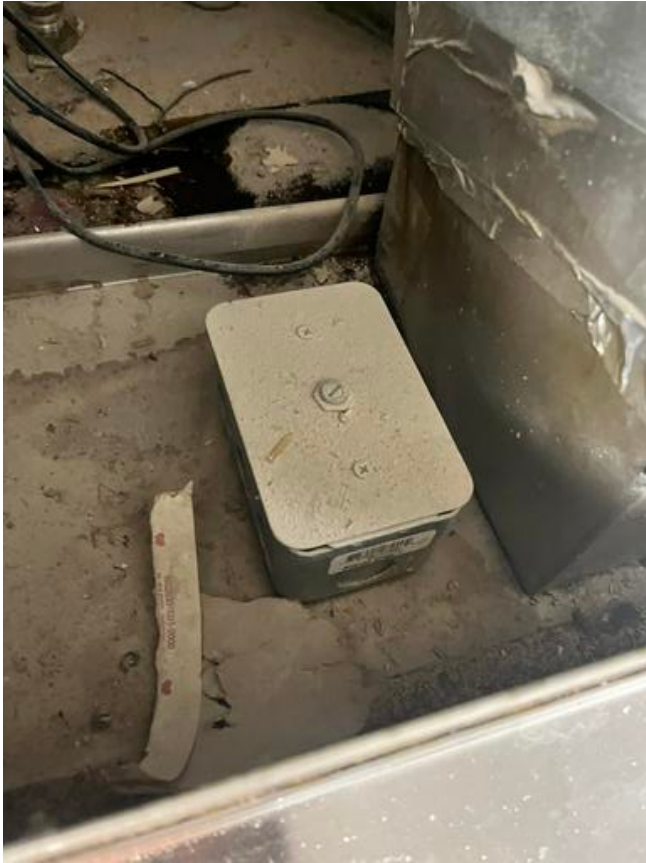
IMG_6718

#338 Existing Hood-1: Capture jet speed controller is not functional

Existing hood-1 left and right capture jet speed controllers were not wired in. Unable to balance capture jets.

After performing smoke capture test the capture jets still provide proper smoke capture.
