Report: Deficiency Report

Function: Test, Adjust, & Balance

11-24-25 WHATABURGER #1667 LARGO, FL

Whataburger Restaurants

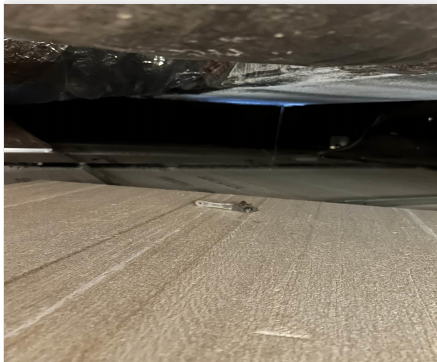
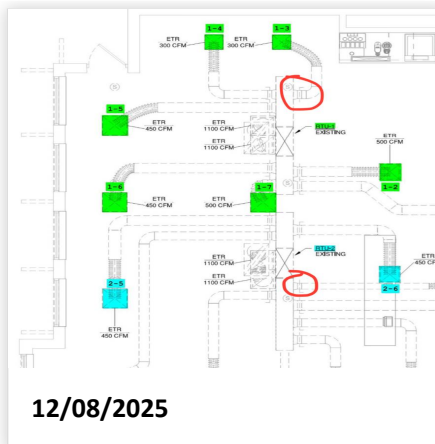
Issue Name : Dining Room - Broken Dampers
Description : Several dampers in the dining room broke when attempting to adjust. Existing damper handles are brittle and prone to failure. Recommend mechanical inspection. Unable to balance the dining room until broken dampers are repaired.

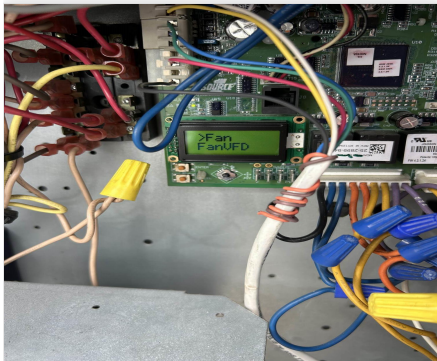
Issue Name : Economizers Not Operational
Description : All RTU economizers are not functional. For RTUs 1 and 2, the damper does not respond to setpoint changes. RTUs 3 and 4 do not have economizer setpoints enabled on the controller. All economizers must be functional to complete TAB.
Created By : National TAB **Assigned To :** National TAB - Will Turnbough
Status : Open
Priority : Urgent **Asset Tag :**
Originated Date : 12/08/2025 - Mark Johnson - National TAB
