Report: Prelim Report
Function: Test, Adjust, & Balance
Date: 05/07/2025
Completed By: National TAB

PROJECT
05-05-25 CHIPOTLE #5182 MARIETTA, OH

Project: 05-05-25 CHIPOTLE #5182 MARIETTA, OH

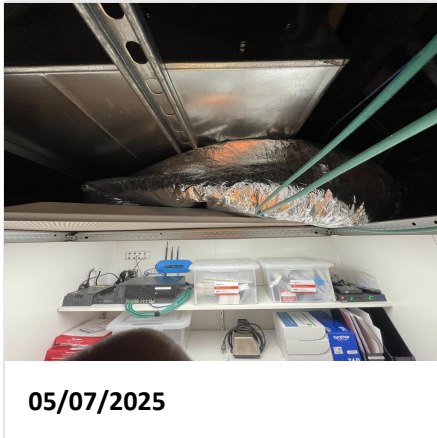
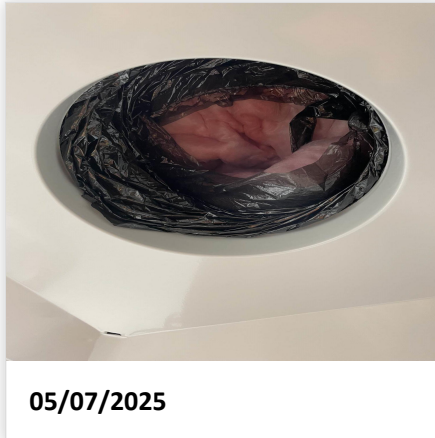
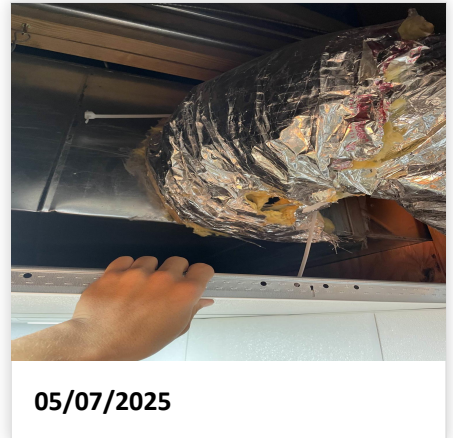
Issue Name : Office Diffuser Restricted Flow
Description : Supply diffuser for managers office is well below design due to poor connection at take-off and kinked flex / poor routing to diffuser.
Created By : National TAB **Assigned To :** National TAB - Jordan Best
Status : Open
Priority : Urgent **Asset Tag :**
Originated Date : 05/07/2025 - Jordan Best - National TAB

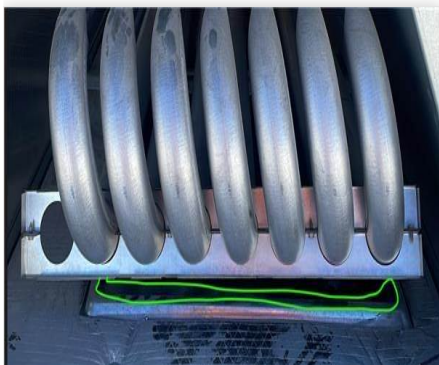
Issue Name : RTU-2 Supply Air Leakage
Description : RTU-2 is below design at full speed due to a gap inside the supply section of the unit. RTU discharge opening is not centered over duct opening causing air to leak into the roof membrane and above ceiling. This issue must be corrected before TAB can be completed.
Created By : National TAB **Assigned To :** National TAB - Jordan Best
Status : Open
Priority : Urgent **Asset Tag :**
Originated Date : 03/18/2025 - Jordan Best - National TAB

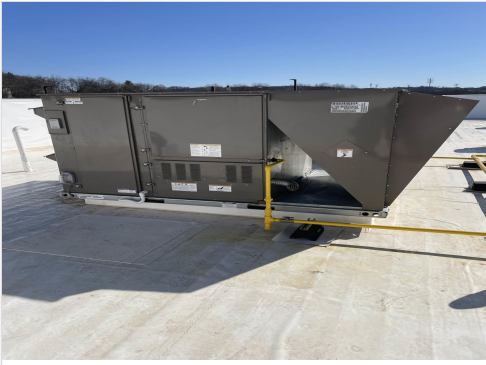
Asset: RTU1

Test Data		
	Design	Actual
SF CFM	3500	2457
RA CFM	3000	2095
OA CFM	500	362
RL Voltage	-	212.6/214.1-214.8
RL Amperage	-	5.2 VFD
SF Rotation	-	CCW
SF System SetPt	-	100%
RA Damper Position	-	85%
Min OA Damper Position	-	15%
Min OA Damper Type	-	MOTORIZED
OA Enthalpy Setpt	-	27B

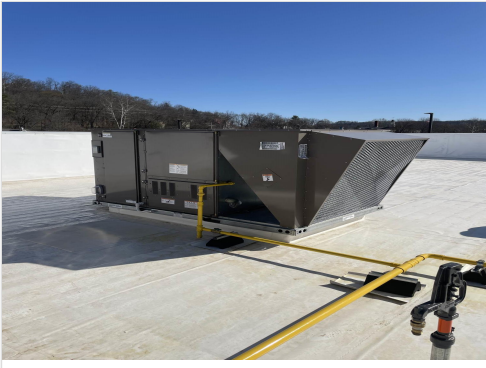
Asset: RTU2

Test Data		
	Design	Actual
SF CFM	4000	3053
RA CFM	3000	2307
OA CFM	1000	746
RL Voltage	-	213.7/213.2/212.8
RL Amperage	-	6.27 VFD
SF Rotation	-	CCW
SF System SetPt	-	100%
RA Damper Position	-	75%
Min OA Damper Position	-	25%
Min OA Damper Type	-	MOTORIZED
OA Enthalpy Setpt	-	27B
