**Report: Deficiency Report
Function: Test, Adjust, & Balance
Date: 09/30/2025
Completed By: National TAB**

**PROJECT
09-29-25 QT #1107 ANDERSON, SC**

**QUIKTRIP
4705 SOUTH 129TH EAST AVENUE
TULSA, OK 74134**

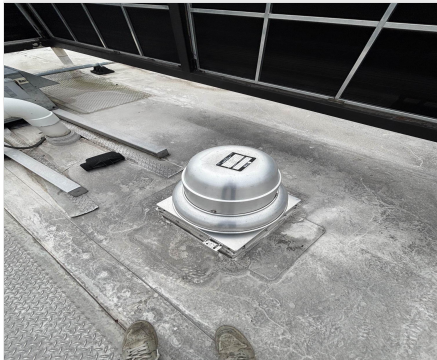
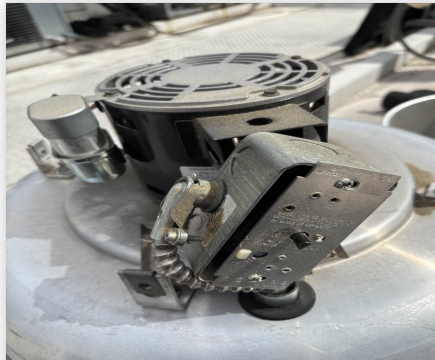
Issue Name : EF-1 speed controller
Description : The speed controller on EF-1 is not working, fan was left on high, above design.
Created By : National TAB **Assigned To :** National TAB - Brianna Biggs
Status : Open
Priority : Medium **Asset Tag :** EF1
Originated Date : 09/30/2025 - Christian Moller - National TAB

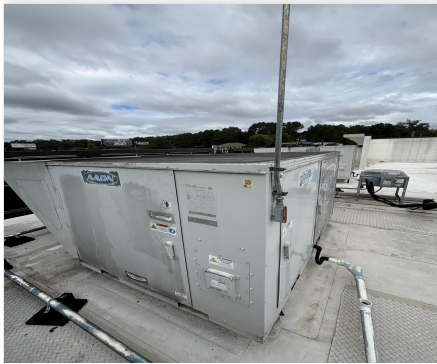
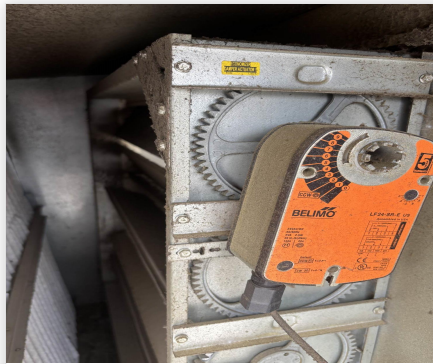
Issue Name : RTU-3 economizer doesn't close all the way
Description : The economizer on RTU 3 does not close more than 0.75". This is enough for 807 CFM of OA but does not close enough to find a set point for the 350CFM of OA also required. (Picture shows lowest set point)
Created By : National TAB **Assigned To :** National TAB - Brianna Biggs
Status : Open
Priority : Medium **Asset Tag :** RT-3
Originated Date : 09/30/2025 - Christian Moller - National TAB
