Report: Deficiency Report
Function: Test, Adjust, & Balance
Date: 09/30/2025
Completed By: National TAB

PROJECT
09-29-25 QT #1107 ANDERSON, SC

4123 CLEMSON BLVD

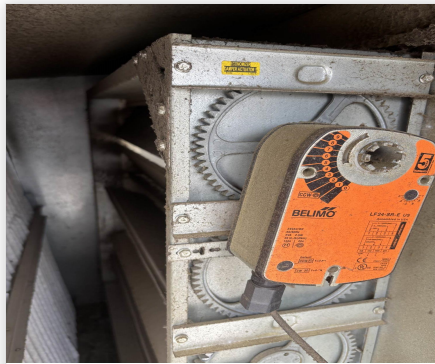
Issue Name : RTU-3 economizer doesn't close all the way
Description : The economizer on RTU 3 does not close more than 0.75". This is enough for 807 CFM of OA but does not close enough to find a set point for the 350CFM of OA also required. (Picture shows lowest set point)
Created By : National TAB **Assigned To :** National TAB - Brianna Biggs
Status : Open
Priority : Medium **Asset Tag :** RT-3
Originated Date : 09/30/2025 - Christian Moller - National TAB
