## Summary:

The purpose of the visit to True Food in Santa Monica was to address hood capture issues.

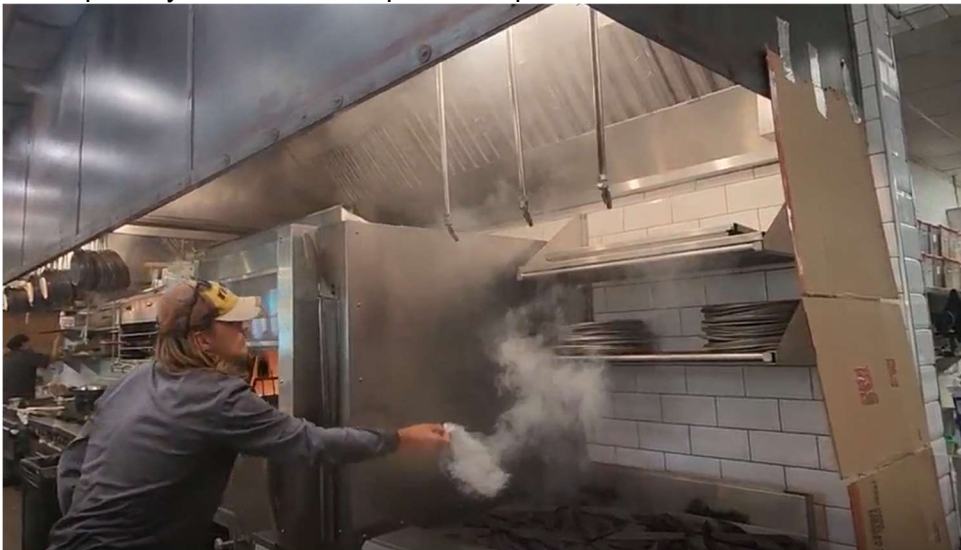
3. Vertical end panels need to be installed on both ends of the hood. Mocked up cardboard to temporarily test and this improved capture.

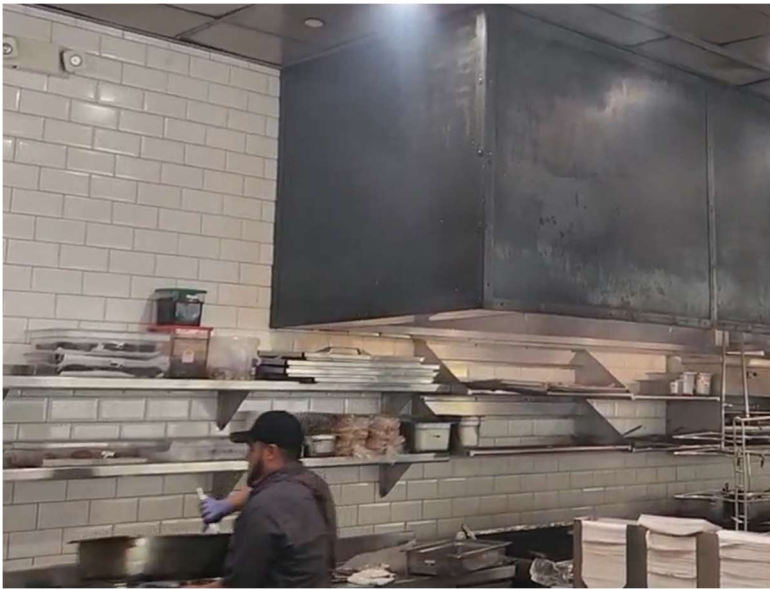
4. The shelving and salamander above the equipment creates more adverse effects on hood performance at the cooking surface. Especially the shelving that is over equipment then continues to the left to go outside the hood. All smoke under shelving will travel left, continue out of the hood and then into space. The shelving needs to stop 12" from left end of hood and then at least partial end panel-30" wide & down 6" below the shelving in hood.

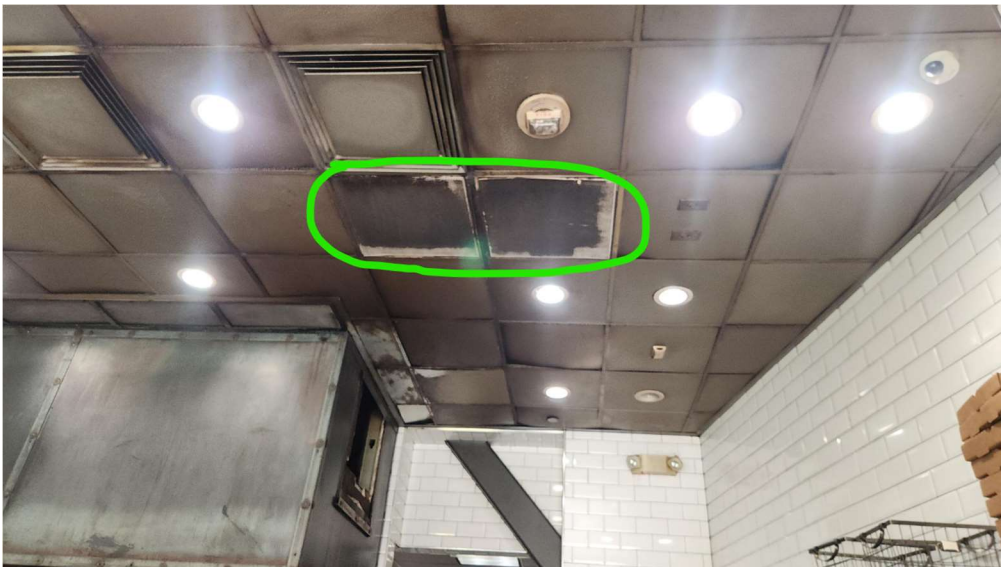
5. HVAC system is a plenum style return and there are returns located in close proximity to the hood. They are clogged with grease right now so they are not causing any issue. But they need to be cleaned and then relocated towards the front of the kitchen at least 8 feet from the hood.

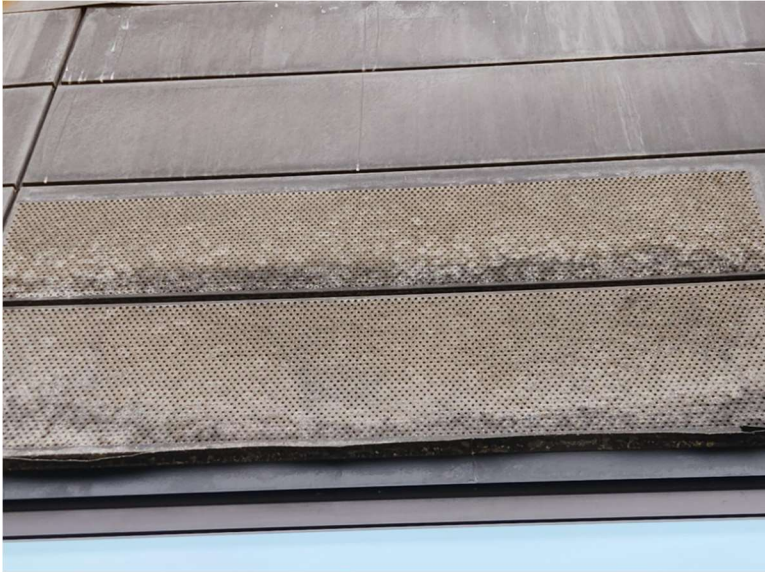
6. MUA airflow is 3487 CFM (68% of design). Part of the reason is that the intake louver appears to be clogged. Recommend cleaning (wait until after changes to exhaust

system are addressed)

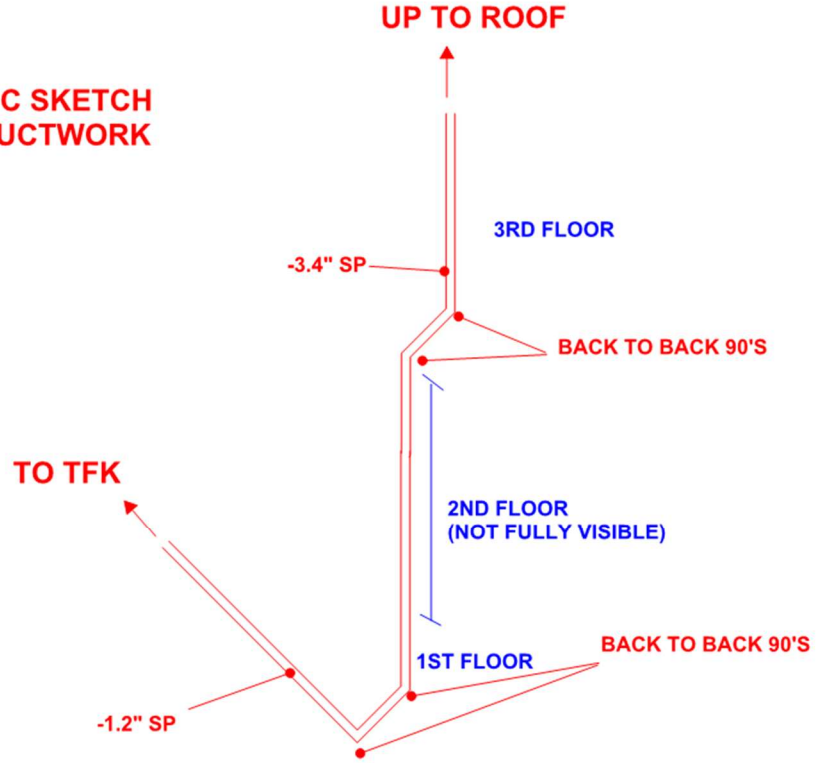
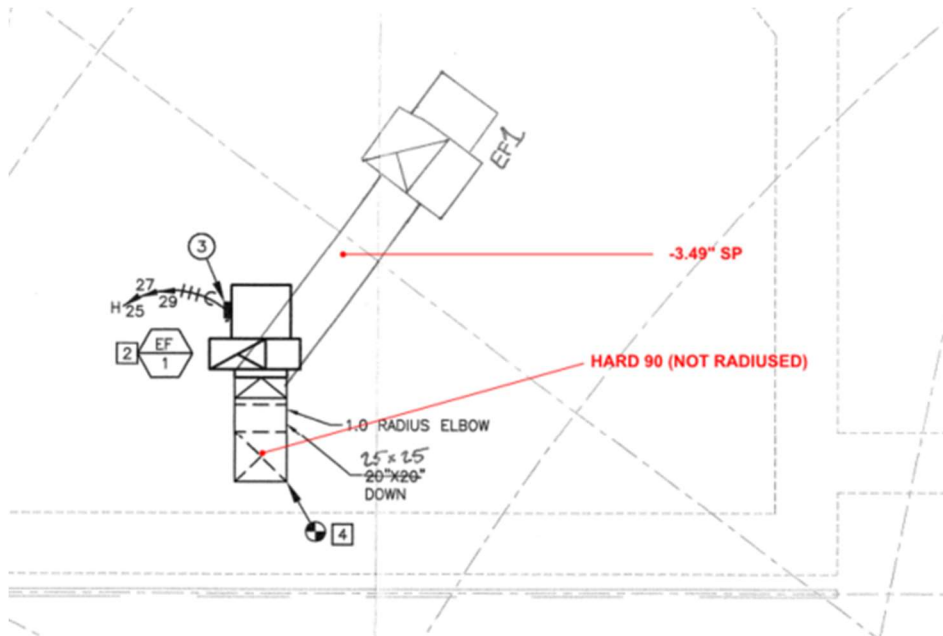
**VERTICAL ISOMETRIC SKETCH  
OF MALL GREASE DUCTWORK**

The remaining accessible exhaust duct run was inspected except for the second floor section of ductwork. Not all transitions are visible, but it appears there are between 6 to 8 transitions in the ductwork. There is also about a half of an inch of grease build up at one of the 90 degree transitions outside of True Foods. (see photos and sketches on the following pages).

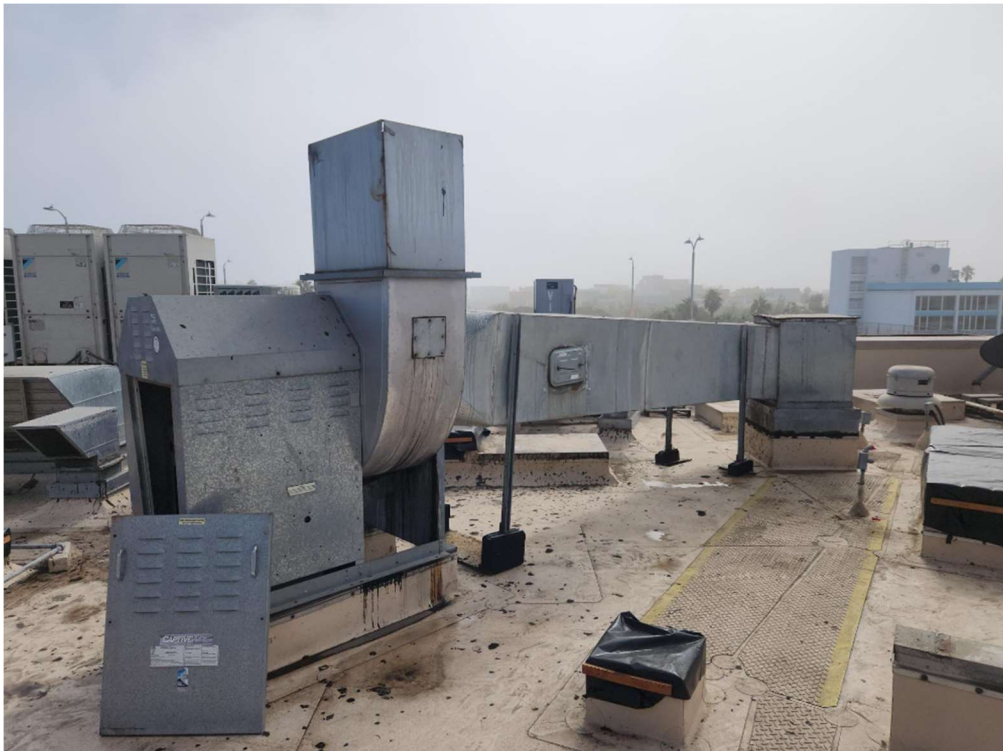
Roof top grease duct/exhaust fan:

EF-1 is running at 6 amps out of and FLA of 9 amps. The motor is set to run at 70hz out of a maximum of 75hz. Did not want to increase the speed further as the fan is already vibrating and airflow could only be increased slightly anyway. The static pressure was measured at the fan as -3.5". After the MUA was inspected and read out the ductwork above ceiling for EF-1 was inspected. The static pressure at the clean out door immediately before the duct leaves true foods space is -1.1" which is significantly lower than what was read on the roof. There is also grease build up in the ductwork.

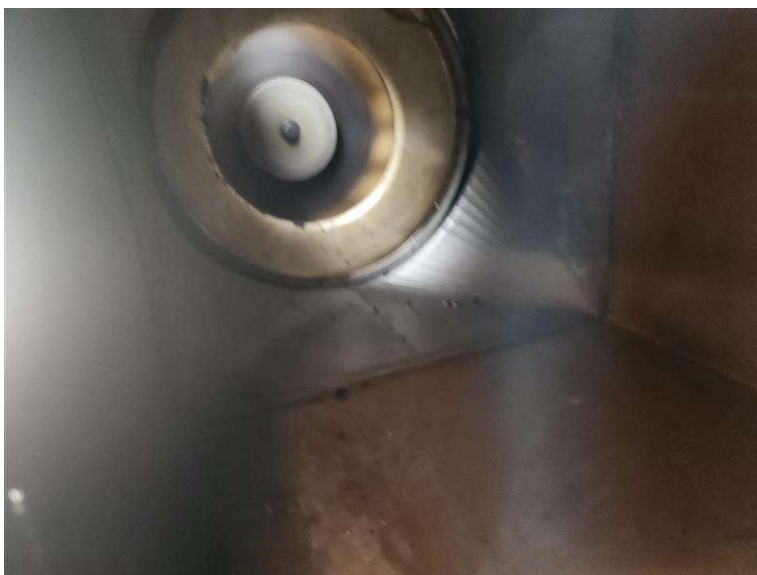
Fan inlet is clear and unrestricted

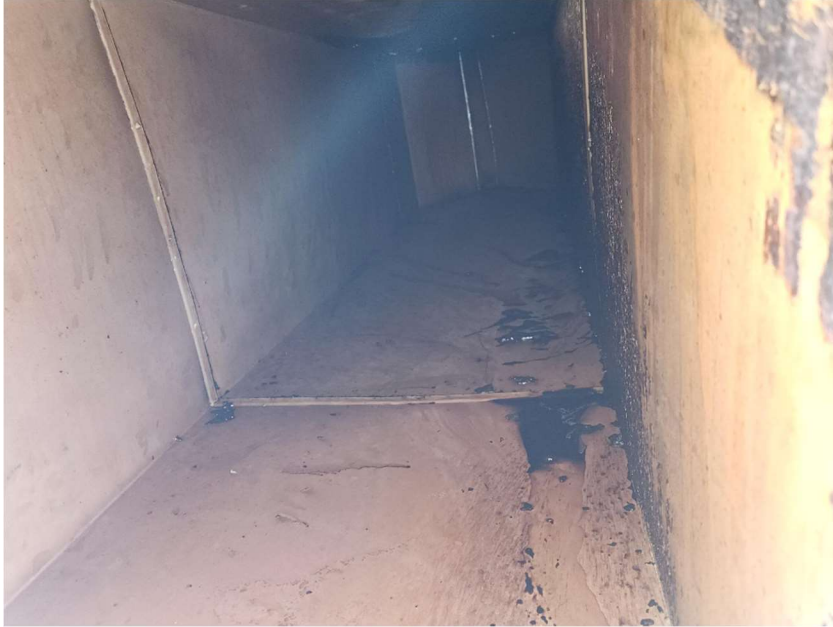
Ductwork at roof towards the 90 is unrestricted:

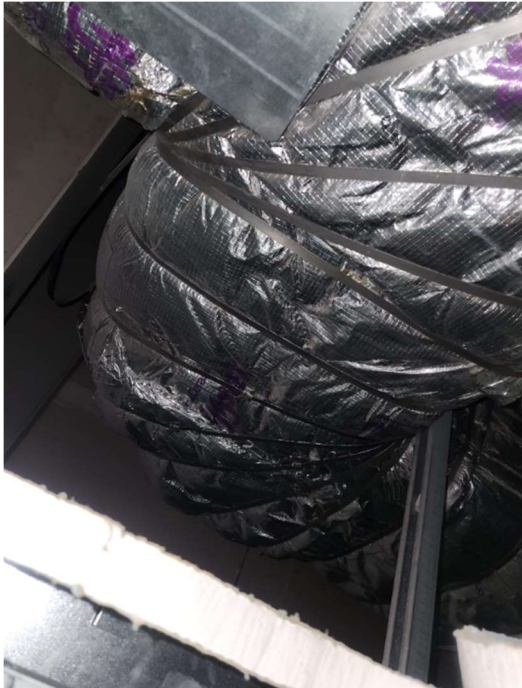
3<sup>rd</sup> floor back to back 90's:

1. The main hood EF is 4144 CFM out of original design of 6400 CFM. The airflow is low primarily due to pressure losses from multiple 90 degree transitions (some back to back) and system effect losses. A new larger fan will likely be required, however the pressure would have to double based on fan law to achieve the original design (7" @ 6400 CFM). This pressure may not be realistic. Also the more you increase velocity in the duct, the higher the impact due to system losses is. This means that airflow may not increase as much as predicted due to these transitions. Either way, it looks like a larger fan is needed. But there may be a need to have some of the ductwork modified if we cannot overcome the back to back 90 degree transitions to get optimum performance. Recommend consulting an OEM to discuss options.

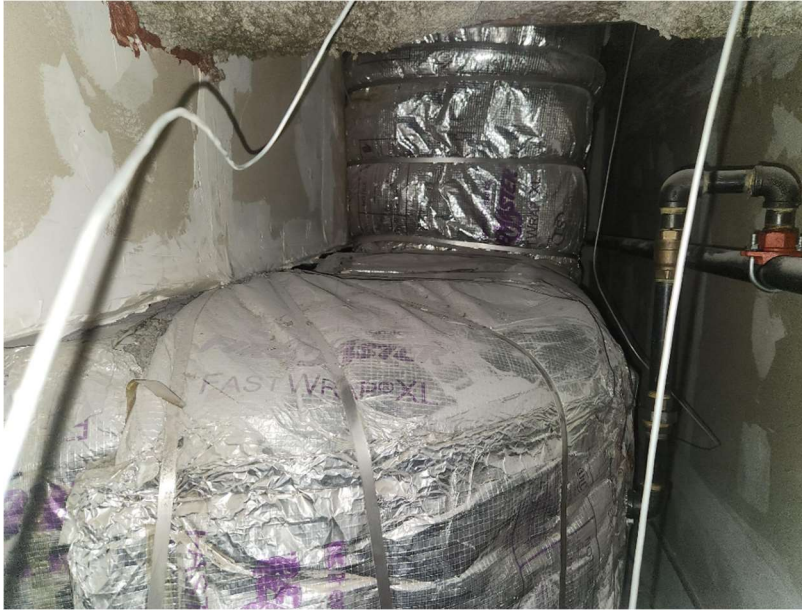
1<sup>st</sup> floor back to back 90's

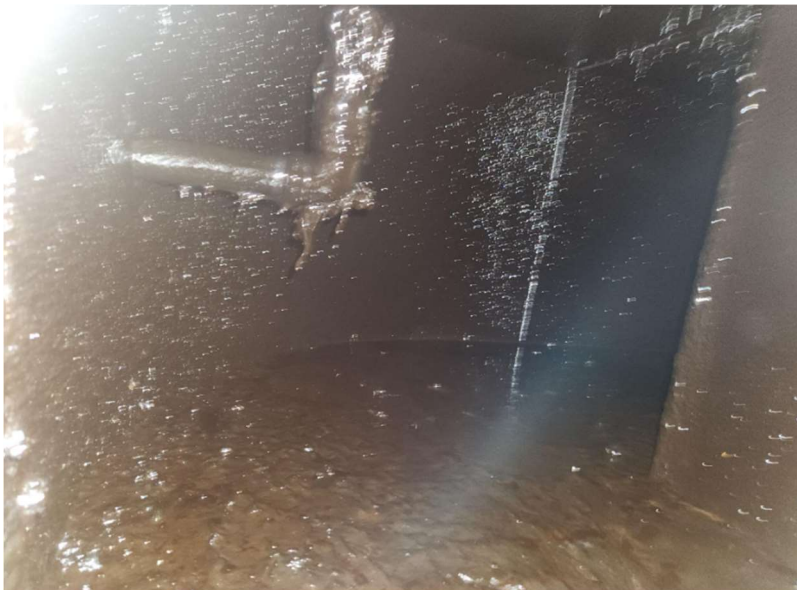
1<sup>st</sup> floor inside the duct. Pools of grease

2. Grease duct is extremely dirty both in True Food space and out side of it. Recommend the ductwork be thoroughly cleaned. This buildup could be having an impact on airflow, so cleaning thoroughly may increase flow some.

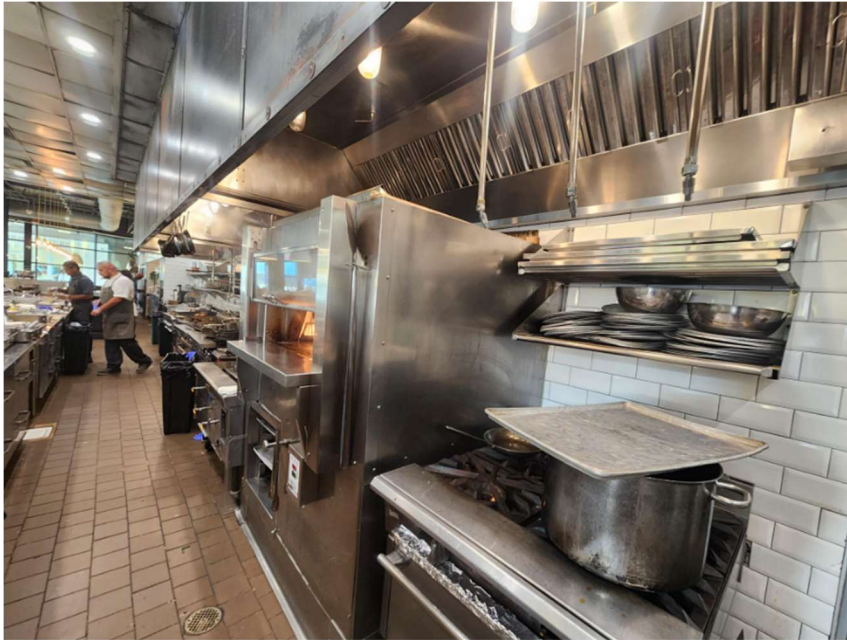
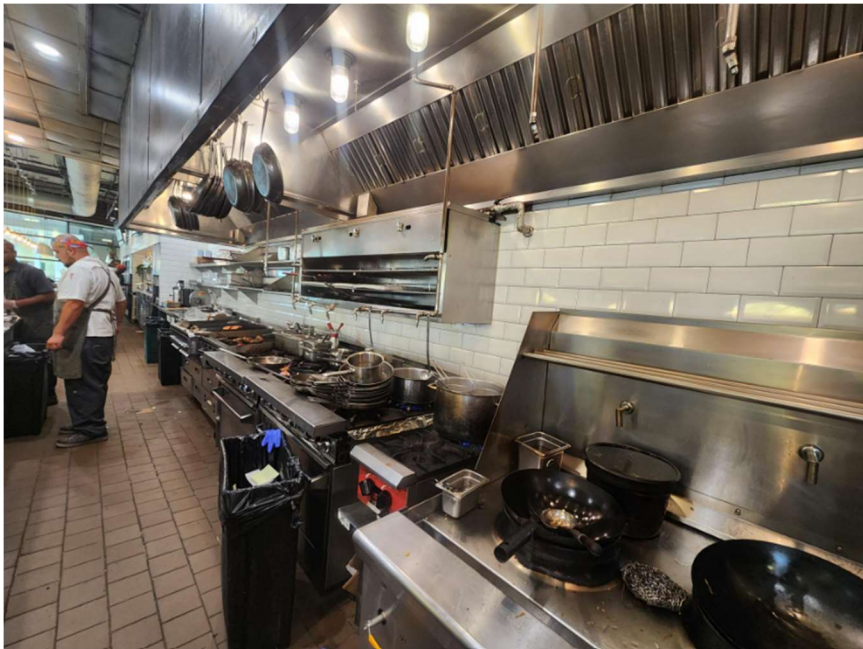
Hood pictures:

While cooking was occurring hood capture was observed to be around 60-70%. A smoke test with a smoke emitter was also used and similar capture observed. The smoke primarily escapes once entering the canopy and then billows out on all sides. The airflow was read out with a velocity matrix which totaled out to 4144 CFM of exhaust which is 69% of design. There are dampers installed at the hood risers and it was confirmed that these were fully open. It was also confirmed that the riser sizes matched design.
