Report: FINAL REPORT
Function: Test, Adjust, & Balance
Date: 11/01/2022

10-24 WALGREENS #03606 - SARASOTA, FL

Project: 10-24 WALGREENS #03606 - SARASOTA,FL

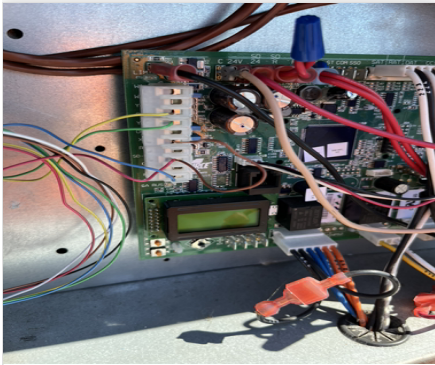
Issue Name : No OCP Wires Landed

Description : There are no OCP wires landed in the new RTUs. NTAB installed jumpers in order to complete balance.
