Report By:

National TAB
1329 E. KEMPER ROAD
SUITE 4210
CINCINNATI, OH 45246

Report: FINAL REPORT
Function: Test, Adjust, & Balance
Date: 11/01/2022

10-24 WALGREENS #03606 - SARASOTA,FL

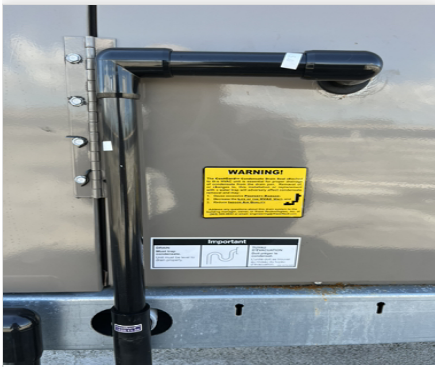
Issue Name : Costgard Piping Not Cemented
Description : The PVC Costgard piping is not cemented and can be twisted or separated.
Created By : National TAB **Assigned To :** National TAB - Will Turnbough
Status : Open
Originated Date : 10/26/2022 - Stephen Tassinaro - National TAB

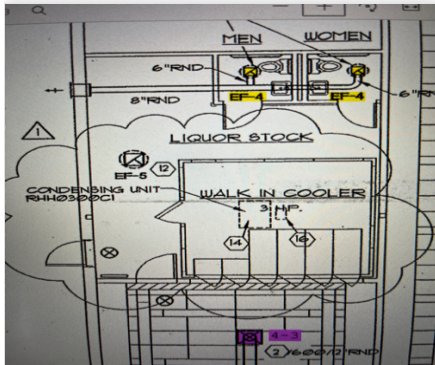
Issue Name : EF-5 Not Running
Description : NEW EF-5 (Liquor Stock) is not running. Unable to locate a thermostat or switch to signal the fan. Liquor manager is not aware of any switches nor has he noticed the fan running at any time.
Created By : National TAB **Assigned To :** National TAB - Will Turnbough
Status : Open
Originated Date : 10/27/2022 - Stephen Tassinaro - National TAB

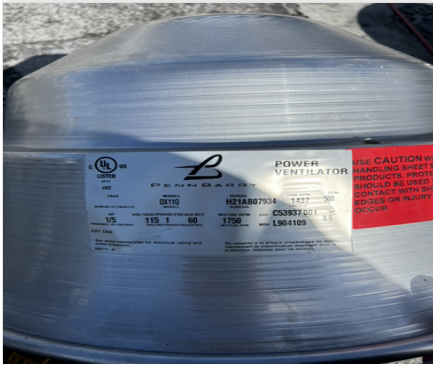
Issue Name : EF-6 Low Flow

Description : EF-6 serving the Women’s RR and the sales floor is low on exhaust flow. The fan data sticker indicates the fan is rated for 500CFM, with the speed controller maximized 547CFM was measured. The original plans indicate a design of 790CFM.

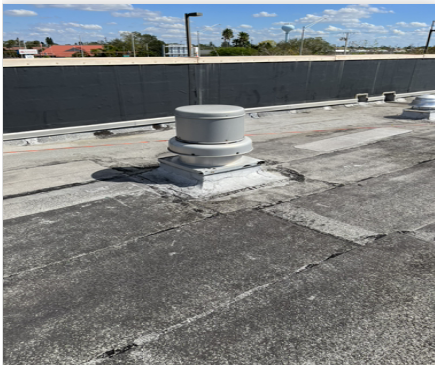
Issue Name : Existing EF-1 Not Functional

Description : EF-1 (Stock Room) is not running. No response from the fan when thermostat set point is changed within the stock room.

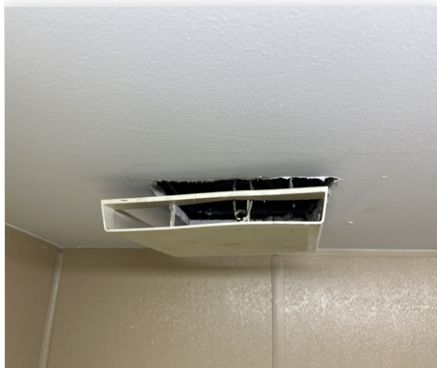
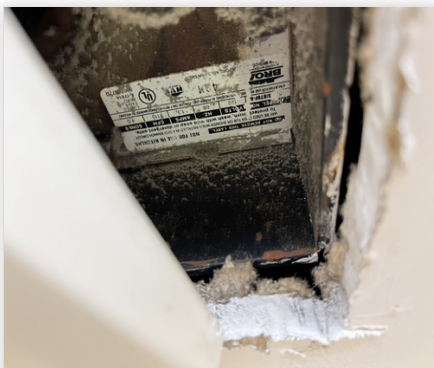
Issue Name : Existing EF-4 Dirty and No Airflow

Description : EXISTING EF-4 serving the liquor restroom is running but not exhausting any air from the space. There is a significant buildup of dust and debris in the fan.

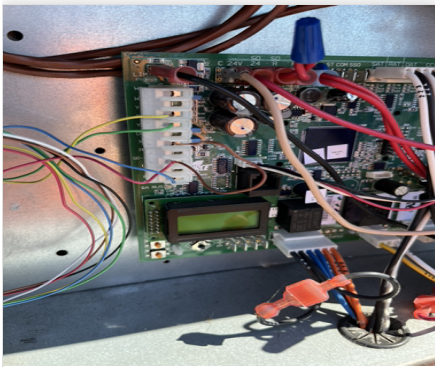
Issue Name : No OCP Wires Landed

Description : There are no OCP wires landed in the new RTUs. NTAB installed jumpers in order to complete balance.

- **11/01/2022 National TAB - Will Turnbough**
 - Acceptable per Startup binder

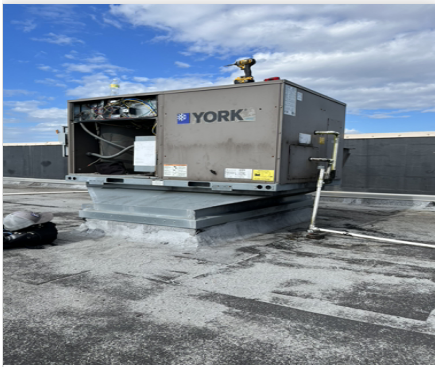
Issue Name : RTU-3 High Static Pressures

Description : RTU-3 (Pharmacy) has high static pressures which appear to be a result of a restrictive curb adapter. The unit is proportionally balanced to 90% of the design. The pharmacy is comfortable in this condition.

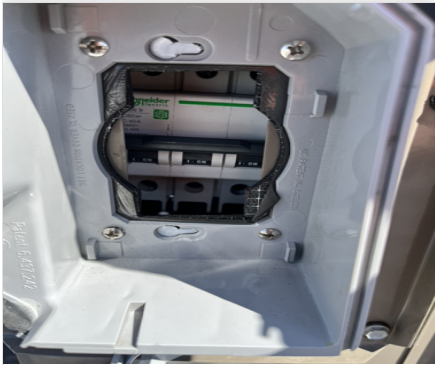
Issue Name : RTU-4 Disconnect Failure

Description : RTU 4 (Liquor) main disconnect switch failed on the last day of TAB. Unable to set outside air and retrieve final data.

RTU-4 NEEDS APPROX 165CFM OF OA IN ORDER TO HAVE +10% PRESSURIZATION OF THE LIQUOR STORE WHEN FANS BECOME OPERATIONAL

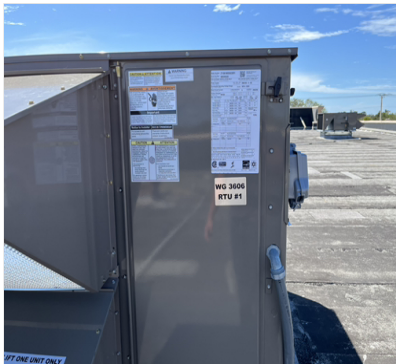
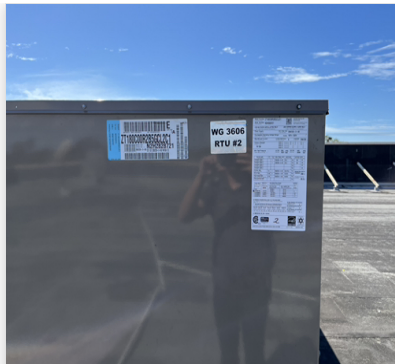
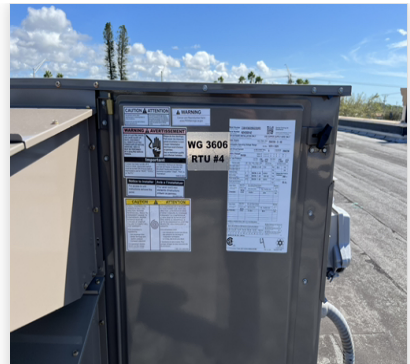
Access doors close tightly with no leaks	Pass
Condensate and gas piping is properly supported.	Pass
Costgaurd is installed per scope of work and piping unions are cemented.	Fail
Additional Comments	COSTGARD PIPING IS NOT CEMENTED.
