Report: FINAL REPORT
Function: Test, Adjust, & Balance
Date: 11/01/2022

10-24 WALGREENS #03606 - SARASOTA, FL

Project: 10-24 WALGREENS #03606 - SARASOTA,FL

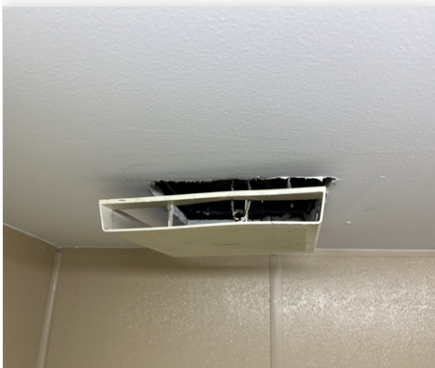
Issue Name : Existing EF-4 Dirty and No Airflow

Description : EXISTING EF-4 serving the liquor restroom is running but not exhausting any air from the space. There is a significant buildup of dust and debris in the fan.

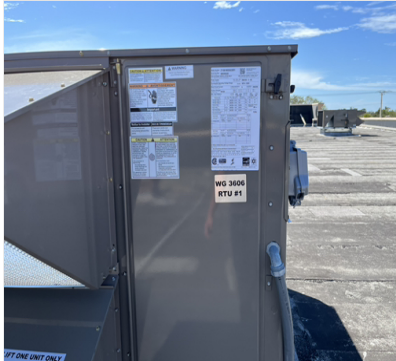
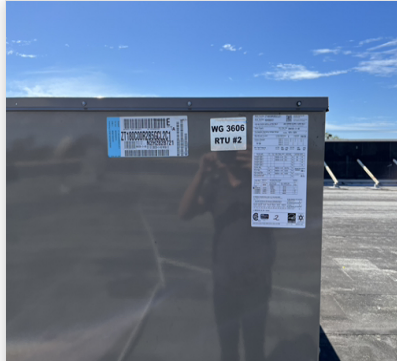
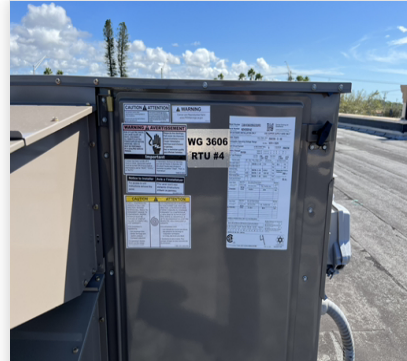
Access doors close tightly with no leaks	Pass
Condensate and gas piping is properly supported.	Pass
Costgaurd is installed per scope of work and piping unions are cemented.	Fail
Additional Comments	COSTGARD PIPING IS NOT CEMENTED.
