**Report: TAB REPORT**  
**Function: Test, Adjust, & Balance**  
**Date: 01/16/2023**

**01-09-23 WALGREENS #03606 -  
SARASOTA, FL**

Project: 01-09-23 WALGREENS #03606 - SARASOTA,FL

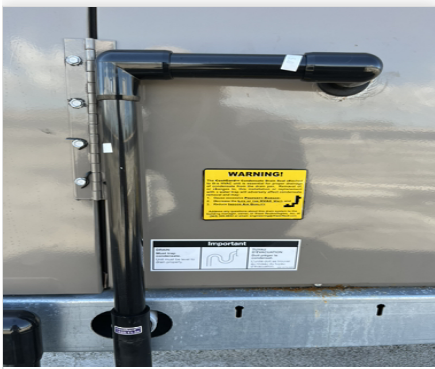
**Issue Name :** Costgard Piping Not Cemented  
**Description :** The PVC Costgard piping is not cemented and can be twisted or separated.  
**Created By :** National TAB **Assigned To :** National TAB - Will Turnbough  
**Status :** Open  
**Originated Date :** 10/26/2022 - Stephen Tassinaro - National TAB

Access doors close tightly with no leaks	Pass
Condensate and gas piping is properly supported.	Pass
Costgaurd is installed per scope of work and piping unions are cemented.	Pass
Additional Comments	(RESOLVED) COSTGARD PIPING IS NOT CEMENTED.

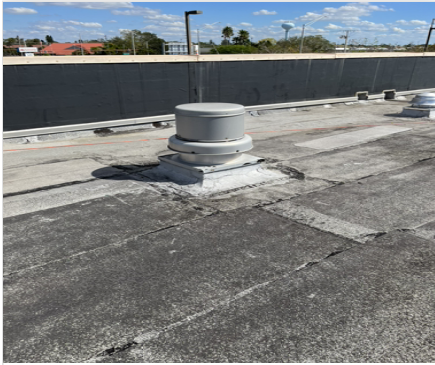
**Issue Name :** Existing EF-1 Not Functional

**Description :** EF-1 (Stock Room) is not running. No response from the fan when thermostat set point is changed within the stock room.

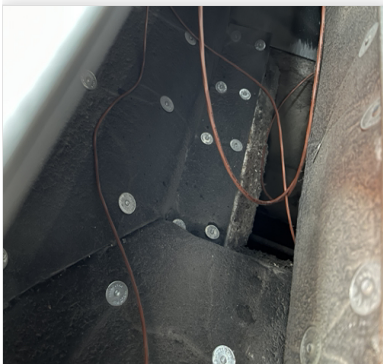
RETURN.jpeg

- **02/23/2023**    **National TAB - Ian Fuller**
  - Return is constricted and has to make a 90 degree turn

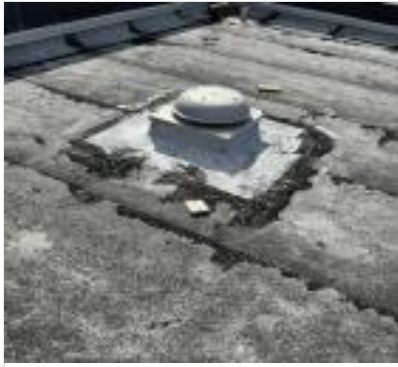
**Description :** EF-7 serves photo area and should be removed and capped by IC.

- **02/23/2023**    **National TAB - Ian Fuller**
  - (RESOLVED) Fan has been removed and capped off.
