**Report: FINAL REPORT**  
**Function: Test, Adjust, & Balance**  
**Date: 11/01/2022**

## 10-24 WALGREENS #03606 - SARASOTA, FL

6465 S TAMIAMI TRL

SARASOTA, FL 34231

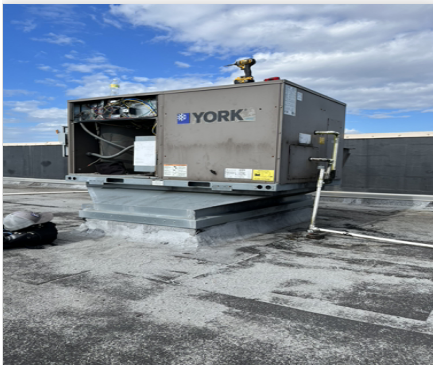
**Issue Name :** RTU-3 High Static Pressures

**Description :** RTU-3 (Pharmacy) has high static pressures which appear to be a result of a restrictive curb adapter. The unit is proportionally balanced to 90% of the design. The pharmacy is comfortable in this condition.

Notes: UNIT PROPOTIONALLY BALANCED TO 90% OF DESIGN. LIMITED TOTAL FLOW LIKELY DUE TO CURB ADAPTER.
