**Report: TAB REPORT**  
**Function: Test, Adjust, & Balance**  
**Date: 01/16/2023**

**01-09-23 WALGREENS #03606 -  
SARASOTA, FL**

Project: 01-09-23 WALGREENS #03606 - SARASOTA,FL

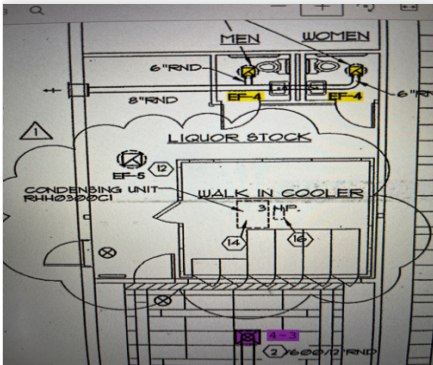
**Issue Name :** EF-5 Not Running  
**Description :** NEW EF-5 (Liquor Stock) is not running. Unable to locate a thermostat or switch to signal the fan. Liquor manager is not aware of any switches nor has he noticed the fan running at any time.  
**Created By :** National TAB **Assigned To :** National TAB - Will Turnbough  
**Status :** Closed  
**Originated Date :** 10/27/2022 - Stephen Tassinaro - National TAB

- **02/03/2023** National TAB - Ian Fuller
  - (Resolved) Fan has been replaced and is now running within design.

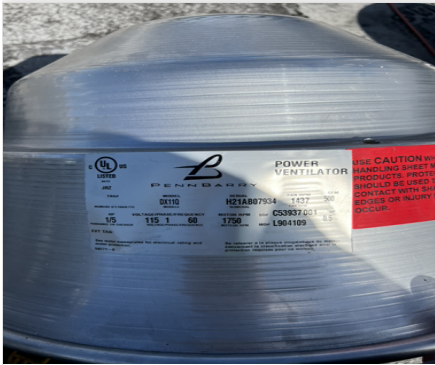
**Issue Name :** EF-6 Low Flow

**Description :** EF-6 serving the Women’s RR and the sales floor is low on exhaust flow. The fan data sticker indicates the fan is rated for 500CFM, with the speed controller maximized 547CFM was measured. The original plans indicate a design of 790CFM.

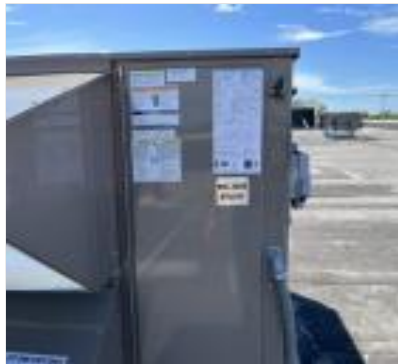
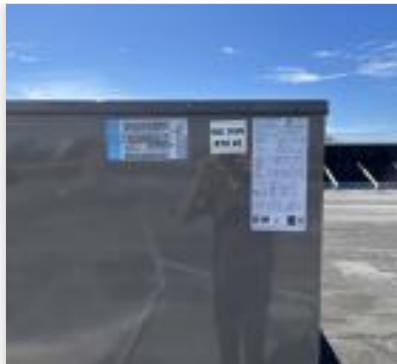
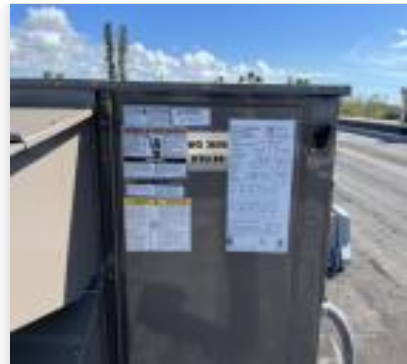
Access doors close tightly with no leaks	Pass
Condensate and gas piping is properly supported.	Pass
Costgaurd is installed per scope of work and piping unions are cemented.	Fail
Additional Comments	COSTGARD PIPING IS NOT CEMENTED.
