Report: TAB REPORT
Function: Test, Adjust, & Balance
Date: 01/16/2023

**01-09-23 WALGREENS #03606 -
SARASOTA, FL**

Project: 01-09-23 WALGREENS #03606 - SARASOTA,FL

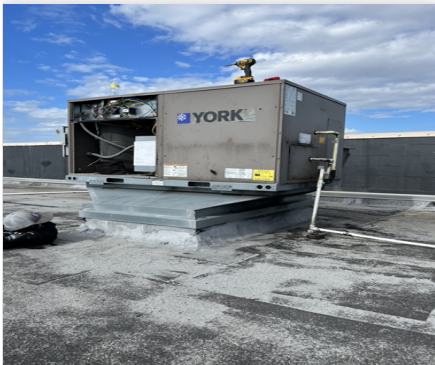
Issue Name : RTU-3 High Static Pressures

Description : RTU-3 (Pharmacy) has high static pressures which appear to be a result of a restrictive curb adapter. The unit is proportionally balanced to 90% of the design. The pharmacy is comfortable in this condition.

Notes: UNIT PROPOTIONALLY BALANCED TO 90% OF DESIGN. LIMITED TOTAL FLOW LIKELY DUE TO CURB ADAPTER.

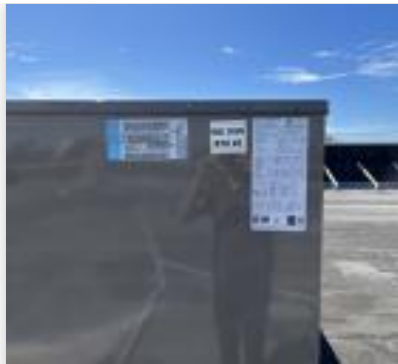
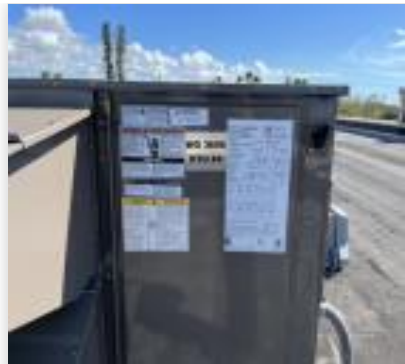
Access doors close tightly with no leaks	Pass
Condensate and gas piping is properly supported.	Pass
Costgaurd is installed per scope of work and piping unions are cemented.	Fail
Additional Comments	COSTGARD PIPING IS NOT CEMENTED.
