National TAB
1329 E. KEMPER ROAD
SUITE 4210
CINCINNATI, OH 45246

Report: TAB REPORT
Function: Test, Adjust, & Balance
Date: 01/16/2023

**01-09-23 WALGREENS #03606 -
SARASOTA, FL**

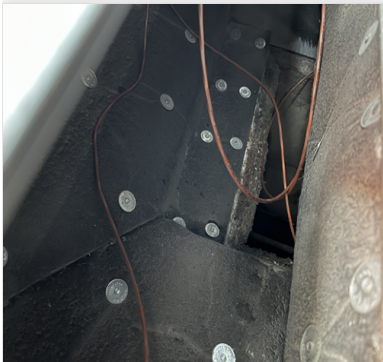
RETURN.jpeg

- **02/23/2023** **National TAB - Ian Fuller**
 - Return is constricted and has to make a 90 degree turn
