10-24 WALGREENS #03606 - SARASOTA,FL

Project Issue Information

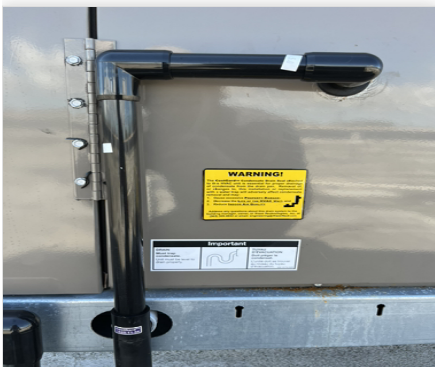
Issue Name : Costgard Piping Not Cemented

Description : The PVC Costgard piping is not cemented and can be twisted or separated.

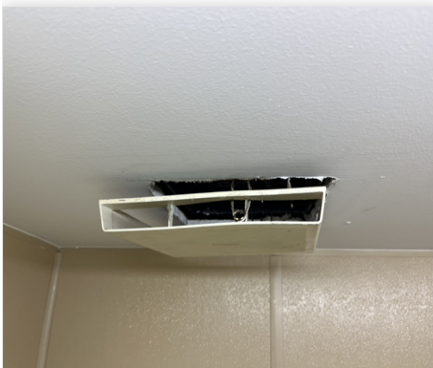
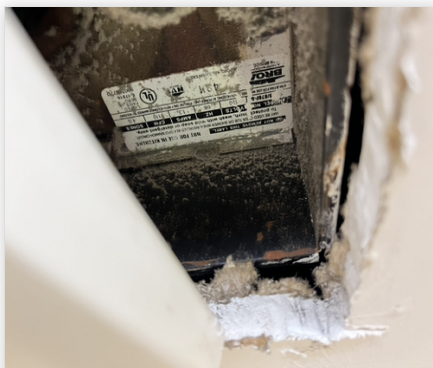
Issue Name : EF-4 Dirty and No Airflow

Description : EXISTING EF-4 serving the liquor restroom is running but not exhausting any air from the space. There is a significant buildup of dust and debris in the fan.
