Report: TAB REPORT
Function: Test, Adjust, & Balance
Date: 01/16/2023

**01-09-23 WALGREENS #03606 -
SARASOTA, FL**

Project: 01-09-23 WALGREENS #03606 - SARASOTA,FL

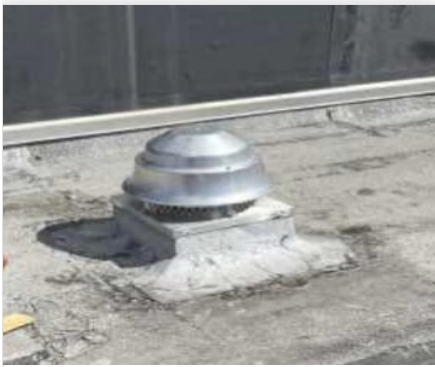
Ef3(1).jpeg

Issue Name : EF#3 controller is broken

Description : Speed controller on fan is not functional. Cannot turn down fan into design.

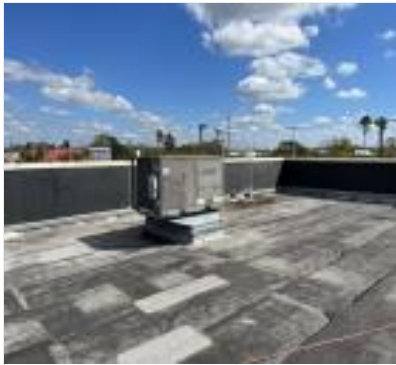
Description : RTU-3 (Pharmacy) has high static pressures which appear to be a result of a restrictive curb adapter. The unit is proportionally balanced to 90% of the design. The pharmacy is comfortable in this condition.

Notes: UNIT PROPOTIONALLY BALANCED TO 90% OF DESIGN. LIMITED TOTAL FLOW LIKELY DUE TO CURB ADAPTER.

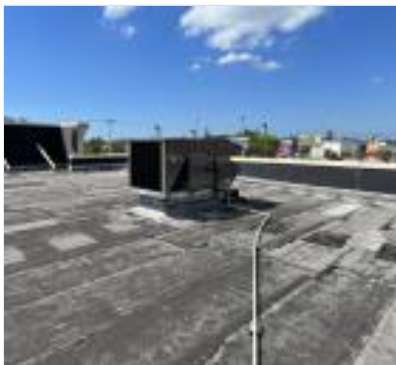
RTU-4

Notes: SERVICE DISCONNECT NOT FUNCTIONAL AT END OF BALANCING. UNIT WOULD NOT TURN ON TO COMPLETE TAB.
